La Maison
Hamlet Road
Haverhill
Suffolk
CB9 8EE

REF: TCR/710

Report compiled by RH Tree Consultants Ltd
January 2024

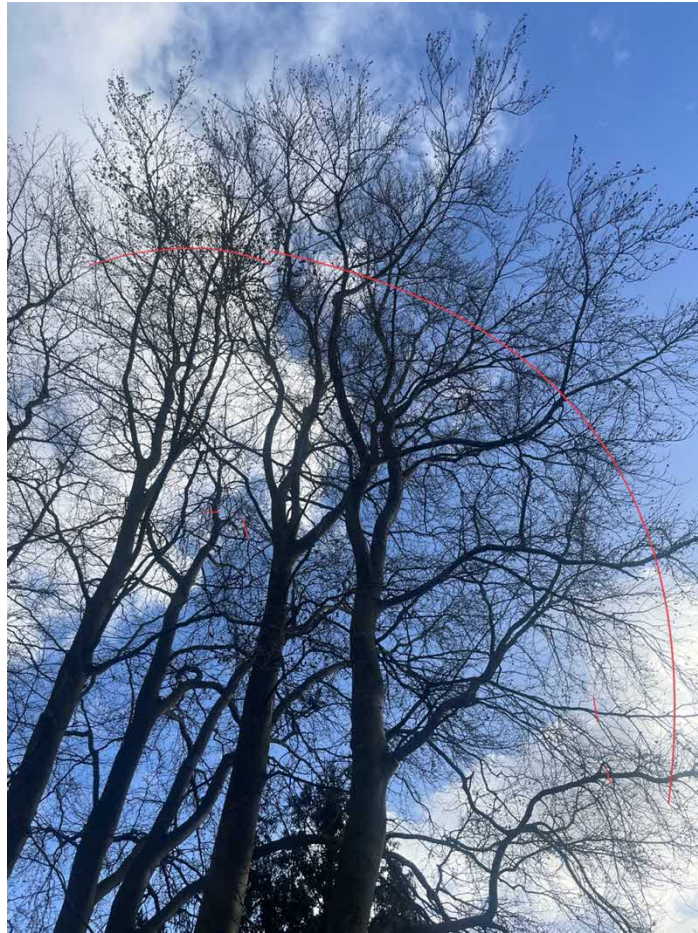
Fig 1. *Tree reduction diagram. These works should allow for the retention of maximum leaf mass to allow the best ongoing physiological condition of the trees*

REASONING: Proactive intervention rather than reactive to failure. The specification made for T002, T003 and T004 is not ideal due to the current growth habit and lack of internal branches but is considered the best overall balance for future management.
