Woodlands Hotel, Haverhill, CB9 7UW
Structural Inspection Report

Prepared for Country Court Care Group

20 June 2022

Glyme Structures Ltd

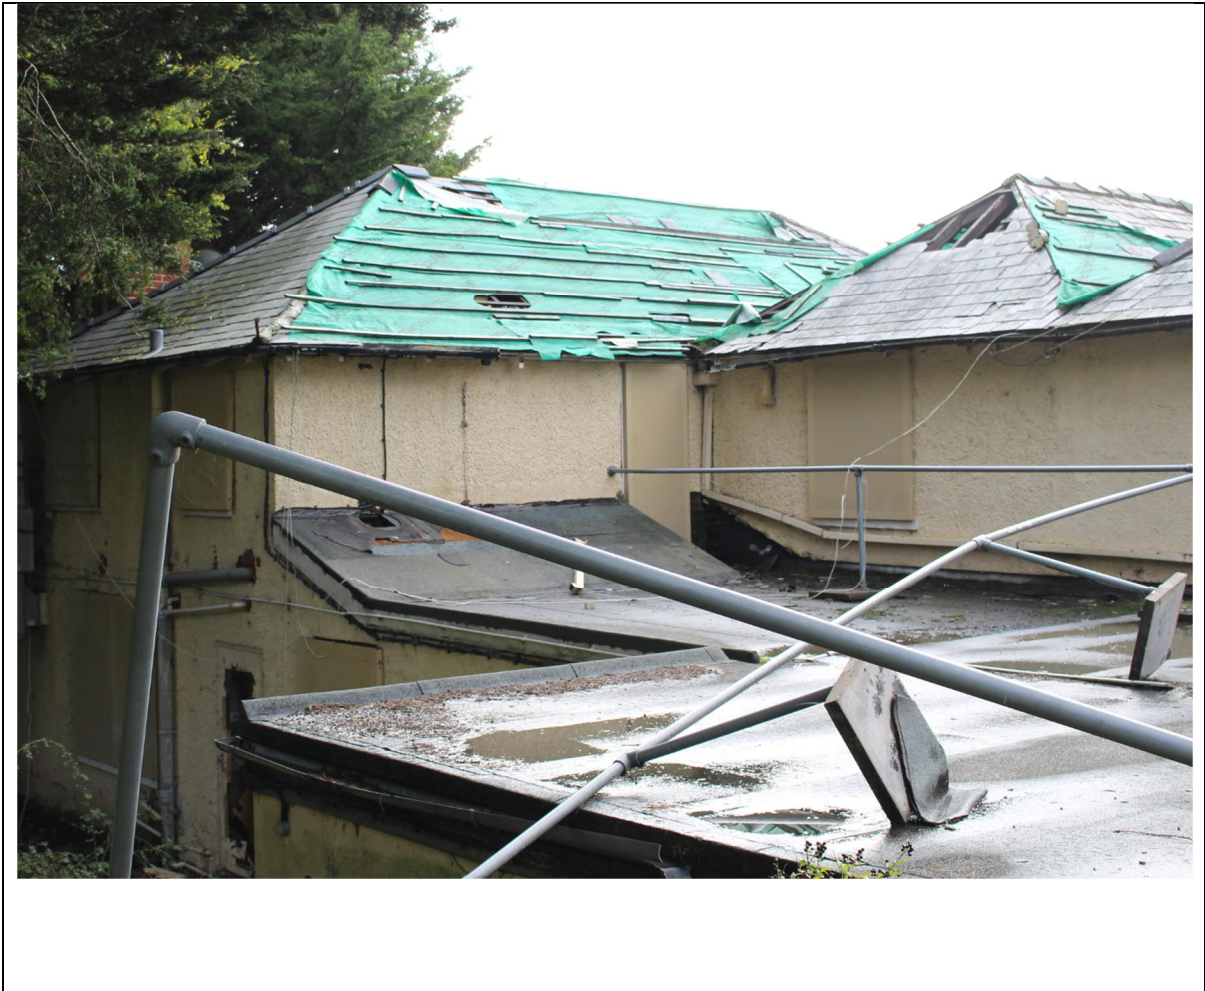
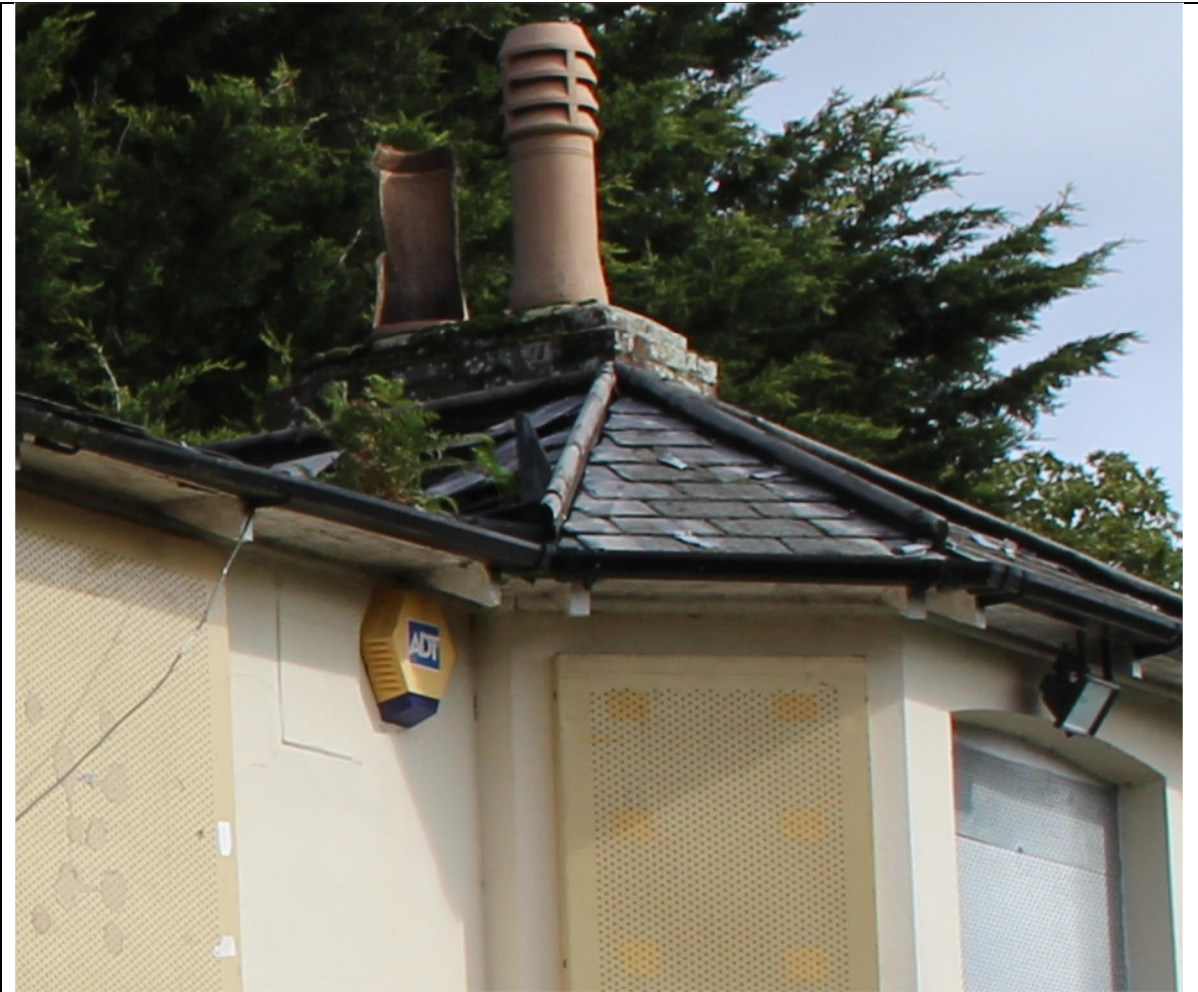
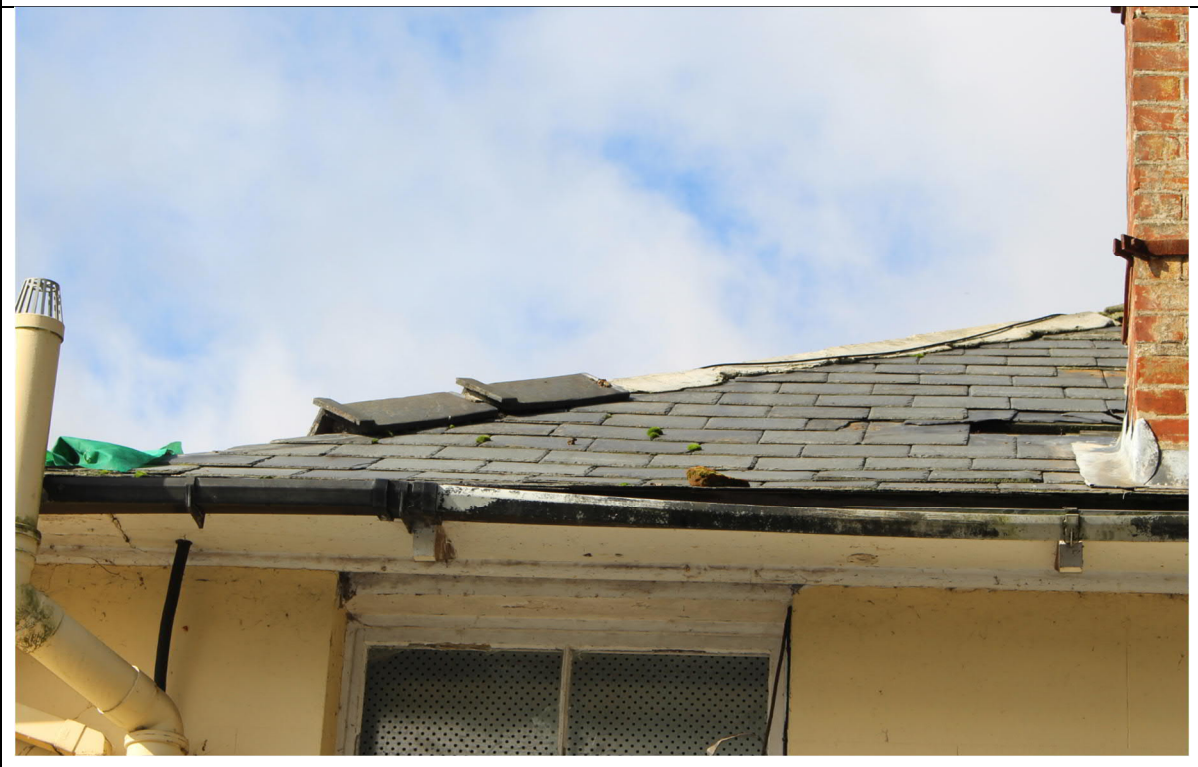
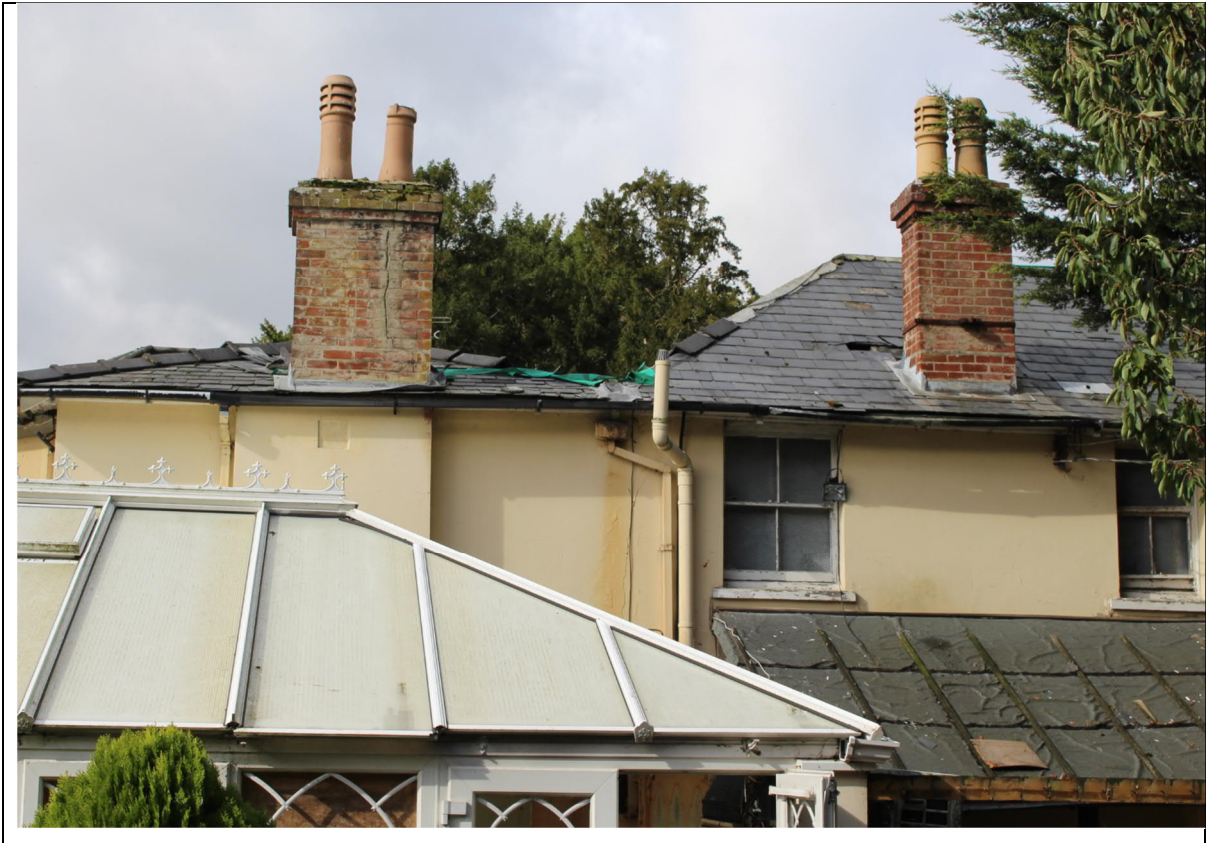
Photos of roof

Almost all parts of the roof of the two storey elements of the building are severely deteriorated, probably as the result of vandalism. These are the blue areas in the aerial photograph above. The photographs in the appendix illustrate. The damage is so extensive that further comment is unnecessary. This exterior damage has a significant impact on the condition of the interior of the building, as discussed later.

- Remove and replace the roof slates, with no more than about 20% of existing slates being reclaimable.
- Remove and replace all timber elements of the roof throughout.
- Remove and replace a substantial proportion of the first floor joists, together with the floorboarding
- Carry out extensive remediation of the masonry. This would probably require underpinning of the front façade, taking down and rebuilding at least two chimneys, and extensive use of Helifix type bed joint reinforcement.
- Remove completely and replace all internal finishes
- Very probably replace all windows.
- Complete new installation of electrics and water services.

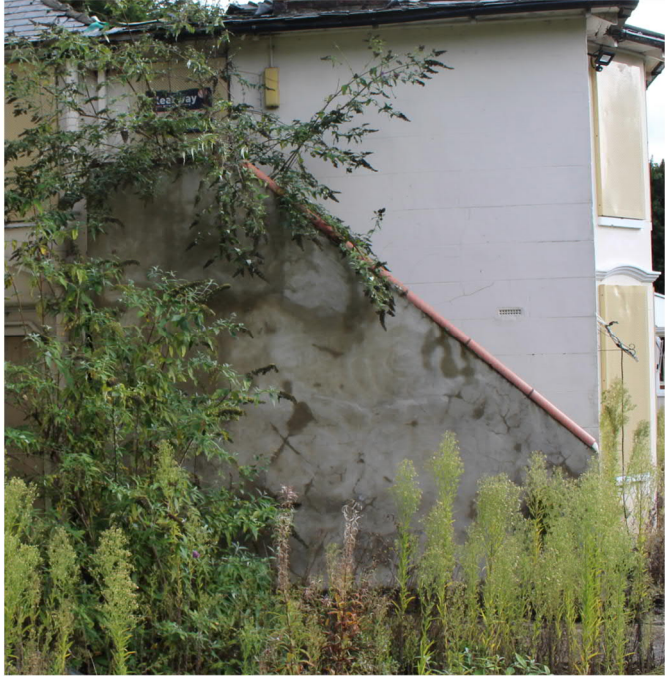
There is weathering and cracking to most parts of the west elevation, and the front elevation around the bay windows is suffering from severe cracking.

<p>West elevation - external stair flight</p>	<p>water damaged render with cracks</p>

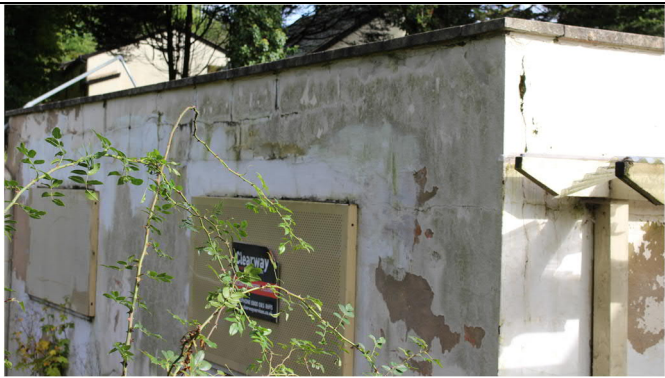
<p>Wall behind the flight</p>	<p>moderate cracking</p>	<p>As photo above</p>
<p>Single storey extension</p>	<p>Very deteriorated render, with extensive cracking between blocks on upper courses</p>

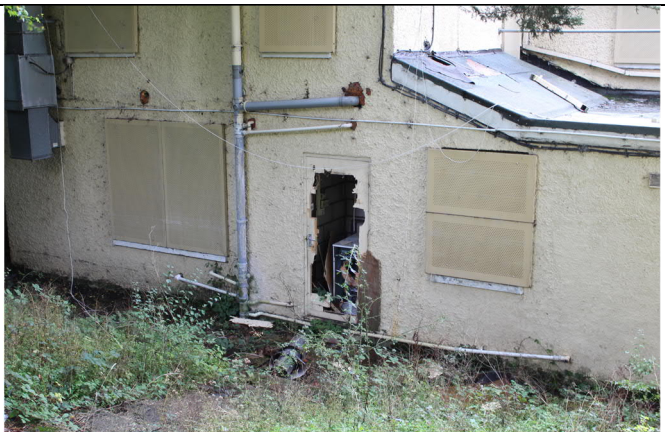
<p>Rear elevation</p>	<p>No significant structural damage, but poor cosmetically and in terms of weather proofing</p>

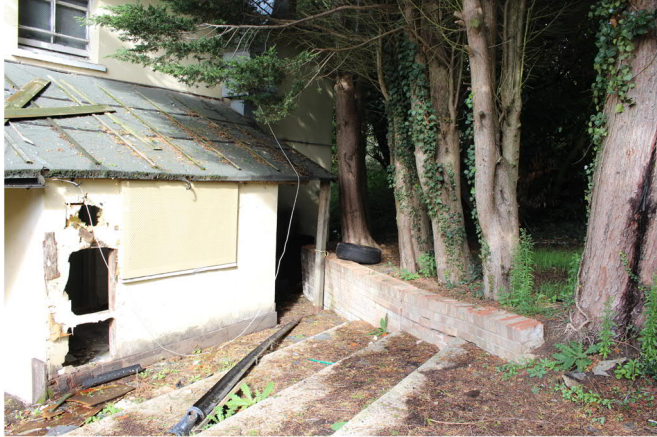
There are numerous large trees on the site (presumably giving rise to the name Woodlands). Several of these trees are in close proximity to the buildings (sufficiently close to have an impact on the foundations).

<p>East elevation</p>	<p>Large trees (Leylandi?) in unacceptably close proximity to the building. Badly deteriorated lean-to extension.</p>

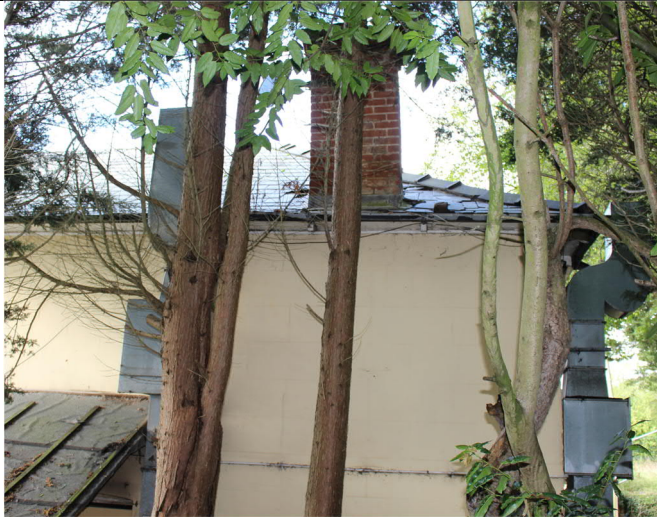
There are three chimneys, one to the rear and one at either end of the frontage. The rear chimney has a marked lean, and the front chimney to the East has an evident crack through its full height. Where inspectable (only from a distance, from ground level), the flashing around the chimney base was damaged.

<p>Chimney (towards rear) with visible lean</p>

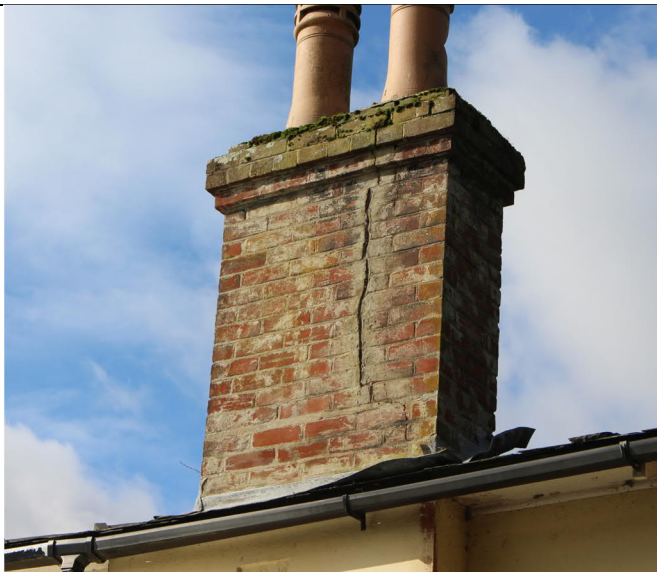
<p>Chimney (towards front) with deep crack over full height</p>

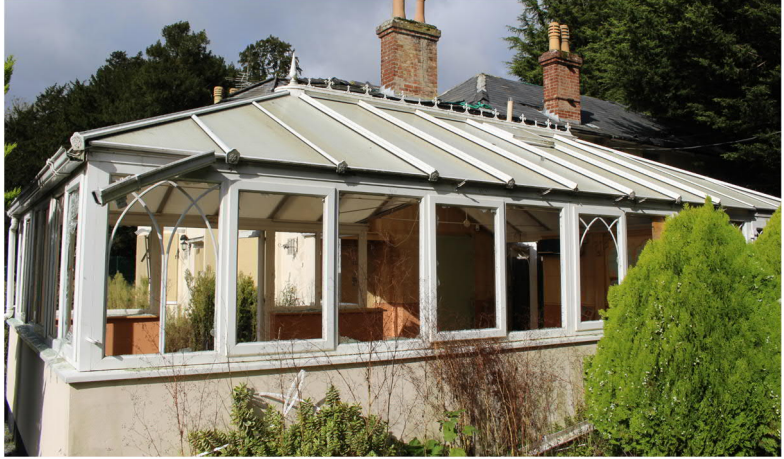
<p>Conservatory</p>	<p>Structure of negligible merit or value, badly vandalized</p>

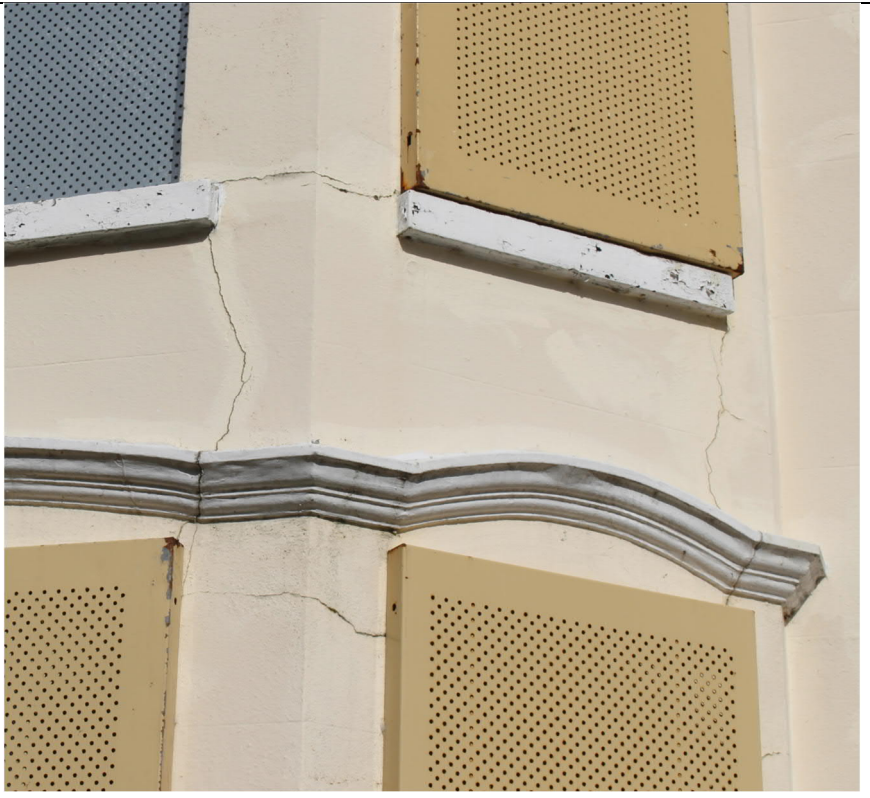
<p>Front elevation</p>	<p>Extensive cracking around both bay windows and front door around first floor level</p>

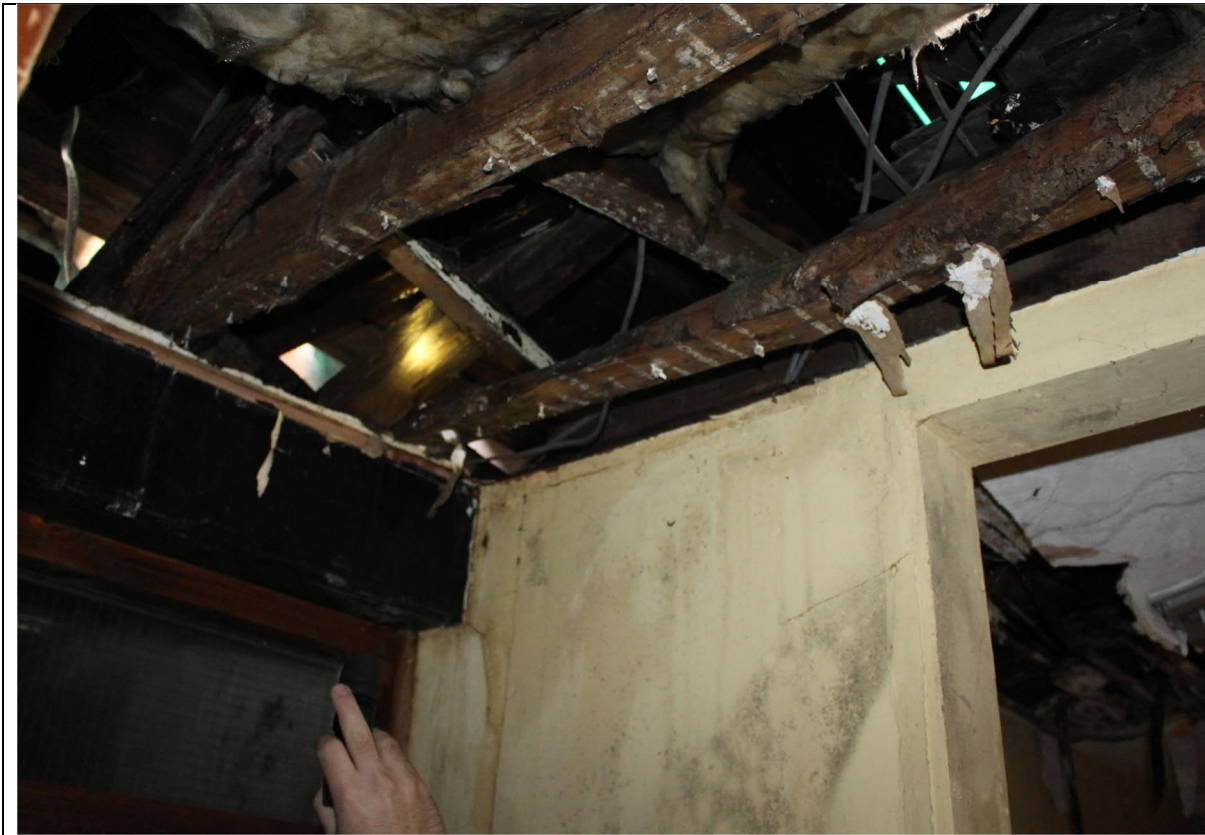
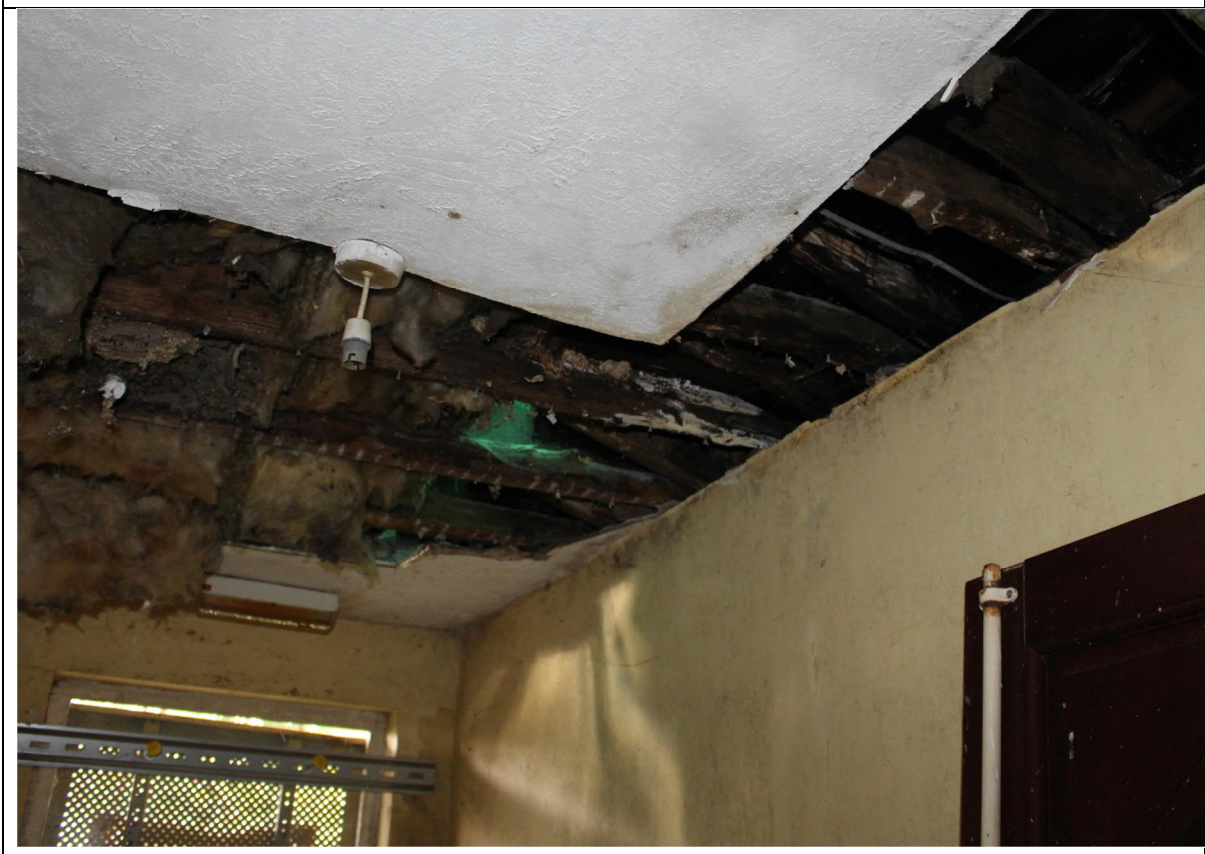
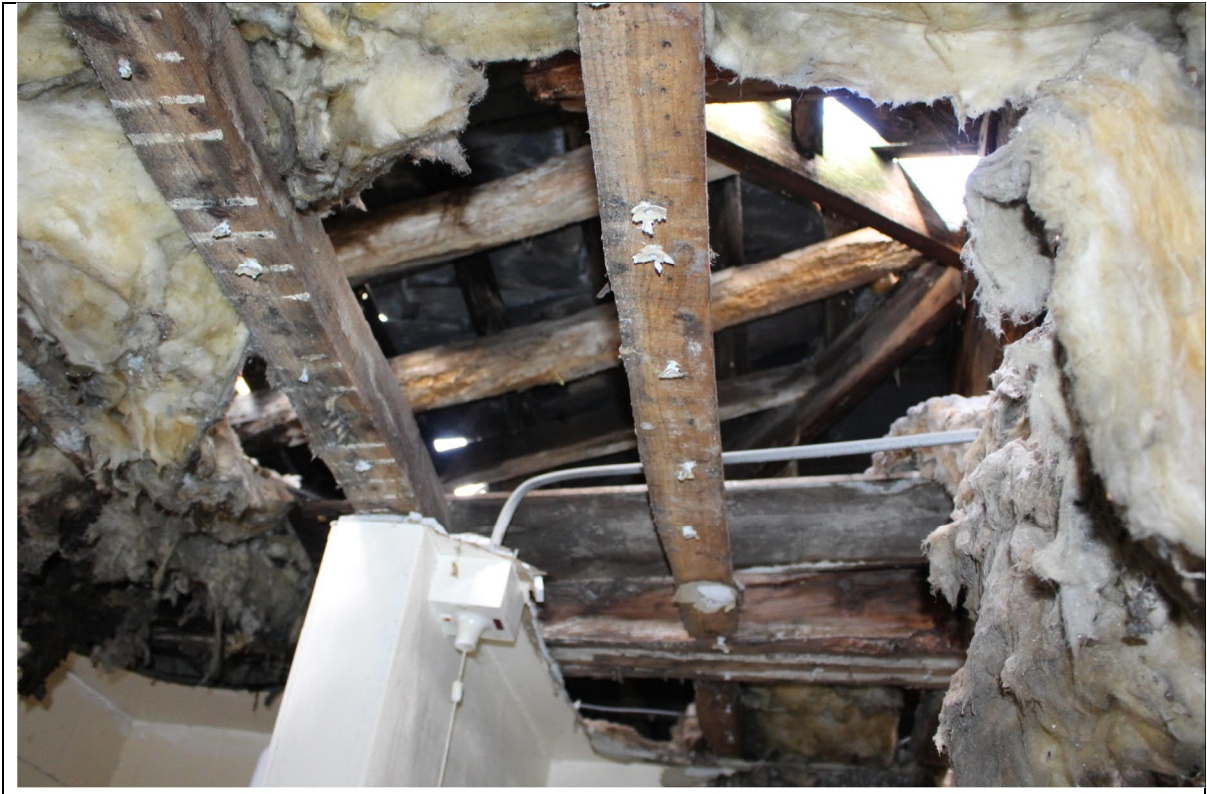
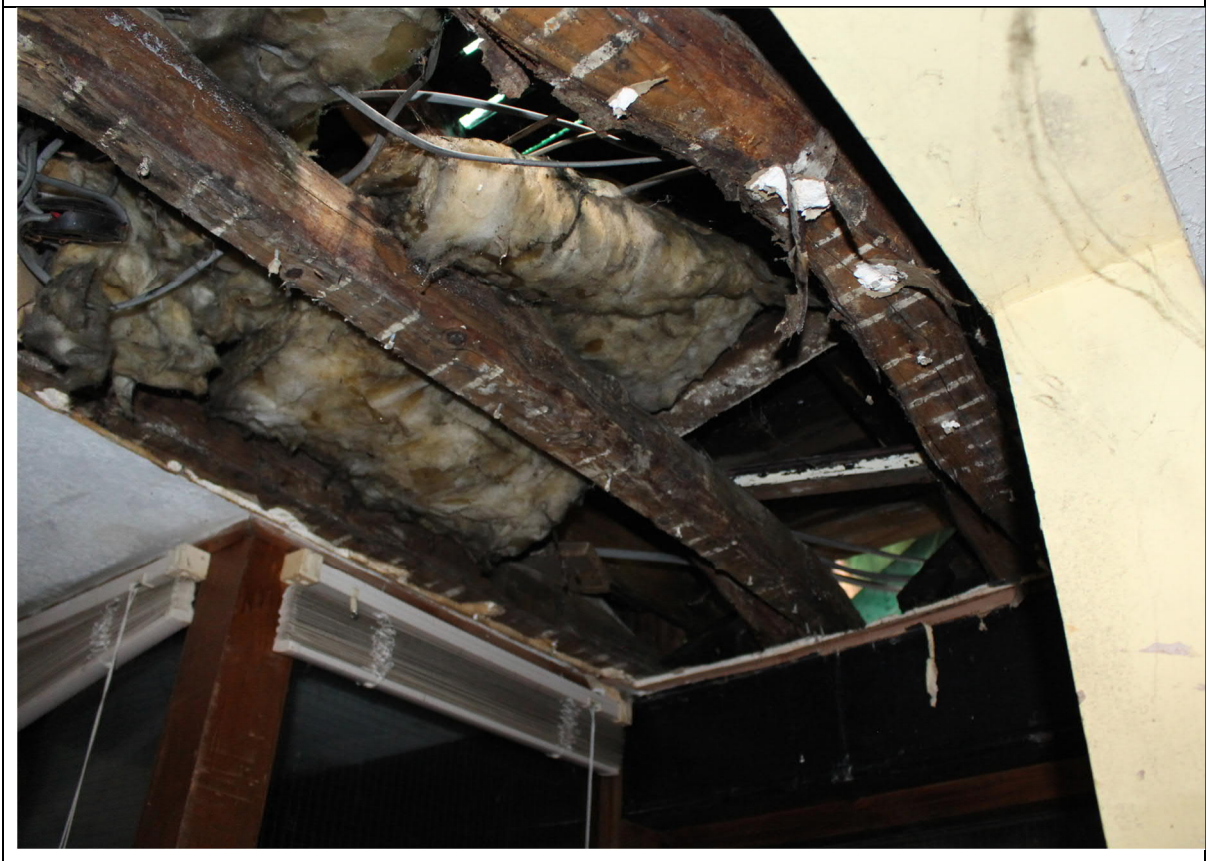
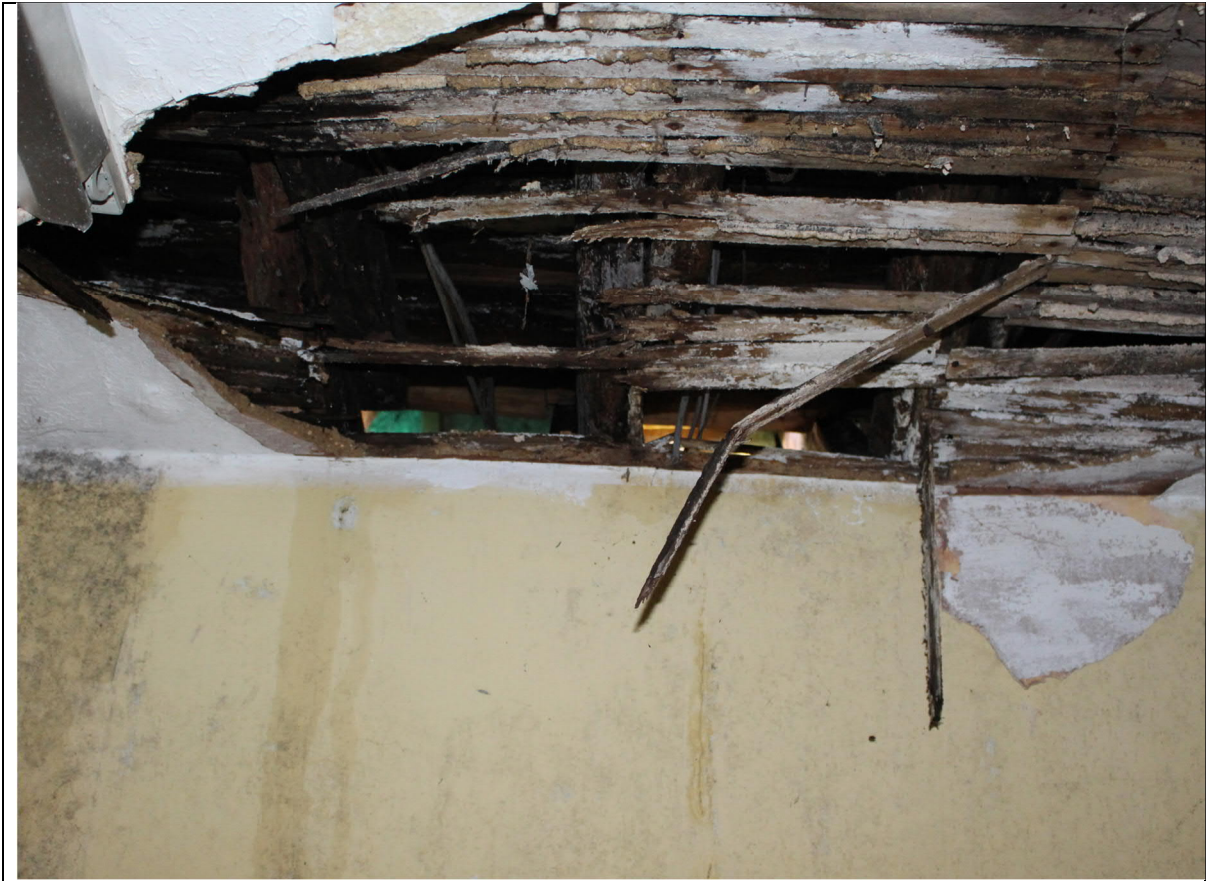
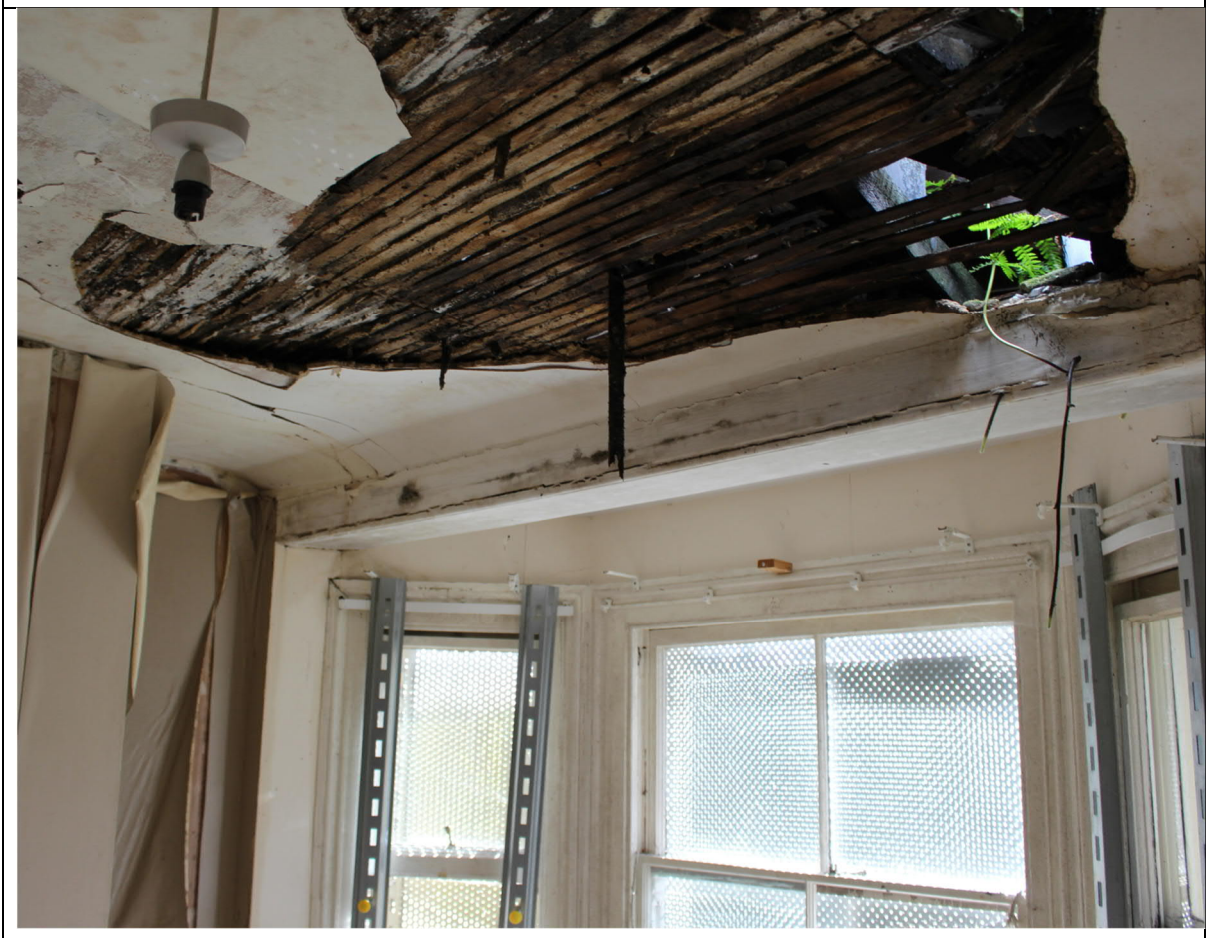
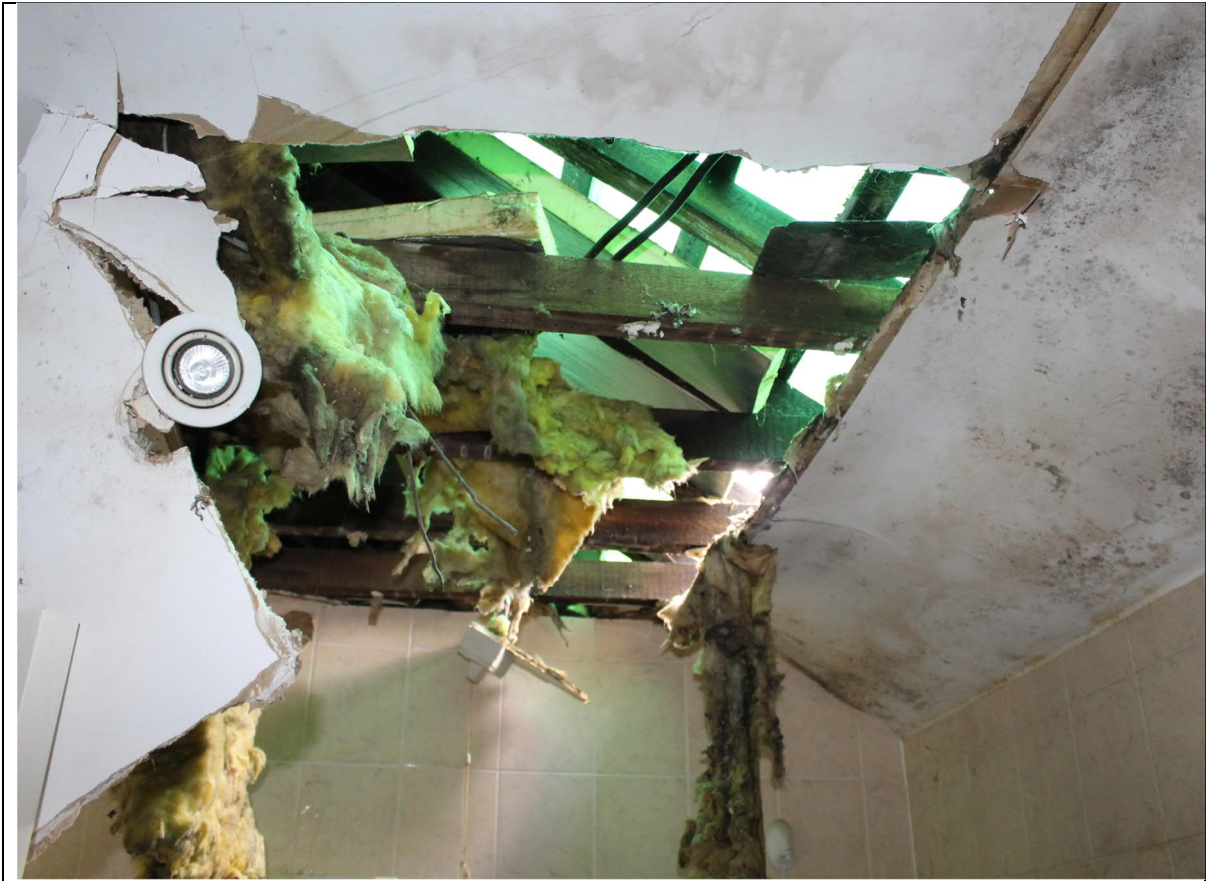
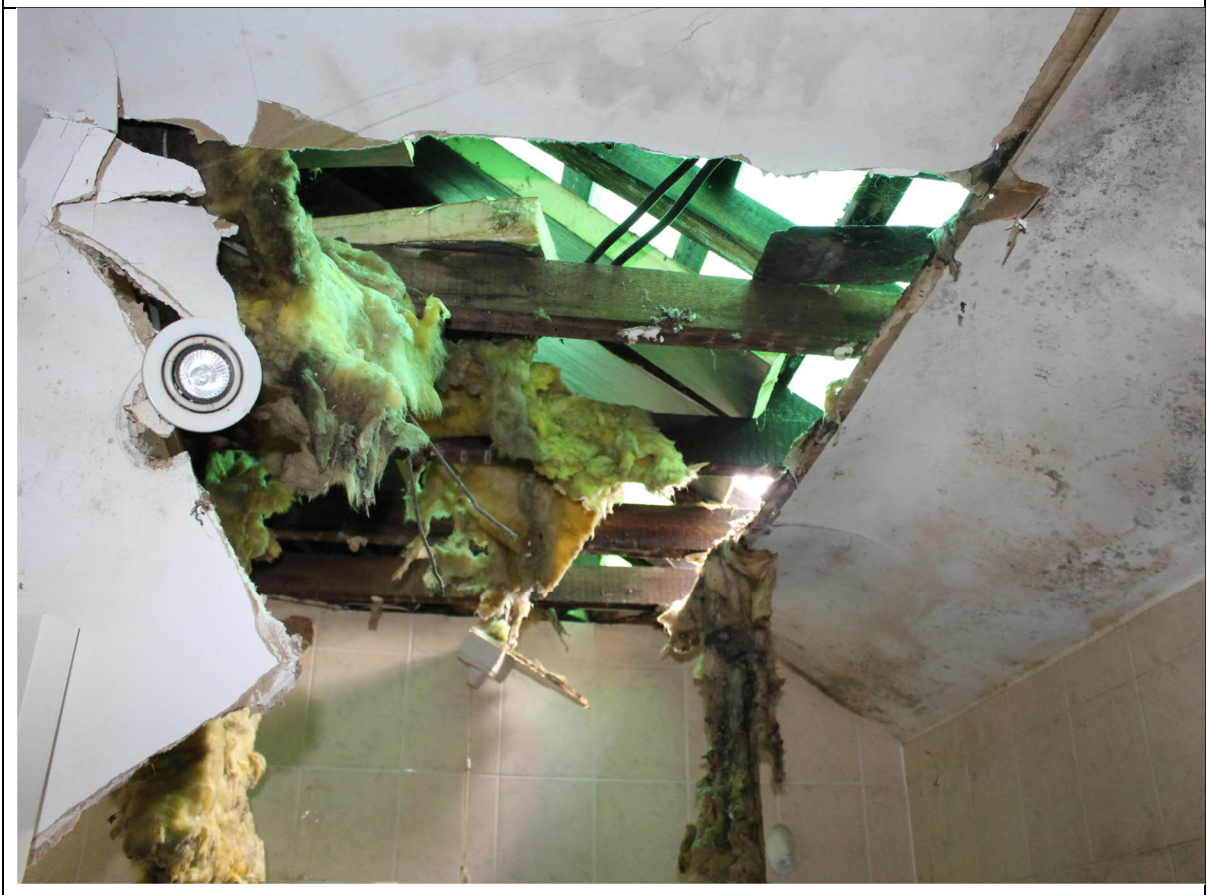
Photos of first floor

As a result of this, numerous roof timbers are decayed, and lath and plaster ceilings have experienced partial collapse in almost every room. The photos in the appendix illustrate, and further comment is considered unnecessary.
