Woodlands Hotel, Haverhill, CB9 7UW
Structural Inspection Report

Prepared for Country Court Care Group

20 June 2022

Glyme Structures Ltd

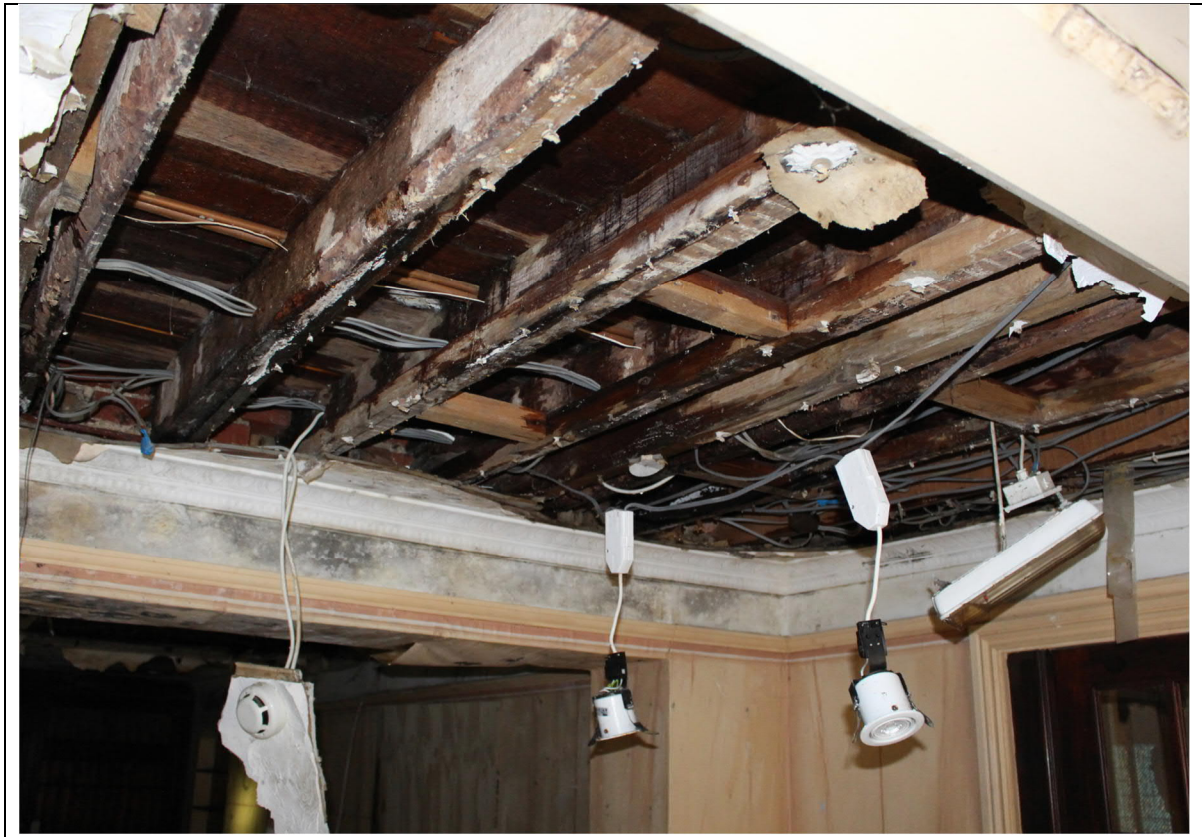
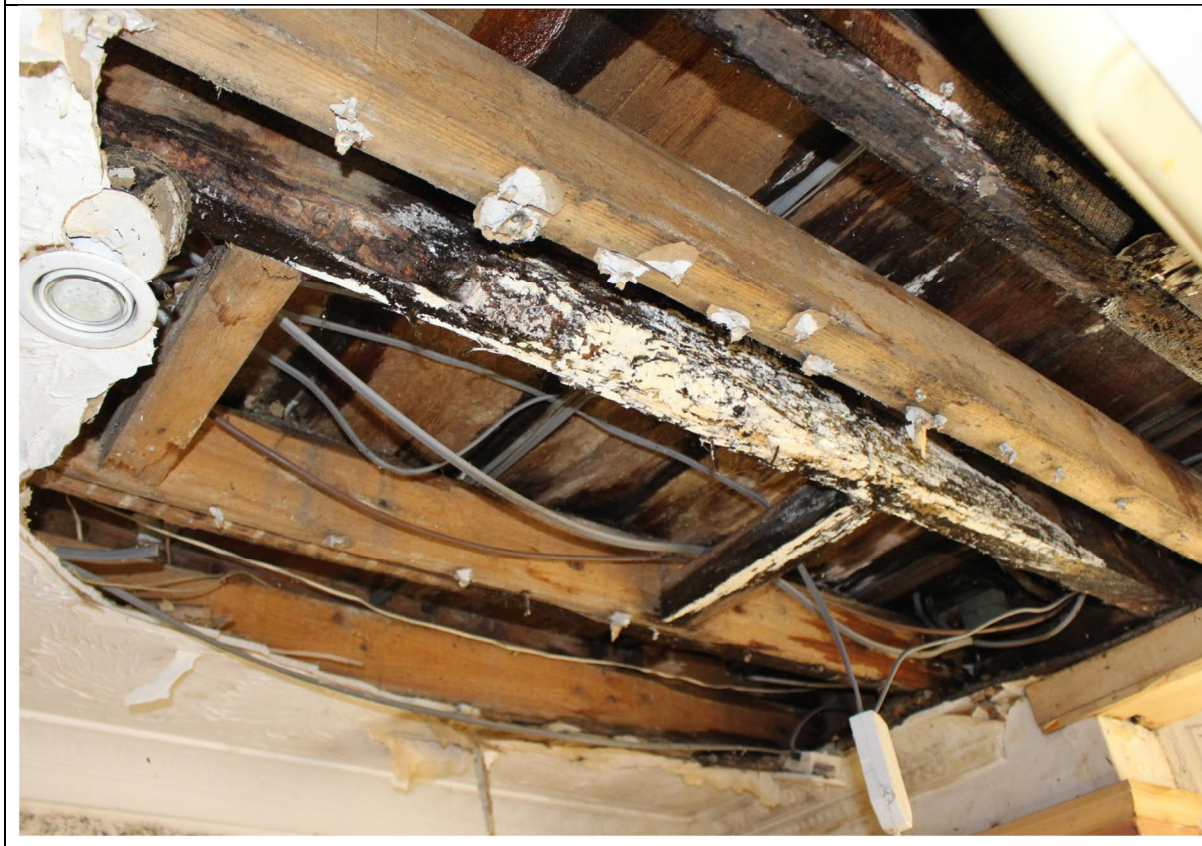
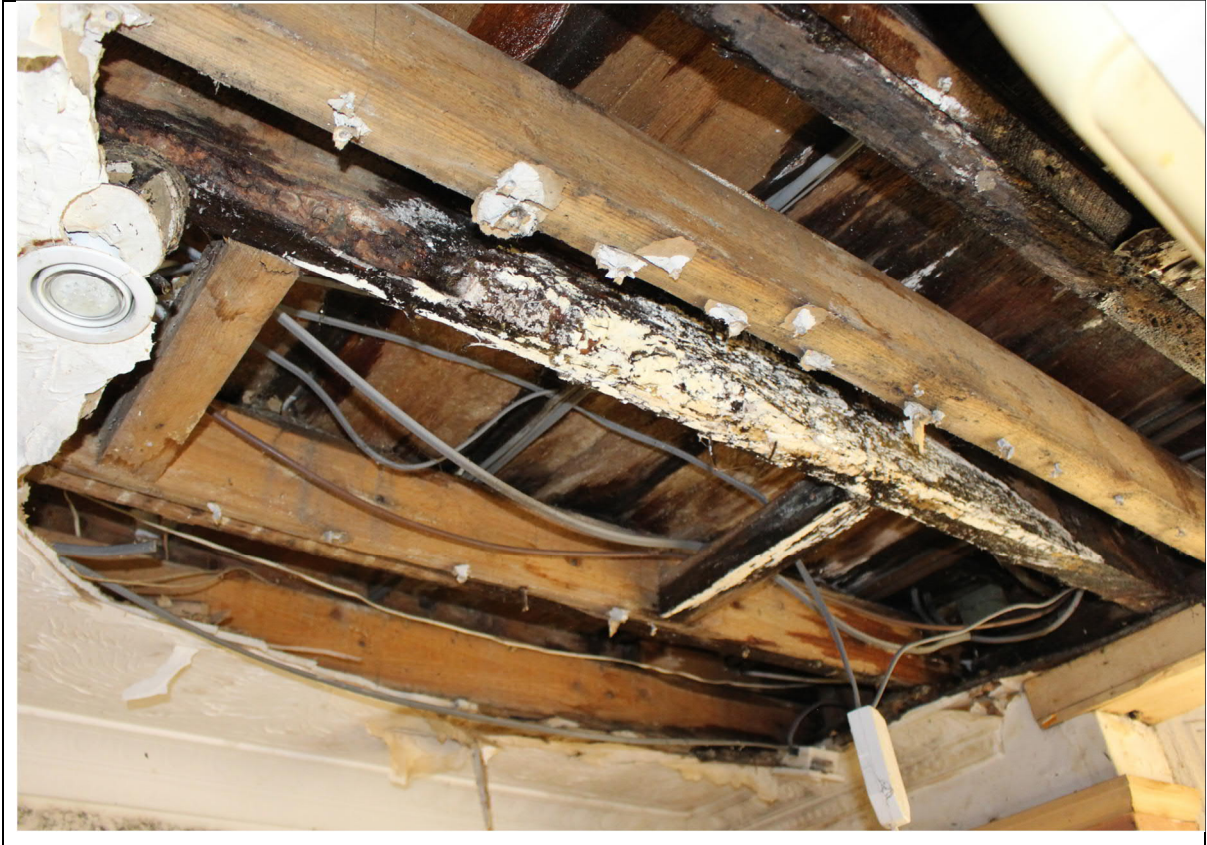
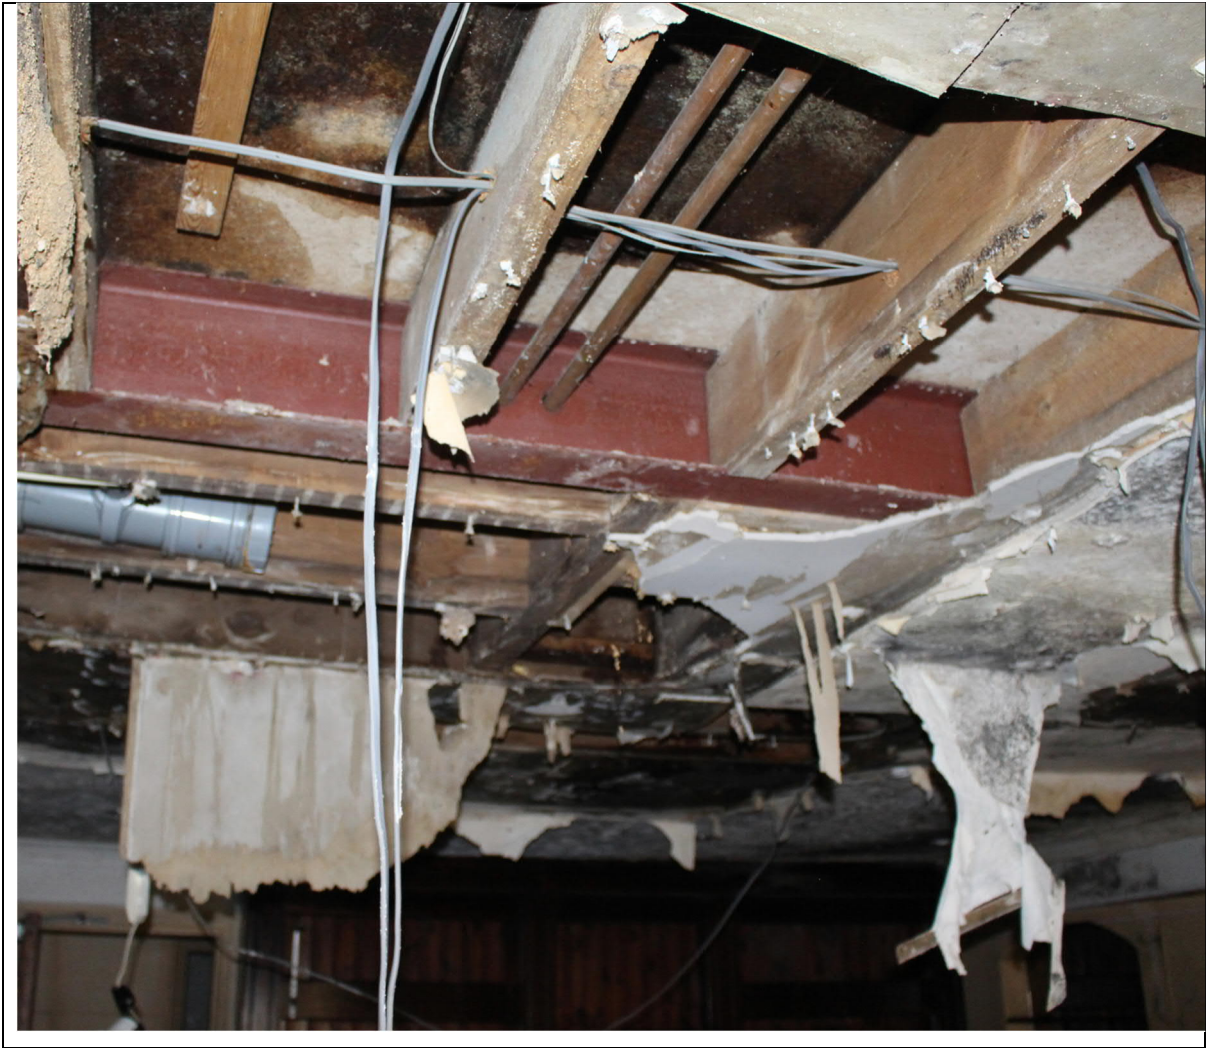
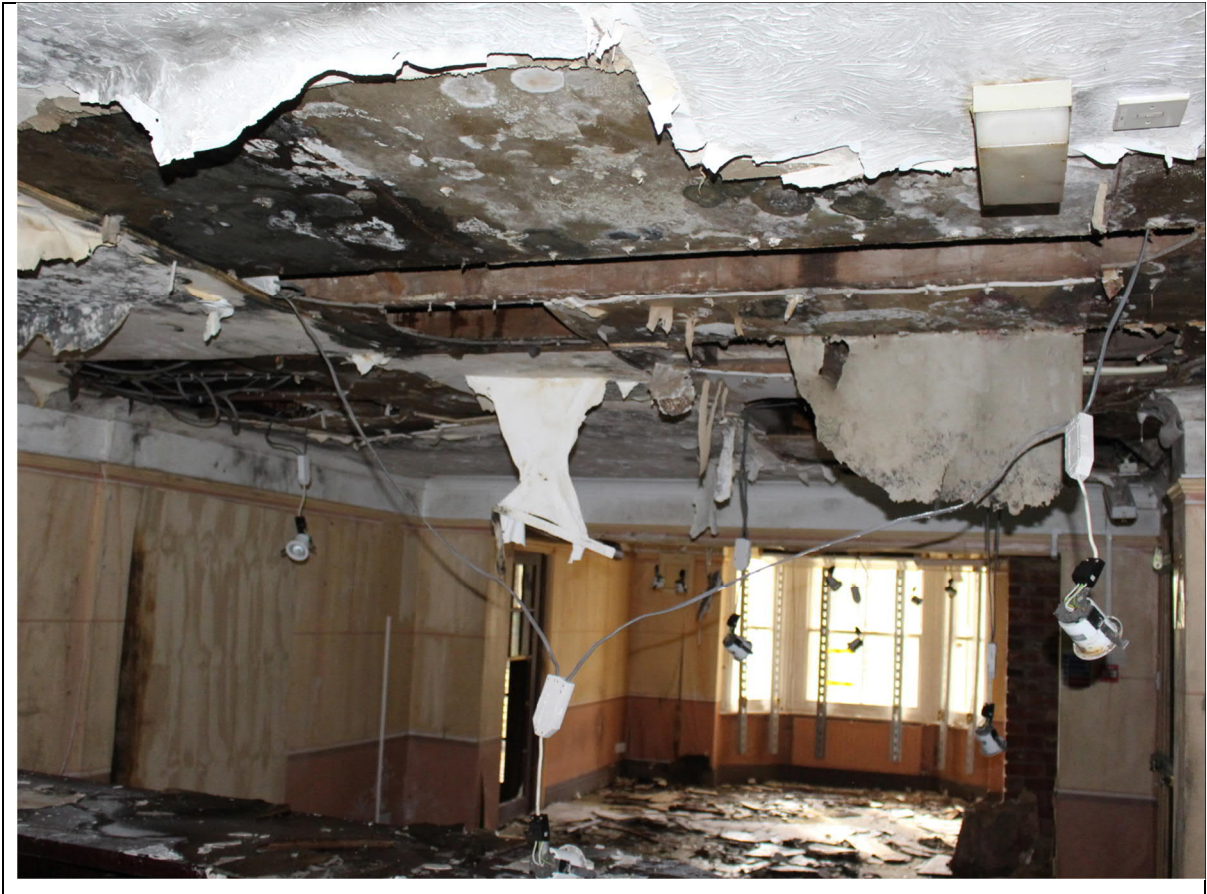
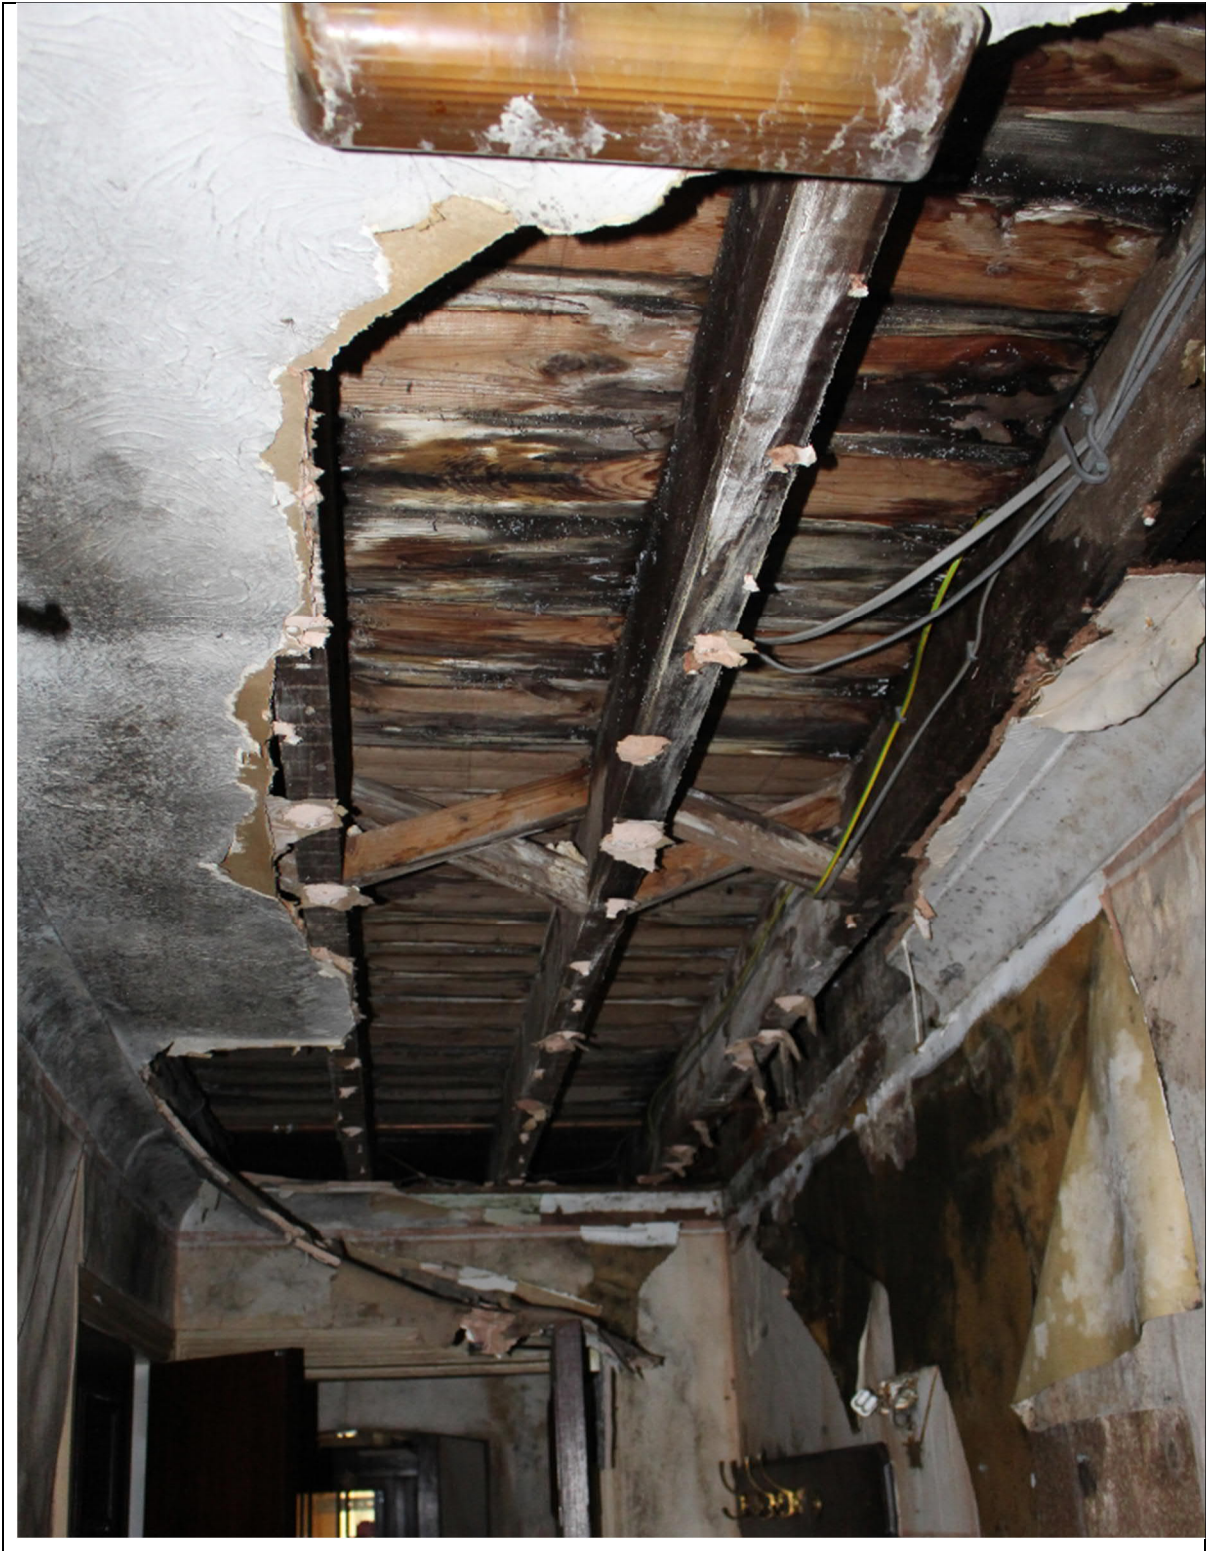
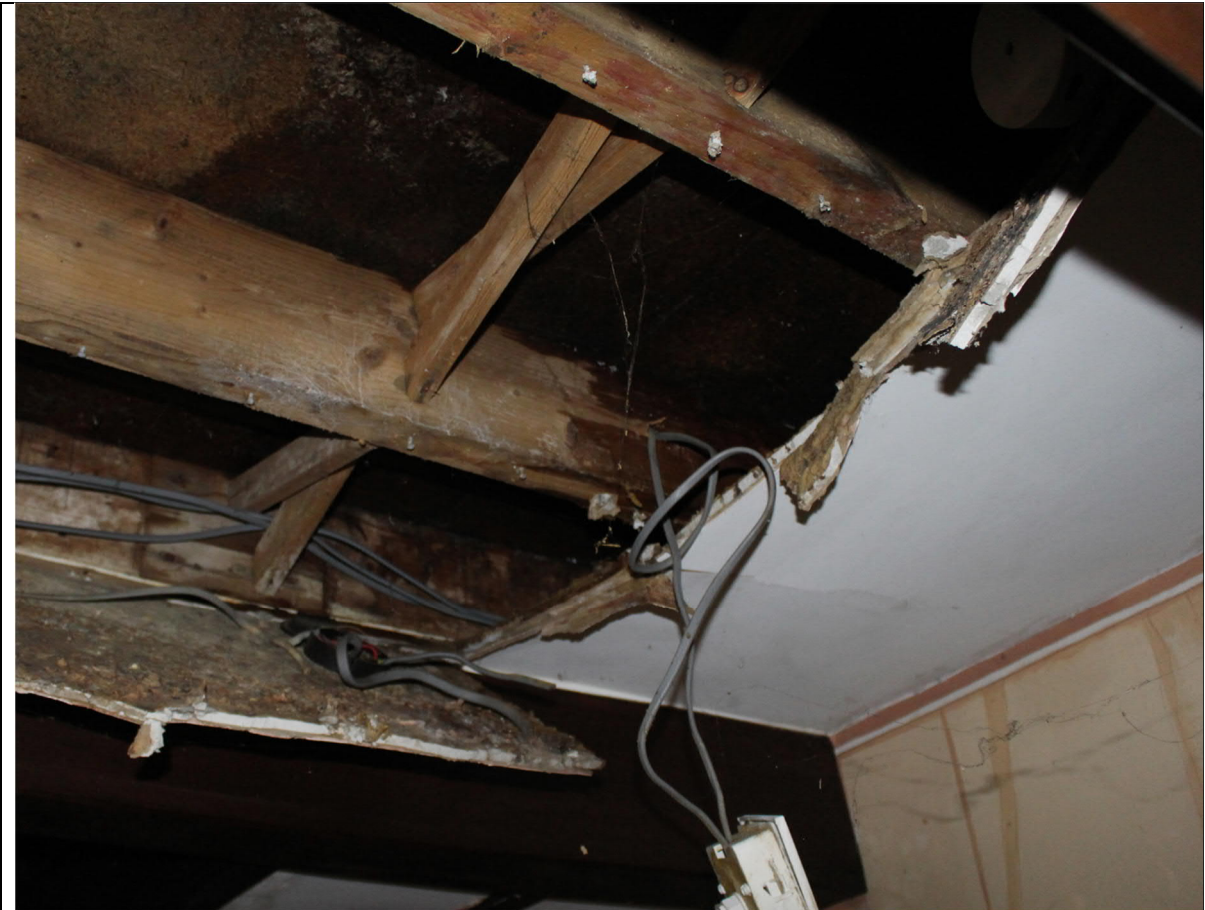
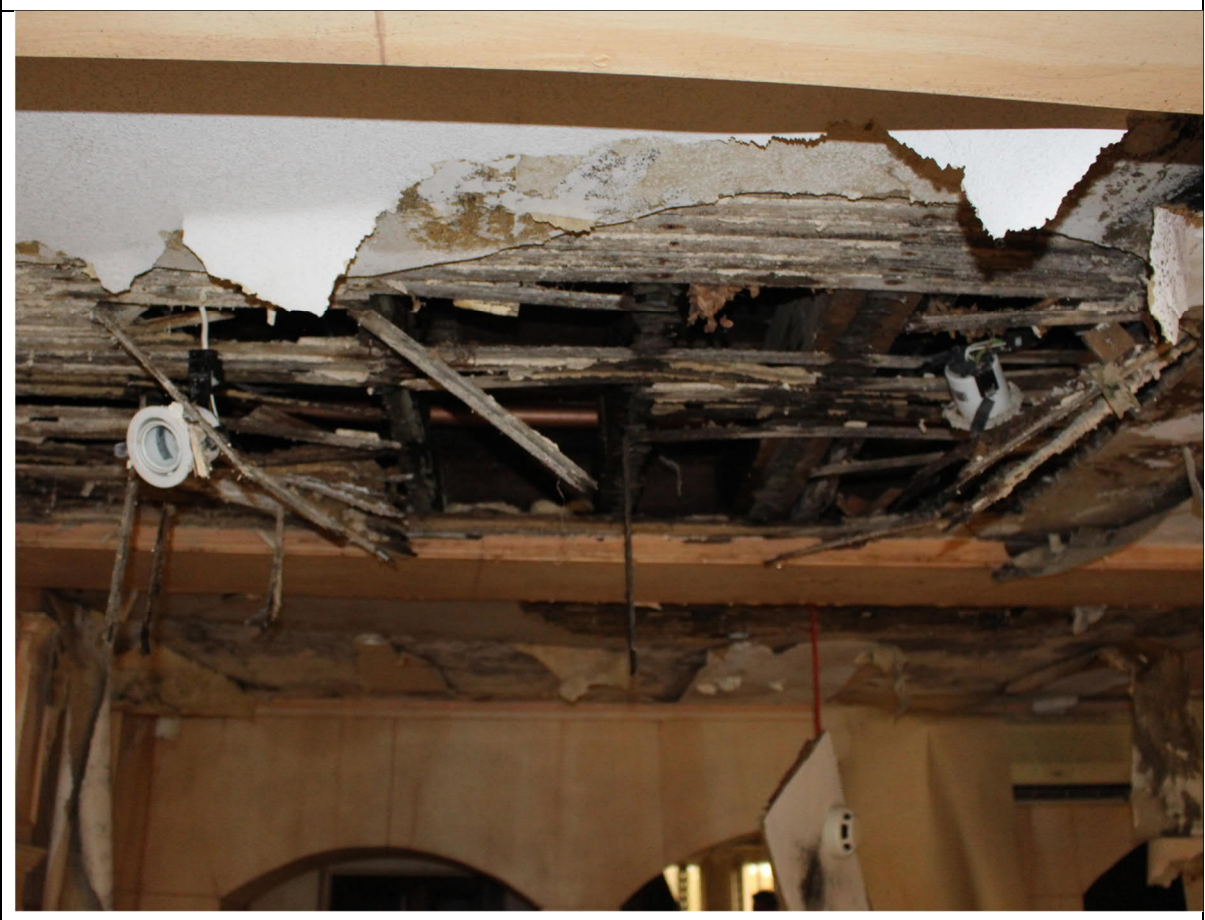
Photos of ground floor

The consequence of the failure of the roof, and, as a result, extensive water penetration into the first floor rooms, has led to extensive damage at ground floor also. The damage to the ceiling at ground floor is almost as extensive as that at first floor, again with signs of decayed timbers as well as lost areas of ceiling.

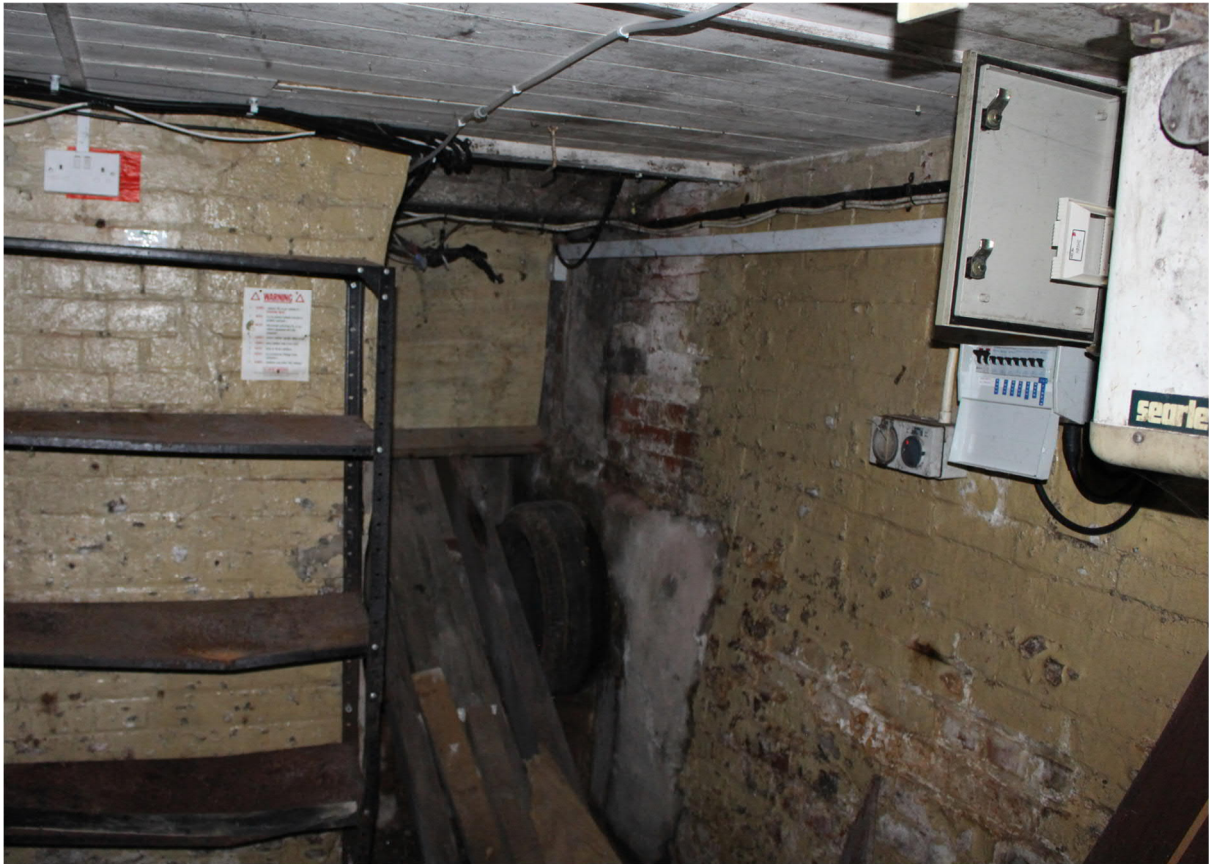
Photo of basement

The brick walls appear sound, and the floor structure above appears to be in reasonably sound condition.

There are some limited signs of damp, as evidenced by peeling paintwork, which is normal for most cellars.
