Health & Safety Tree Survey

Land to the west of Park Road
Haverhill, CB9 7SR

Date: 31/05/2024

Report reference: TGA.2636.TreeSurvey

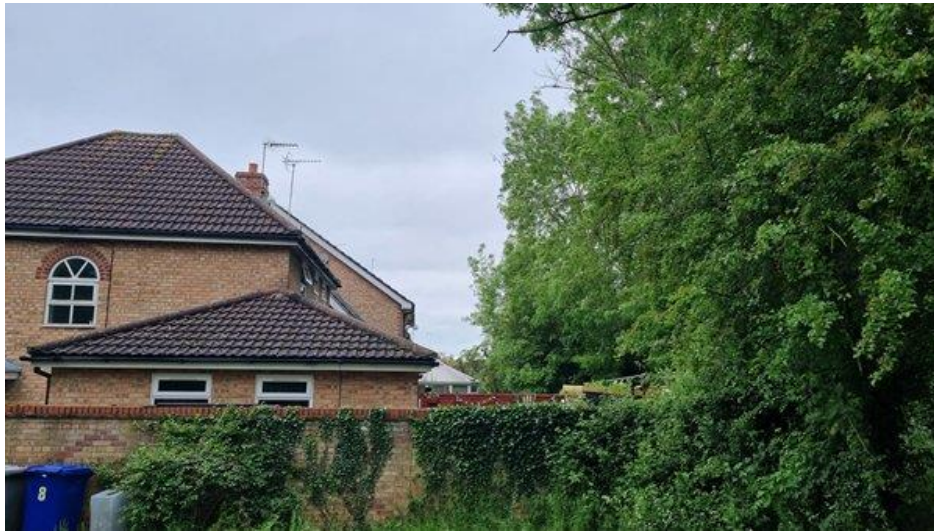
- 3.4. The trees have not been historically maintained, and the group has not been thinned. The canopies of the trees within the group overhang the gardens of Nos. 8 – 14.

Trees viewed from south, encroaching over gardens of Nos. 8 – 14

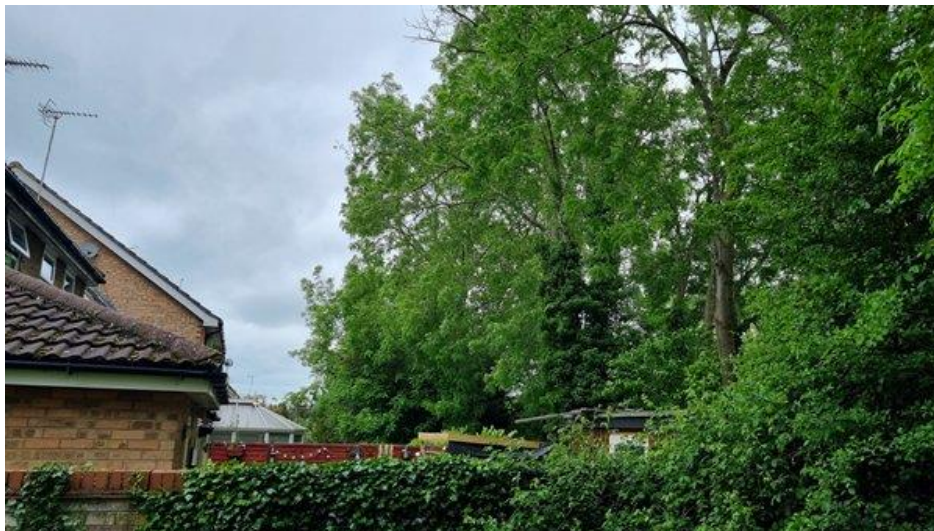
Alternate angle view, showing encroachment over gardens

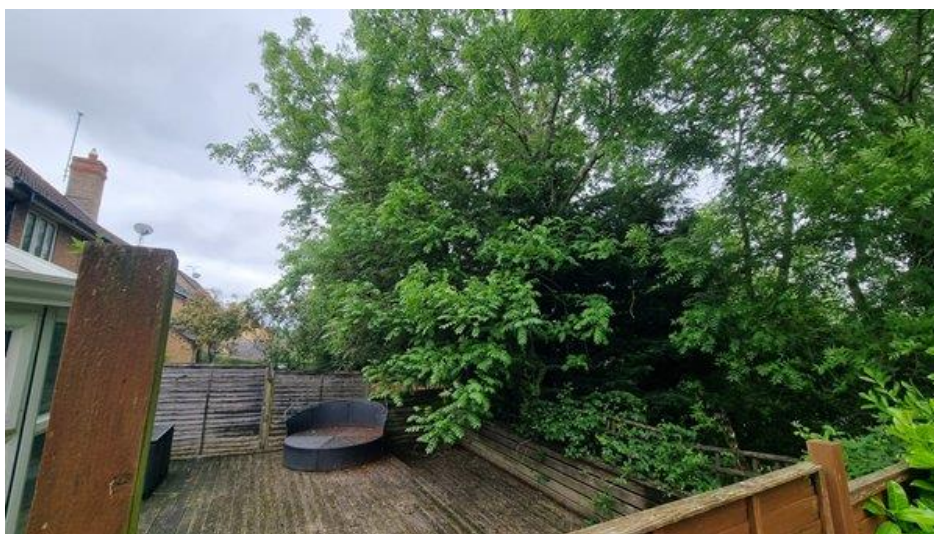
Trees encroaching over garden of No 14

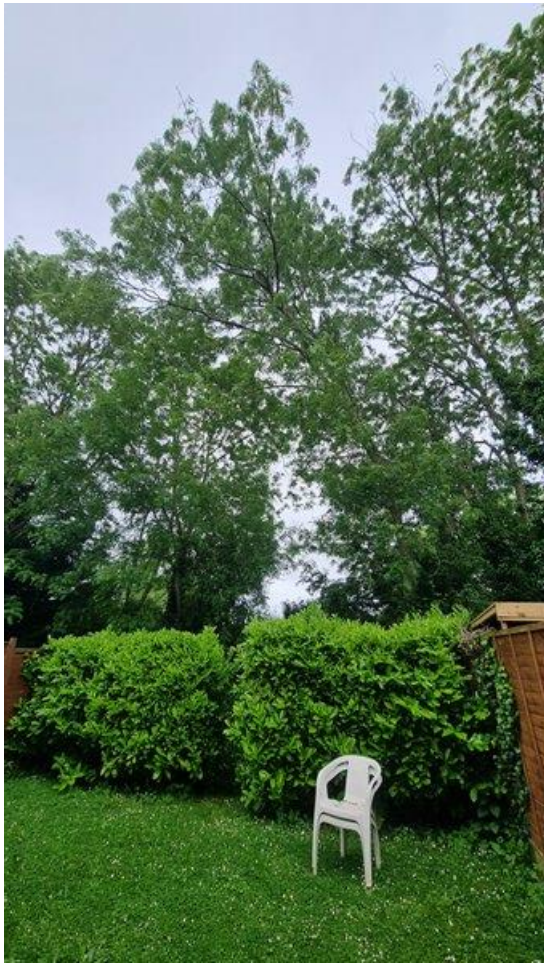
Tree T006 leaning tree to rear of No 10

- 4.2. For trees T001, T002 it is considered preferable to fell these trees to reduce the canopy overbearing the gardens.
- 4.3. Trees T003 and T006 are not suitable for retention adjacent to the gardens due to dieback or structural issues.

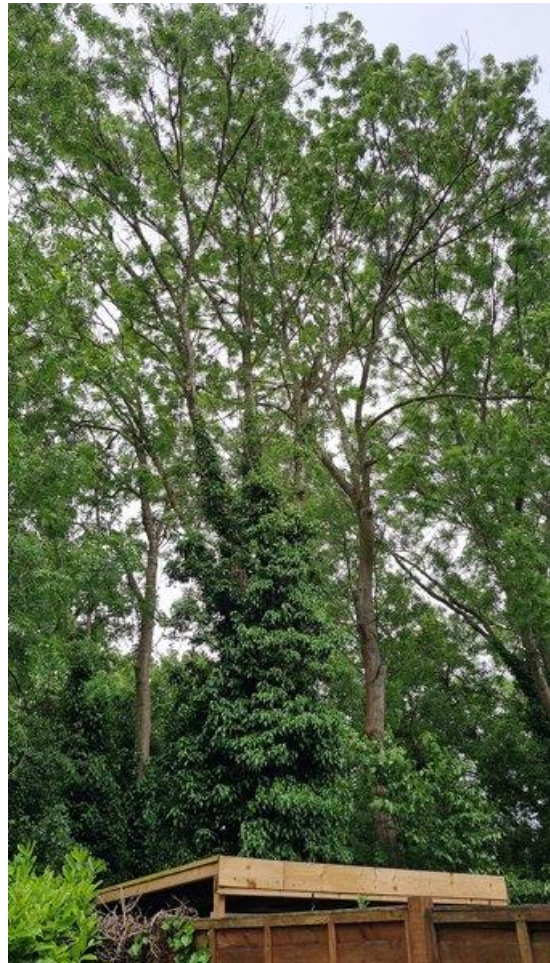
- 3.5. There is ash dieback present within the group of trees such that the long term life expectancy of the group is likely to be limited. According to 'Ash Dieback Guidance for Tree Owners, Managers, Contractors and Consultants' published by Arboricultural Association. Common Ash (*Fraxinus excelsior*) is a prolific native tree species accounting for 12% of broadleaved woodland in Great Britain and is commonly found in parks, gardens and hedgerows.

**Tree T003 Ivy infested stem, ash dieback
throughout upper crown**
