3 PROBLEMS AND RECOMMENDATIONS

3.1 Problem 1: Inadequate deflection on vehicle paths

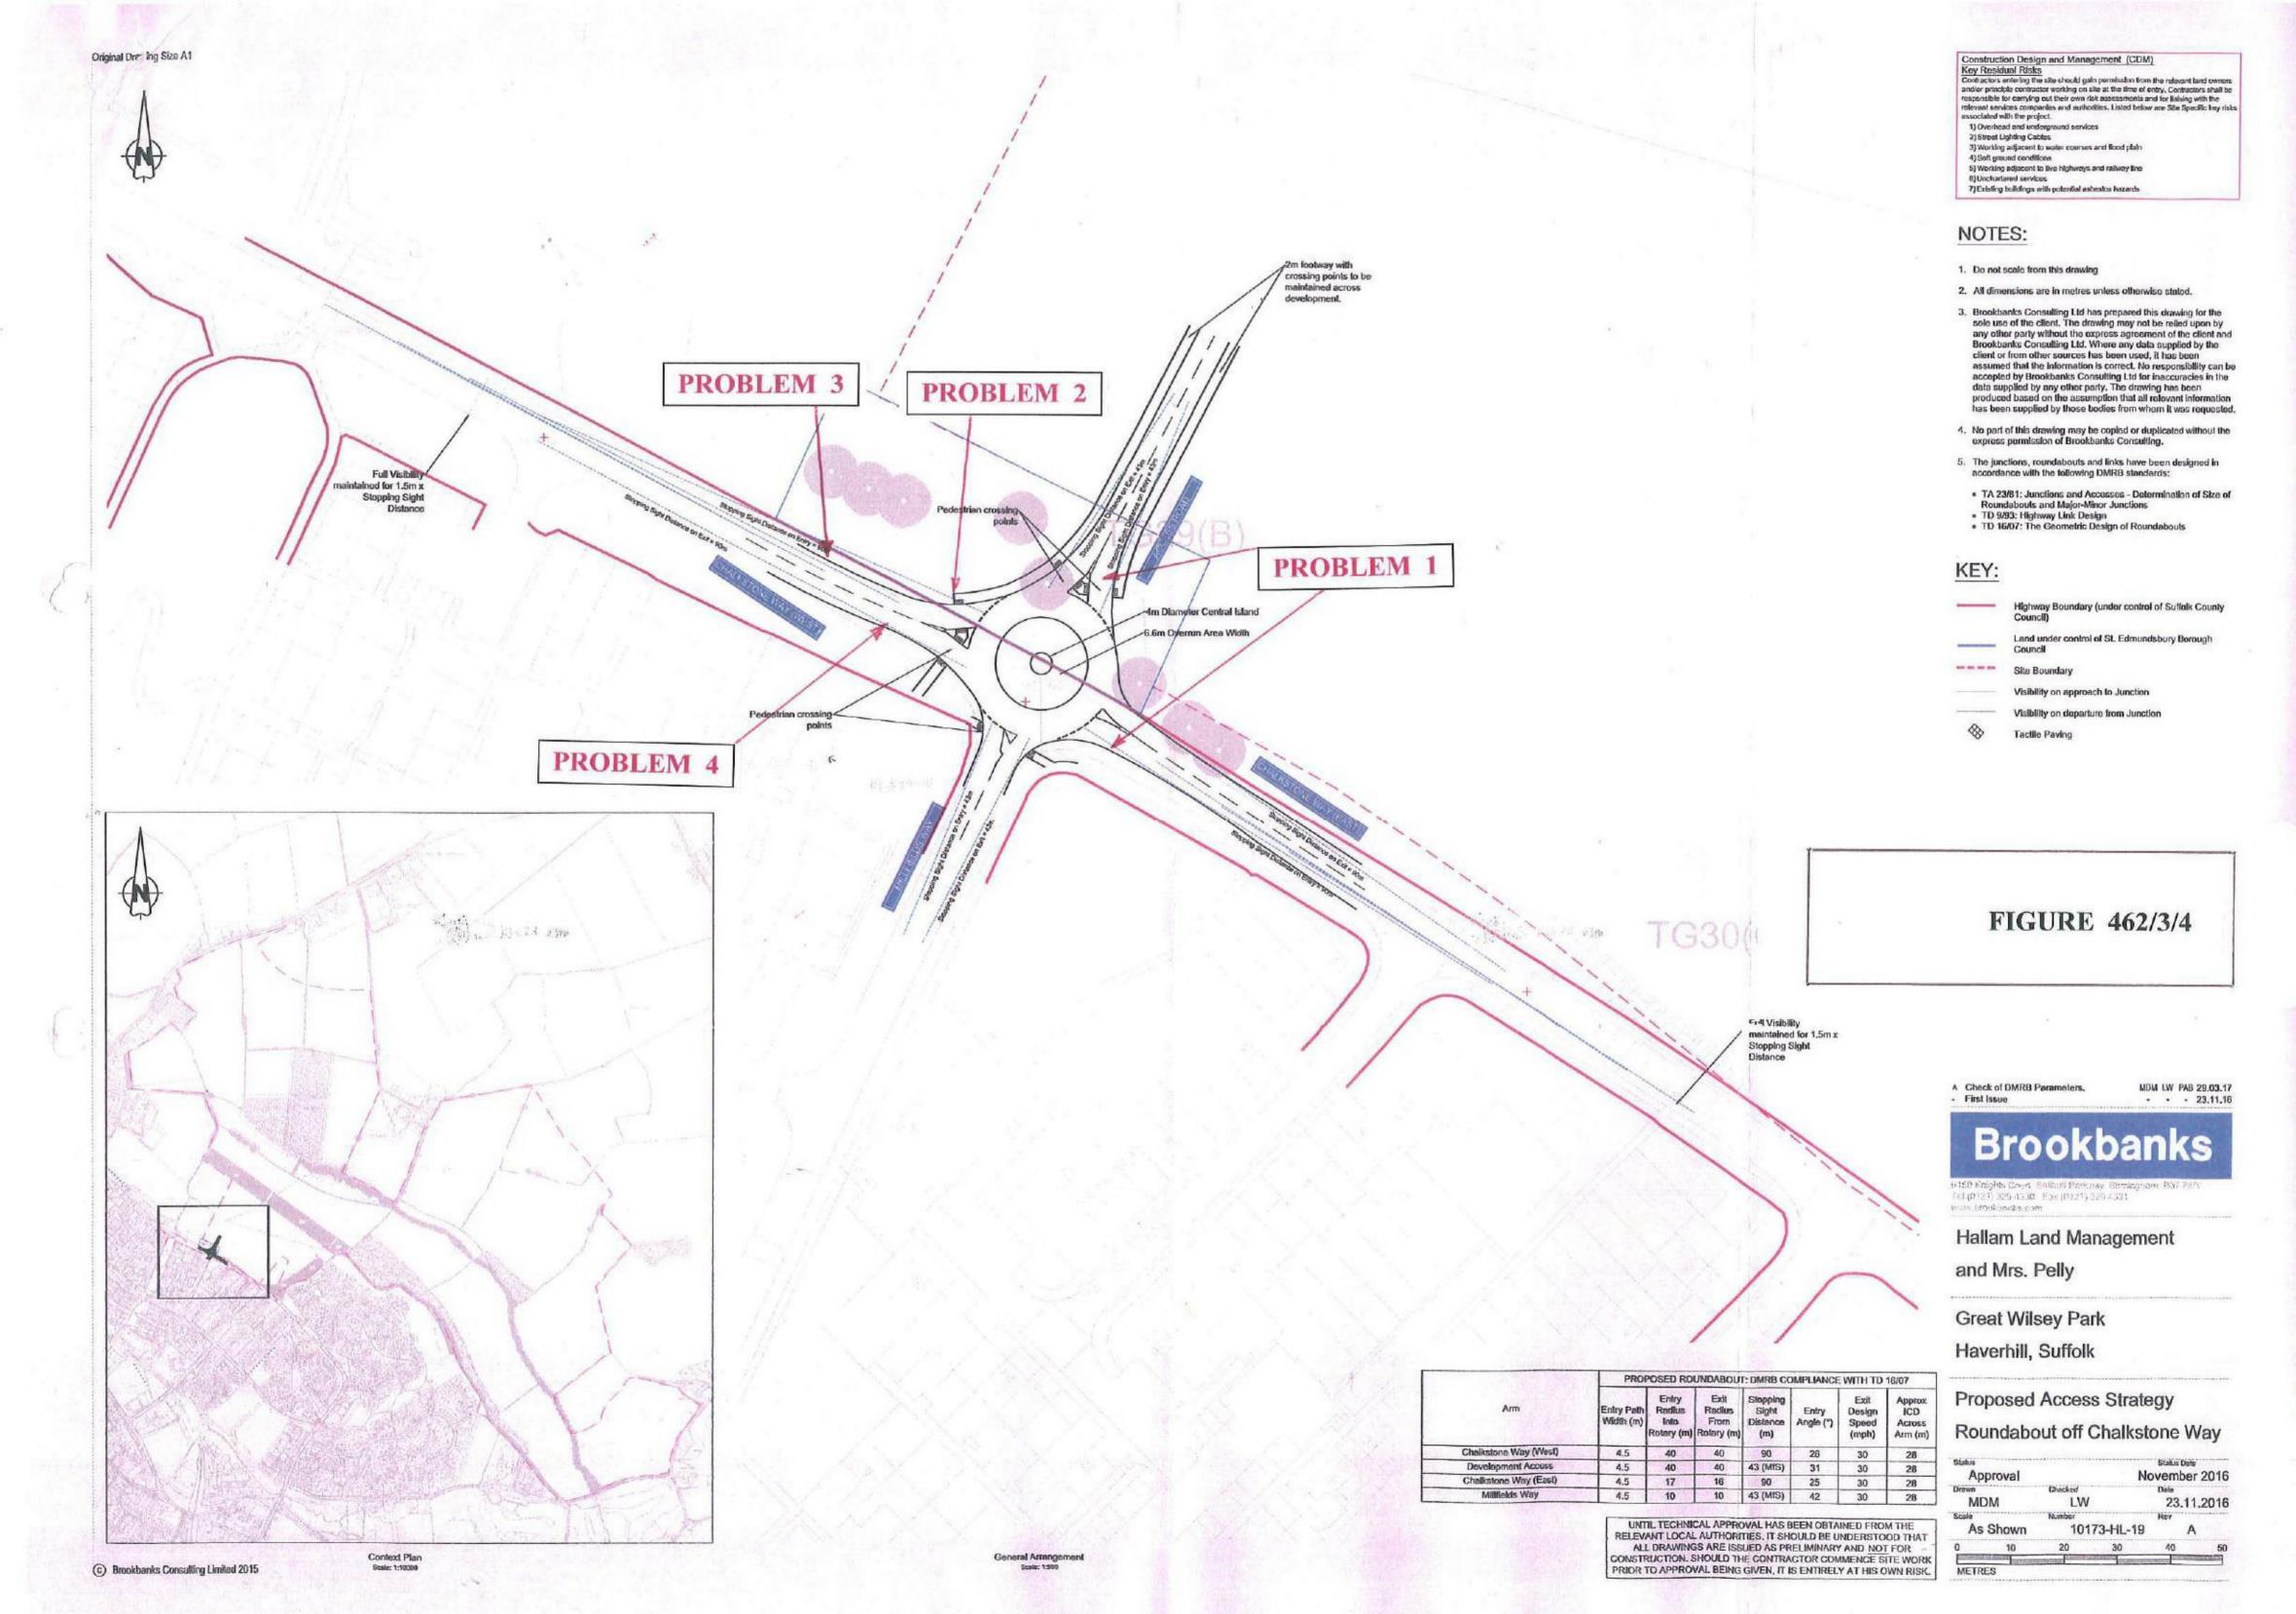
462/3/4 – PROBLEMS SHEET DRAWING

Location: Eastern and northern arms approaches to the roundabout.

Summary: The design layout of the roundabout is such that there is potential for failure

to give way on entry resulting in straight-ahead collisions with roadside

furniture or side-impact or shunt type collisions.

- 3.1.1 For the roundabout entry from the east (Chalkstone Way) the entry path curvature is in the region of 140m and for the roundabout entry from the north the entry path curvature is in the region of 100m, both using the over-run area edge as the vehicle path guide. Such potential approach paths give inadequate entry path curvature to fully-prevent traffic from entering the roundabout at too high a speed or having to resort to late-braking (DMRB standard TD16 also refers).

- 3.1.2 The drawings do not show any traffic calming measures on the development Access Road.
- 3.1.3 Whilst the Auditors do acknowledge that Chalkstone Way is a traffic-calmed road the situation could be hazardous to cyclists, particularly in view of the wide overall circulatory carriageway width as associated with all compact roundabout layouts that are designed to accommodate specific large/long vehicle types, not all of which type might use the subject roundabout and approach roads.

3.2 Problem 2: NMUs

Location: NMU paths to/from the development.

Summary: Inadequate provision of NMU facilities could lead to NMU conflicts and/or

NMUs using non-designated routes or making crossings of roads at inadvisable locations with risks of slips, trips and falls injuries.

- 3.2.1 The footway from the development ends at the northwestern quadrant with pedestrians having to cross Chalkstone Way to gain access to the existing footway along the southern side of Chalkstone Way. Not far west of the proposed roundabout is the Westfield Primary Academy school so the Auditors would expect some NMU demand between the development (the Access Road roundabout) and the school which is not catered for in the current proposals unless such trips cross and re-cross Chalkstone Way.

3.3 Problem 3: Bus stop location

Location: Chalkstone Way west of the roundabout.

Summary: Stationary buses blocking entry to the roundabout could cause risks of

frustrated following vehicle drivers overtaking when unsighted and colliding with traffic exiting the roundabout or even driving the wrong way around

the roundabout.

3.3.1 The existing bus stop west of the roundabout is located only approx. 25m ahead of the roundabout 'Give Way' line and the drawing has no indications of bus stop relocation.

3.4 Problem 4: Speed cushion feature

Location: Chalkstone Way immediately west of the roundabout.

Summary: Proximity of feature to roundabout entry/exit would be a potential

frustration to drivers causing potential rash decision-making or encourage pedestrians to cross the road where no formal crossings is intended and which could surprise drivers and lead to vehicle/pedestrian conflicts.

3.4.1 There is an existing speed cushion arrangement immediately west of the roundabout located only approx. 15m ahead of the roundabout 'Give Way' line and the drawing has no indications of its removal. With a roundabout so close the speed cushion arrangement would appear superfluous and could safely be removed – however, 'Problem 1' relates in respect of speed control on the roundabout approaches.

- 3.1.4 The recommendations are that:
 - The roundabout should be re-designed to ensure that vehicle entry paths have radii tighter than 70m radius (such re-design might involve the provision of a larger roundabout); and

- Traffic calming should be applied to the development Access Road.

- 3.2.3 The recommendation is that:
 - The footway along the western side of the development Access Road should be continued on to the school entrance not far west of the proposed roundabout with, perhaps, enhancement to shared cyclist/pedestrian status.

3.3.2 The recommendation is that:

The bus stop should be relocated further west, sufficiently away from the roundabout.

3.4.2 The recommendation is that:

The speed cushion arrangement should be relocated a short distance further west.
