Hallam Land Management

Great Wilsey Park, Haverhill

Arboricultural Assessment

August 2015

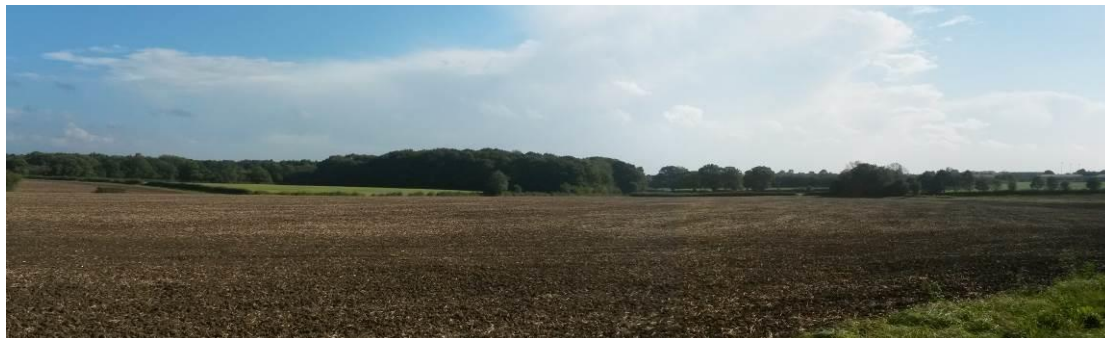
Immediately to the east and adjacent to woodland W5 was W7. Although these two areas of woodland had merged together there was a clear distinction between the two when observed from an elevated view point. Trees within W7 displayed younger proportions in comparison to the neighbouring specimens of W5 along with a more regular spaced pattern giving the impression that this woodland was planted at a later date. Discussions with the land owner confirmed that this plantation was intended to produce a crop of Christmas trees which had never been harvested and had subsequently been allowed to outgrow. Species also differed slightly with a higher content of deciduous trees such as common larch *Larix decidua*, grand fir *Abies grandis* and Norway spruce *Picea abies*.

Photograph 1: Elevated view of W5 and W7

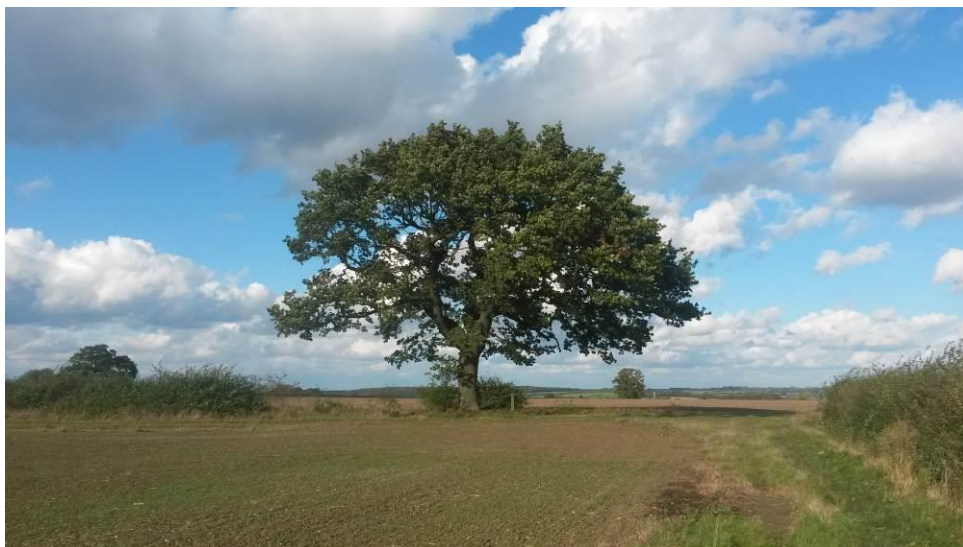
- 3.13 There were a number mature oaks situated throughout the site creating visually prominent features due to their proportions and characteristics. T8, T9, T11, T13, T14, T15, T16, T17, T19, T51, T57, T59 and TG18 were all English oak trees situated within field boundary hedgerows housing typical defects / habitat features such as sections of hung up dead wood and minor damage to branches amongst the crown. These specimens were considered to be a mixture of high and moderate arboricultural quality with trees of greater visual prominence and / or conservation value being regarded as retention category A.

Photograph 2: Typical form of a mature English oak across the site

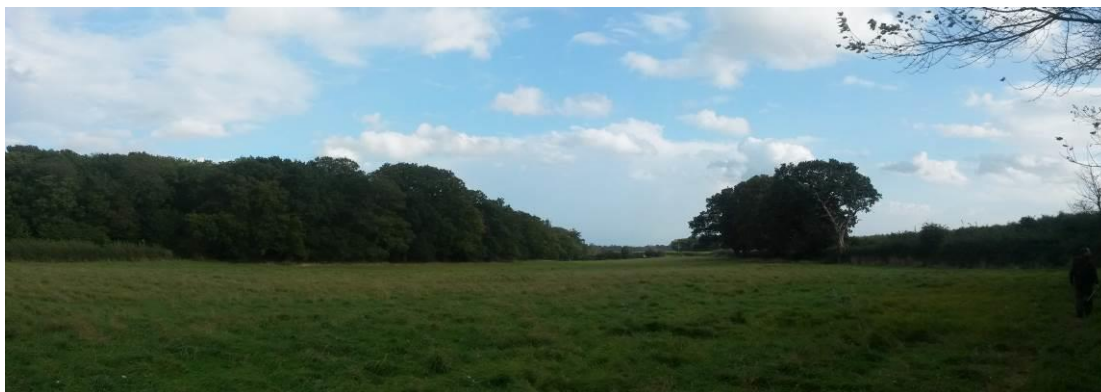
These oak specimens all displayed physical conditions and characteristics typically found on such trees in this type of environment with open grown crowns supporting several broken branches, branch stubs, branch socket cavities and crossing branch material throughout. Epicormic growth was present amongst the crowns alongside dead wood in various proportions,

evidence of past and recent storm damage. A number of these specimens displayed heart wood in places which had become exposed through the loss of crown sections and in the case of T68 fire damage through vandalism. Despite these notable defects all of these trees were considered to be of high quality in arboricultural terms with considerable remaining life expectancy. The trees also provided prominent visual focal points within the surrounding landscape offering high amenity value and therefore regarded as retention category A.

Photograph 3: Mature English oaks fringing the edge of W5 (left) and trees T65 – T71 (right)

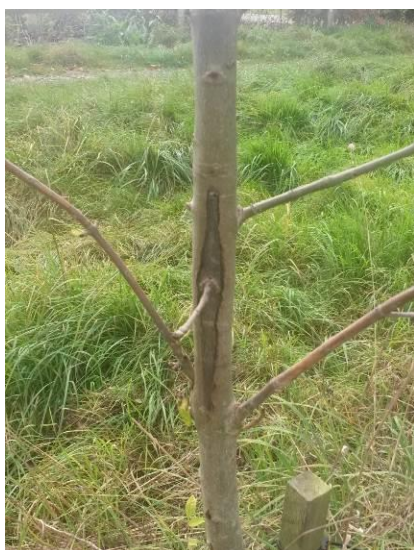
Photograph 4: Ash dieback

-
- 3.23 The symptoms of Chalara dieback of ash *Hymenoscyphus fraxinus* was observed throughout both TG3 and TG5. This disease is caused by a fungus which causes bark necrosis resulting in leaf loss and crown dieback in affected trees and is usually fatal in young trees however, research is ongoing at this current time.

- 3.24 The younger ash trees within TG3 displayed significant dieback and declining health and ash trees within TG5 also exhibited dieback alongside some trees indicating signs of recovery. The removal and burning of these infected specimens would be recommended to reduce the potential for spread of this disease within the surrounding area. Although unfortunate the removal of the infected trees would also act as a method of thinning TG5 to allow the remaining tree cover to mature into quality specimens as part of the group's future management in accordance with industry best practice.

- 4.7 The presence of Chalara dieback of ash was observed throughout TG5 and as a result the removal and burning of the infected ash specimens would be recommended to reduce the potential for spread of the disease within the naturally grown trees surrounding area. The removal of the infected trees will aid in the thinning of TG5 to allow the remaining tree cover to mature into quality specimens as part of the group's future management in accordance with industry best practice.

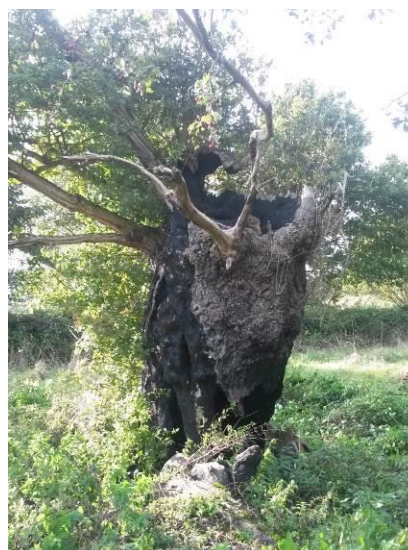
- 3.19 T64 was situated within the northern portion of the site, south of the existing school field and on the edge of TG28. This English oak had been subjected to extensive damage in the past possibly resulting in significant structural failure reducing the crown to a main stem with a couple of lateral branches and epicormic growth. The now hollow stem had been drastically weakened through vandalism which had caused the central stem material to have been lost entirely through fire damage leaving a thin wall of functional tissue. The remains of either past fallen or removed branches were scattered around the base of the tree with a single piece of timber acting as a support to the precariously balanced main stem of T64. At the time of inspection this specimen could also be seen moving in contortedly due to the effects of wind upon the unstable structure twisting the stem.

- 3.20 Although T64 exhibited some characteristics that may be associated with Veteran trees this specimen would be deemed to be in such a condition that it could not be realistically retained as a living tree in the context of the current land use for longer than 10 years and was therefore regarded as retention category U. Due to the fact that Veteran trees are important components of the landscape for a number of reasons including ecological, social, cultural and historical value it is recommended that this tree is allowed to decline over time naturally reaching its own demise. It would be recommended however that T64 is managed sympathetically through similar techniques used on veteran trees to prevent the decline being accelerated. Access should also be restricted in order to prevent further vandalism and reduce the potential for injury to members of the public.

Photograph 5: T64 Oak
