Phase 1 Land Contamination Risk Assessment

**Empire Yard, Land to the Rear of
Boots Opticians Ltd,
No.41 High Street, Haverhill
CB9 8AH**

Date: February 2023

3468D P1 Rahimi – Haverhill, Suffolk

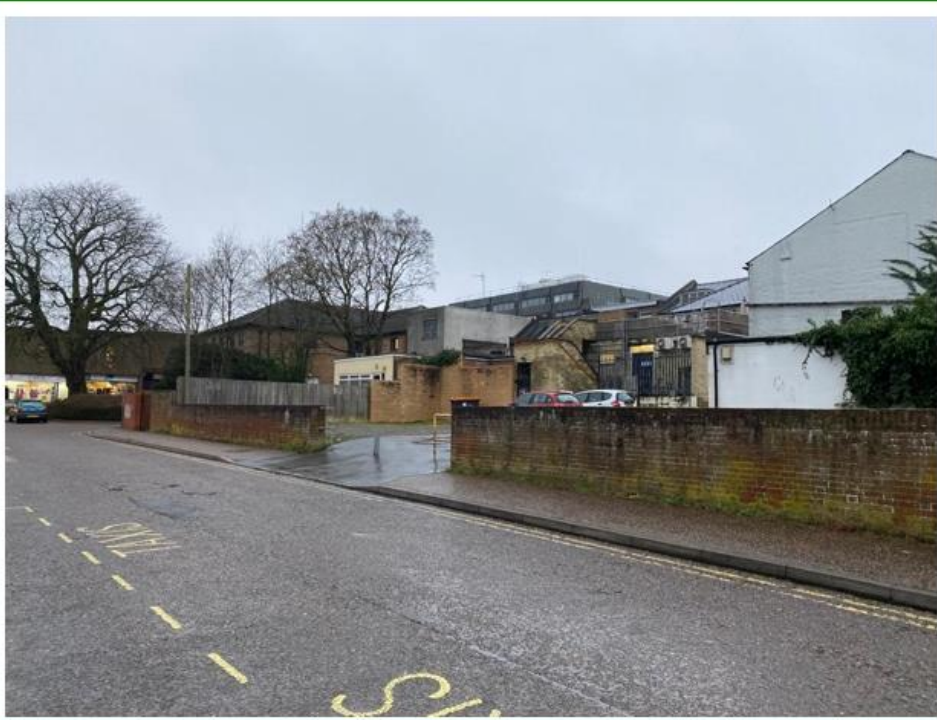
Photo No.1: Facing south from Brook Service Rd showing the north eastern boundary of site and vehicle access

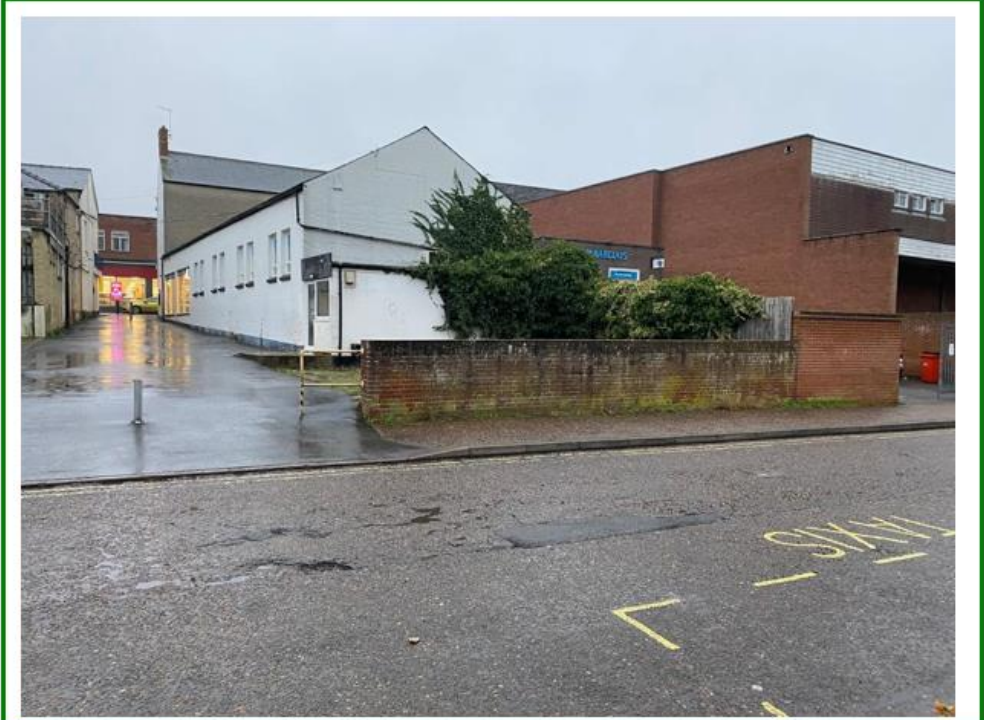
Photo No.2: Facing west from Brook Service Rd showing the north eastern boundary of site and vehicle access

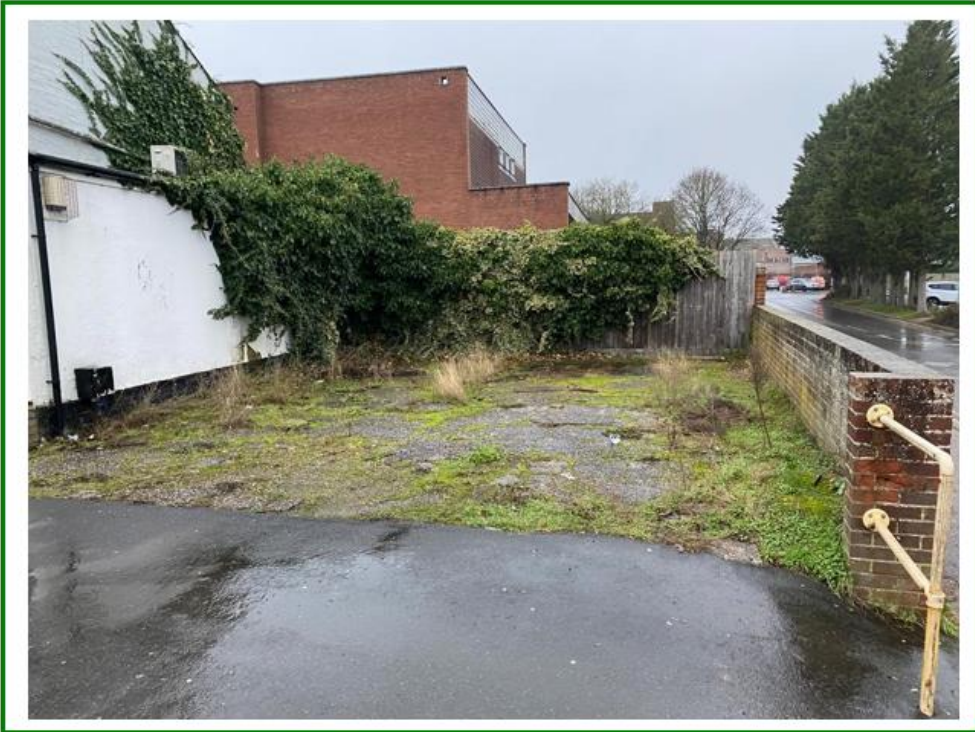
Photo No.3: Facing north from onsite showing the former lock-up garage unit area and fractured concrete here

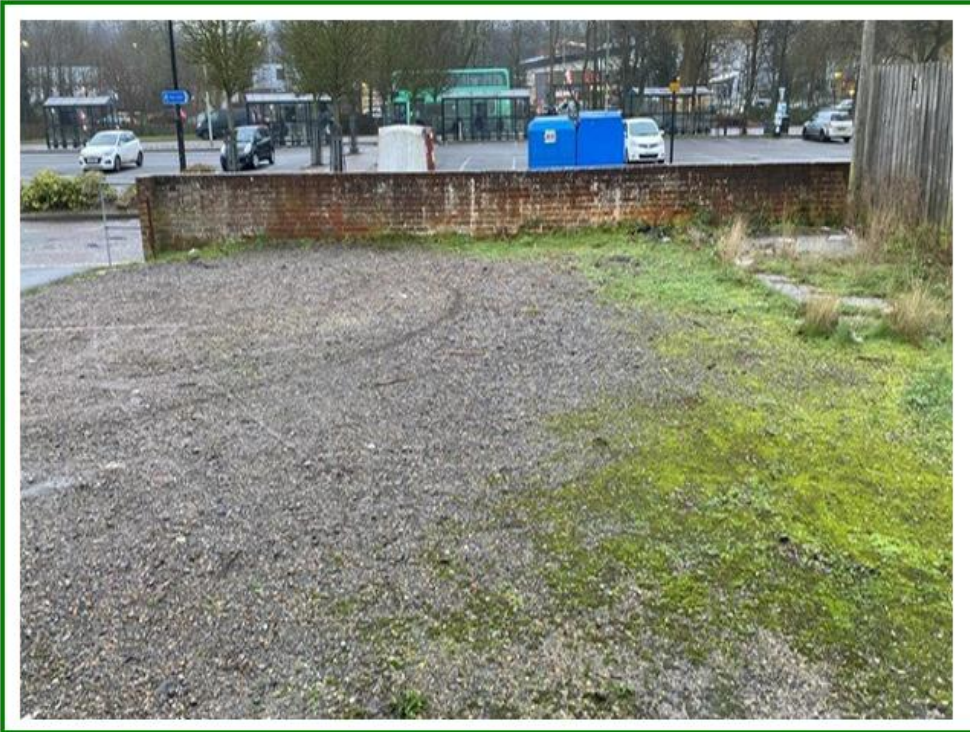
The usage of the site for parking reasons and noted made ground deposits are considered potential sources of contamination.

Photo No.4: Facing NE from onsite showing the former location of structure and made ground gravels on site
