Project Number: 22-0364

Project Title: 23/01994/FUL WHCH Former Woodlands Hotel, Coupals Road, Haverhill

In relation to planning application 23/01994/FUL, Anglian Water have objected to a proposed discharge of surface water from the proposed development to the adopted surface water drainage network. Their concerns are raised in their Pre-Planning Assessment Report as follows:

Aquajet CCTV Survey Results

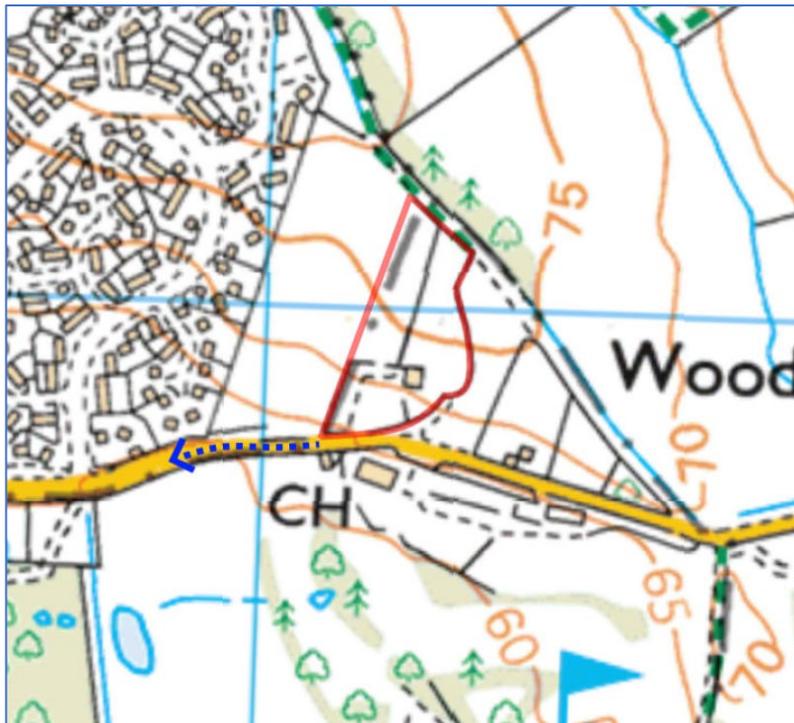
Figure 2: Local topography with overland flow route from the current site.

- The fall of the topography on Coupals Road from the site entrance to the Anglian Water sewer is a fall in excess of 5m over 150m (1in30) – see Figure 2 below,

- As a result of this the surface water currently exiting the site unattenuated will enter the Anglian Water surface water sewers via highway gullies on Coupals Road upstream to the east of the junction with Roman Way,

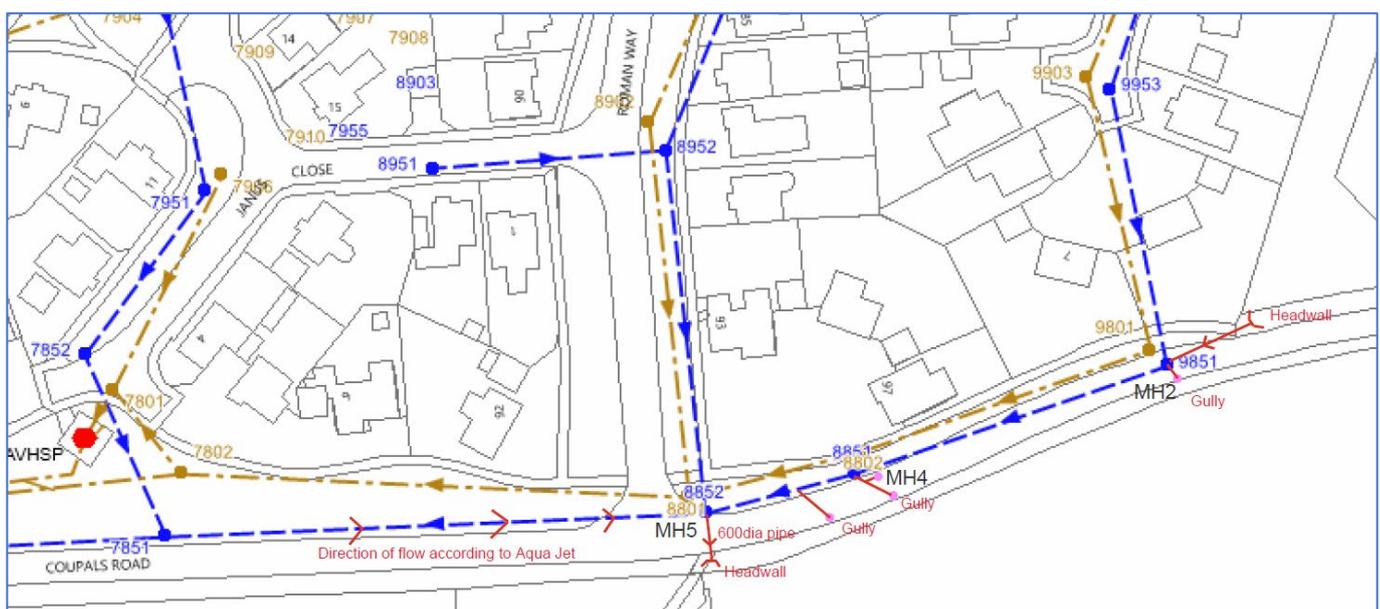
Figure 3: CCTV findings noted over the Anglian Water Sewer Record

The highway gullies within Coupal Road that accept overland flow from the former hotel site have been proven to connect to the Anglian Water sewers.

- The highway gullies within Coupal Road that accept overland flow from the former hotel site have been proven to connect to the Anglian Water sewers.
- The adopted surface water sewers in Coupals Road take a much smaller catchment than Anglian Water were aware of prior to discharging to a headwall outfall to a watercourse to the south of Coupals Road opposite Roman Way.

Considering the above two statements, that we have evidenced with our further investigations, it is clear that the existing Anglian Water 450mm diameter surface water sewer at manhole 9851 has capacity to accept an attenuated piped discharge of 2.5 litres per second from the proposed development as a betterment on the current unrestricted overland flow. As such we request that Anglian Water remove their objection to this proposal.

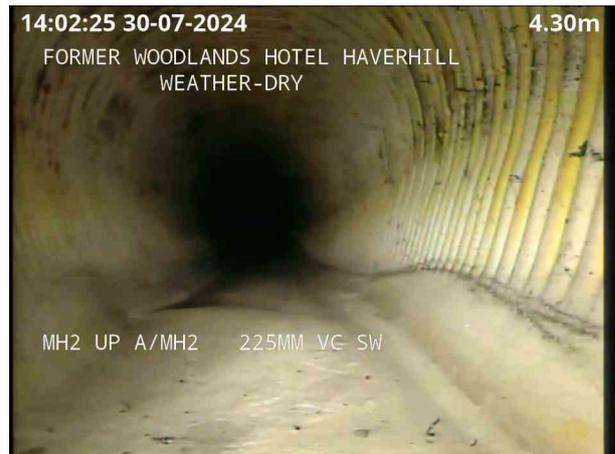
<table><tr> <td style="width: 10%;">0.00</td> <td style="width: 10%;">MH</td> <td style="width: 40%;">Start node type, manhole, reference number: MH2</td> <td style="width: 10%;">00:00:00</td> <td style="width: 10%;"></td> <td style="width: 10%;"></td> <td style="width: 10%;"></td> </tr><tr> <td>4.30</td> <td>D</td> <td>Deformed sewer or drain, 5%</td> <td>00:00:38</td> <td>HEADWA LL1X_0a3f 8008-12c0</td> <td></td> <td>2 / 2</td> </tr></table>

HEADWALL1X_0a3f8008-12c0-4537-b676-b1113ed0dacb_20240808_104637_397.jpg, 00:00:38, 4.30 m
 Deformed sewer or drain, 5%

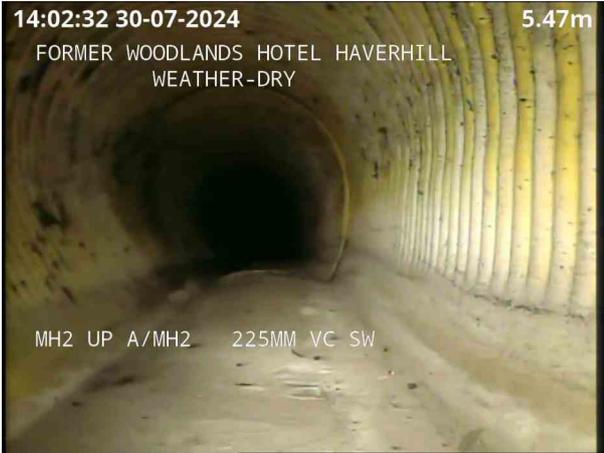
<table><tr> <td style="width: 10%;">0.00</td> <td style="width: 10%;">MH</td> <td style="width: 40%;">Start node type, manhole, reference number: MH2</td> <td style="width: 10%;">00:00:00</td> <td style="width: 10%;"></td> <td style="width: 10%;"></td> <td style="width: 10%;"></td> </tr><tr> <td>5.47</td> <td>S01</td> <td>Deformed sewer or drain, 10%, start</td> <td>00:00:45</td> <td>HEADWA LL1X_475f 2358-37f8-</td> <td></td> <td></td> </tr></table>

HEADWALL1X_475f2358-37f8-4d61-93e8-4e5eed1eeaf_20
 240808_104708_167.jpg, 00:00:45, 5.47 m
 Deformed sewer or drain, 10%, start

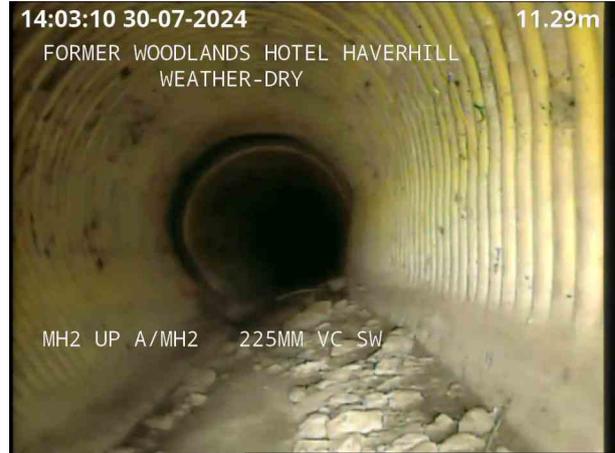
<table><tr> <td style="width: 10%;">0.00</td> <td style="width: 10%;">MH</td> <td style="width: 40%;">Start node type, manhole, reference number: MH2</td> <td style="width: 10%;">00:00:00</td> <td style="width: 10%;"></td> <td style="width: 10%;"></td> <td style="width: 10%;"></td> </tr><tr> <td>11.29</td> <td>DER</td> <td>Settled deposits, coarse, 5% cross-sectional area loss</td> <td>00:01:23</td> <td>HEADWA LL1X_304 a71c9-62c</td> <td></td> <td>3</td> </tr></table>

HEADWALL1X_304a71c9-62c9-45c5-8ad7-ee53d0fe4b6f_20
 240808_104741_140.jpg, 00:01:23, 11.29 m
 Settled deposits, coarse, 5% cross-sectional area loss

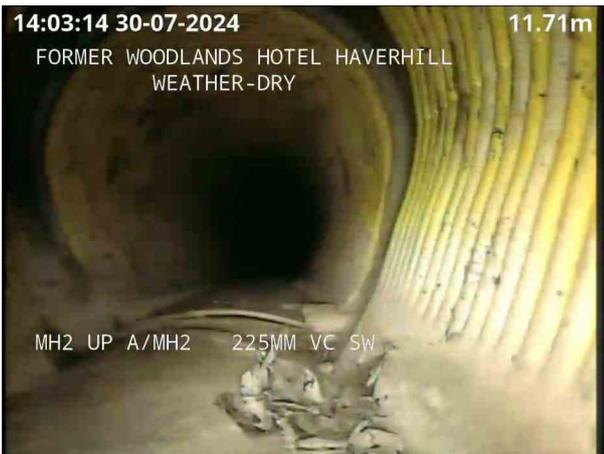
<table><tr> <td style="width: 10%;">0.00</td> <td style="width: 10%;">MH</td> <td style="width: 40%;">Start node type, manhole, reference number: MH2</td> <td style="width: 10%;">00:00:00</td> <td style="width: 10%;"></td> <td style="width: 10%;"></td> <td style="width: 10%;"></td> </tr><tr> <td>11.71</td> <td>OJL</td> <td>Open joint, large</td> <td>00:01:26</td> <td>HEADWA LL1X_a64 c5a0b-f94</td> <td></td> <td>1</td> </tr></table>

HEADWALL1X_a64c5a0b-f949-4b2c-ba7d-ca38ea83f57e_20
 240808_104758_945.jpg, 00:01:26, 11.71 m
 Open joint, large

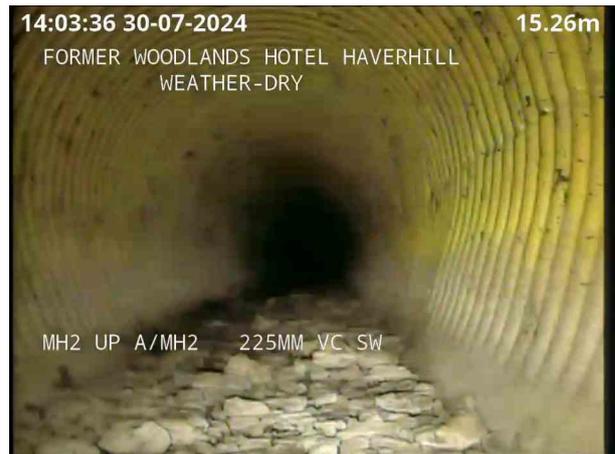
<table><tr> <td style="width: 10%;">0.00</td> <td style="width: 10%;">MH</td> <td style="width: 40%;">Start node type, manhole, reference number: MH2</td> <td style="width: 10%;">00:00:00</td> <td style="width: 10%;"></td> <td style="width: 10%;"></td> <td style="width: 10%;"></td> </tr><tr> <td>15.21</td> <td>S02</td> <td>Settled deposits, coarse, 10% cross-sectional area loss, start</td> <td>00:01:49</td> <td>HEADWA LL1X_3d0f 7251-caed</td> <td></td> <td></td> </tr></table>

HEADWALL1X_3d0f7251-caed-45ef-b591-6f676d69d231_20
 40808_104828_620.jpg, 00:01:49, 15.21 m
 Settled deposits, coarse, 10% cross-sectional area loss, start

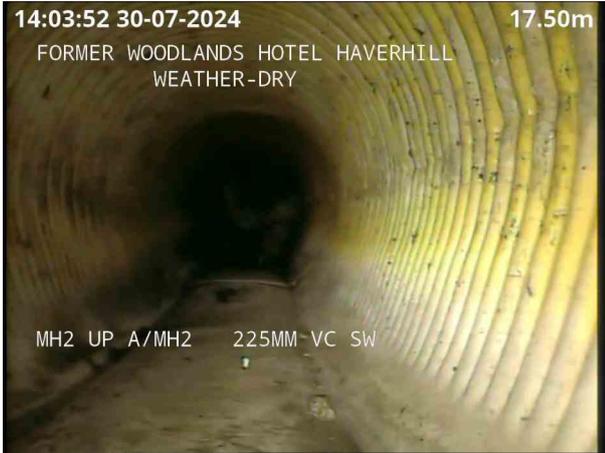
<table><tr> <td style="width: 10%;">0.00</td> <td style="width: 10%;">MH</td> <td style="width: 40%;">Start node type, manhole, reference number: MH2</td> <td style="width: 10%;">00:00:00</td> <td style="width: 10%;"></td> <td style="width: 10%;"></td> <td style="width: 10%;"></td> </tr><tr> <td>17.50</td> <td>F02</td> <td>Settled deposits, coarse, 10% cross-sectional area loss, finish</td> <td>00:02:05</td> <td>HEADWA LL1X_394 840bd-4c7</td> <td></td> <td>3</td> </tr></table>

HEADWALL1X_394840bd-4c7d-4aa8-a06f-cd922cf5709b_20
 240808_104845_697.jpg, 00:02:05, 17.50 m
 Settled deposits, coarse, 10% cross-sectional area loss, finish

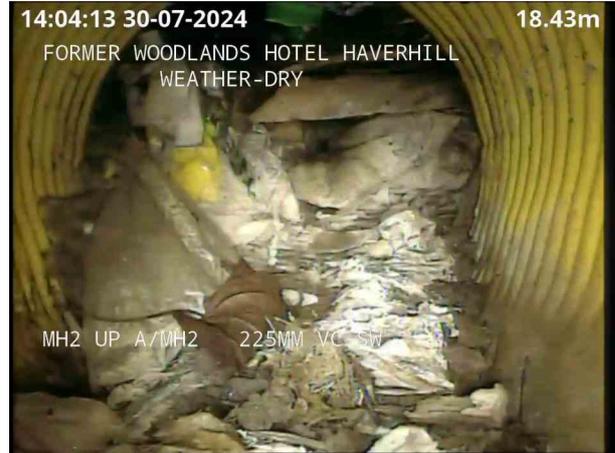
<table><tr> <td style="width: 10%;">0.00</td> <td style="width: 10%;">MH</td> <td style="width: 40%;">Start node type, manhole, reference number: MH2</td> <td style="width: 10%;">00:00:00</td> <td style="width: 10%;"></td> <td style="width: 10%;"></td> <td style="width: 10%;"></td> </tr><tr> <td>18.43</td> <td>DEX</td> <td>Settled deposits, other, 90% cross-sectional area loss: DITCH OVERGROWN/FULL DEBRIS</td> <td>00:02:25</td> <td>HEADWA LL1X_9f13 8096-53da</td> <td></td> <td>5</td> </tr></table>

HEADWALL1X_9f138096-53da-434f-b03c-d2c455c884e9_20
 240808_104938_449.jpg, 00:02:25, 18.43 m
 Settled deposits, other, 90% cross-sectional area loss

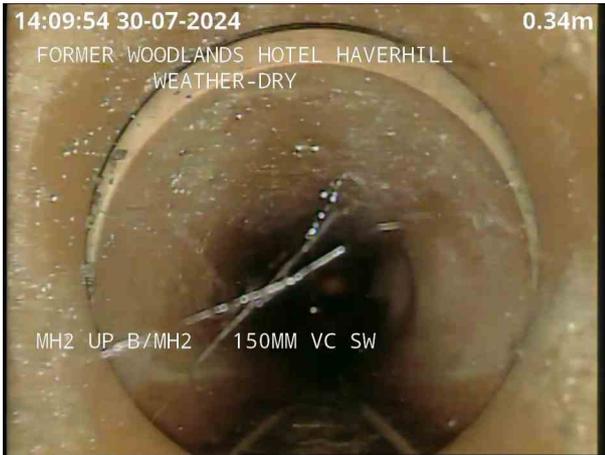
GULLYX_dd5a8695-f347-413c-b579-8f45dd919180_20240808_105211_468.jpg, 00:00:08, 0.34 m
 Joint displaced, medium

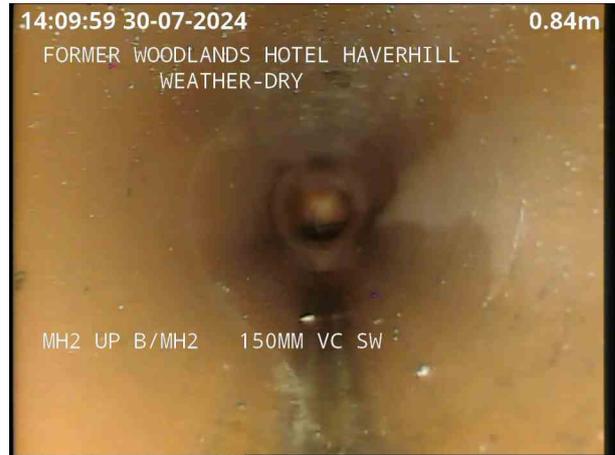
GULLYX_2461f06d-9248-466e-8810-da7079e0571b_20240808_105234_224.jpg, 00:00:13, 0.84 m
 Cracks, spiral from 6 o'clock to 4 o'clock

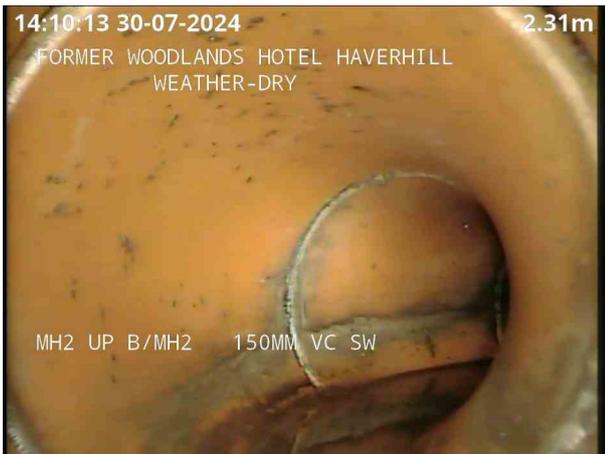
GULLYX_55248e04-cb12-42c1-8ef0-401b3f5ffda1_20240808_105254_288.jpg, 00:00:27, 2.31 m
 Line deviates right
