3.4 BUILDING 3

3.5 BUILDING 4

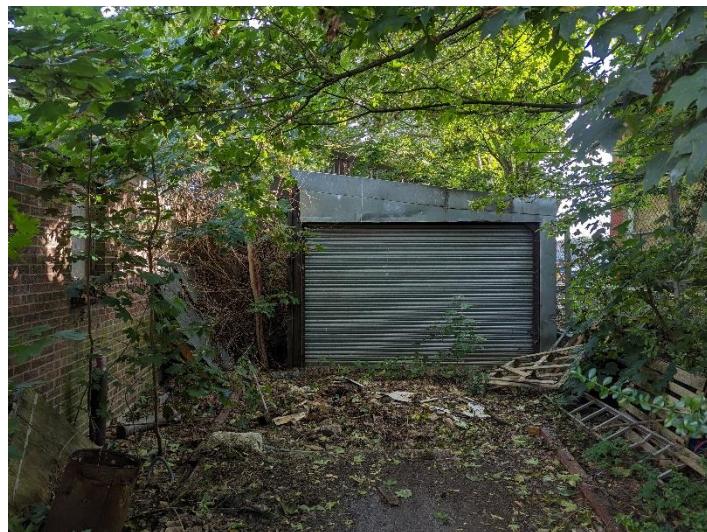
East Elevation abuts building 4.

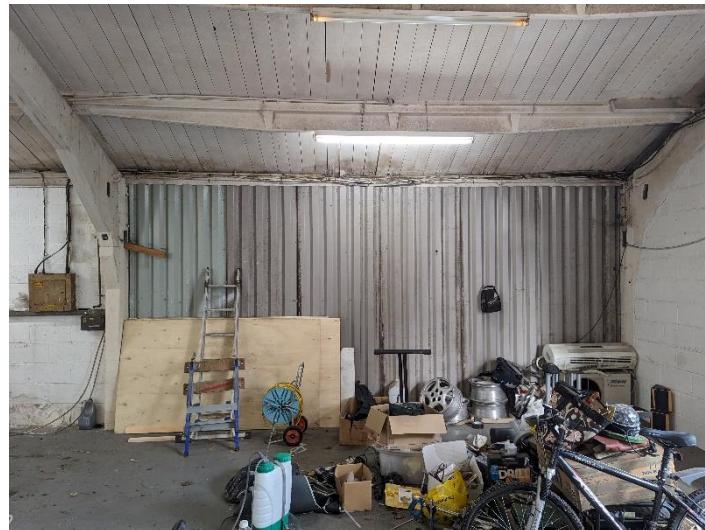
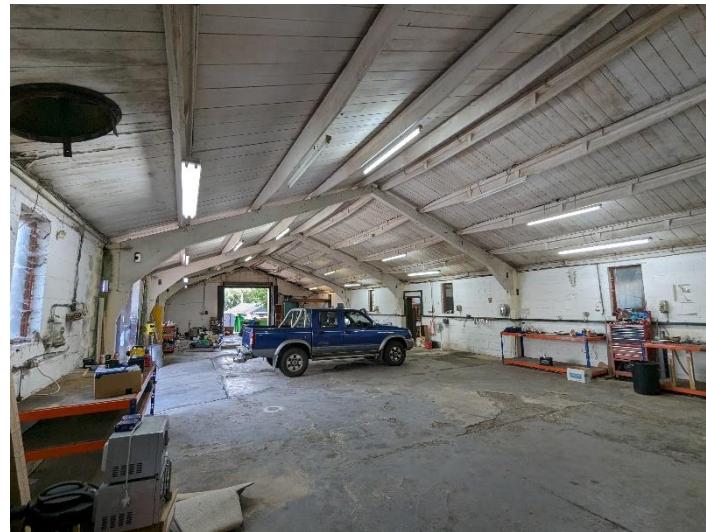
3.4.3 Anecdotally, from an employee of some 15 years, the roof leaks. This is notable where old ventilation extracts have been sealed poorly. Clearly some of the timber boarding needs replacing, however generally appeared in reasonable condition.

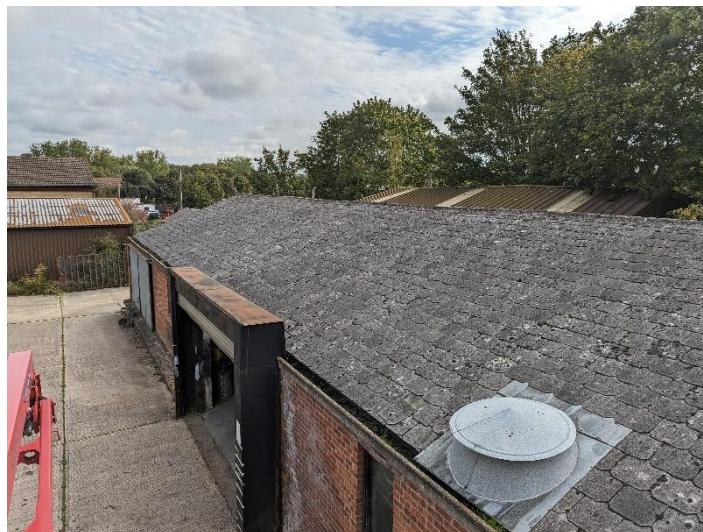
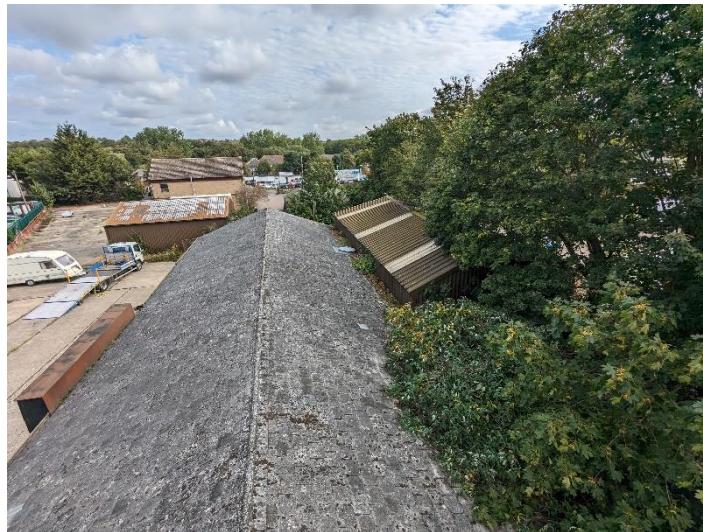
3.4.6 Where building 4 abuts building 3 a change in roof level occurs forming a trapped gutter. Judging by the tideline significant amounts of water appear to form in this valley. The build-up of vegetation obscured the detail of this gutter area. Notably the edge of the original concrete gutter can be seen inside building 4 suggesting that a new gutter should have been formed. However, no additional downpipe was noted.

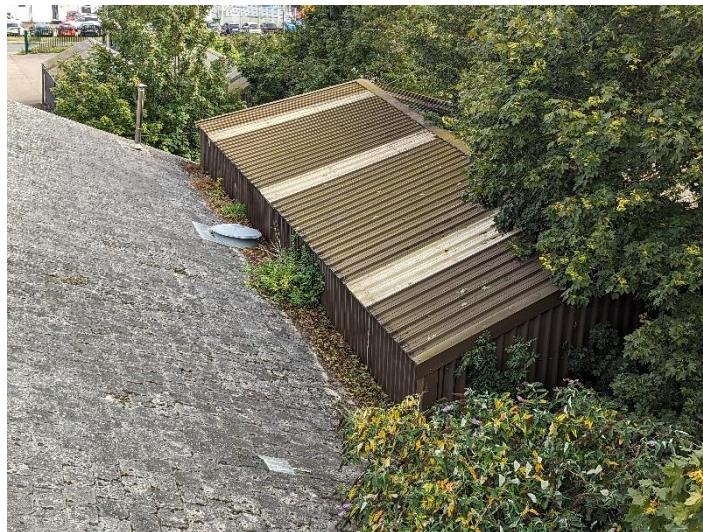
3.4.7 To the west elevation the concrete gutter appears to still be functioning albeit overdue maintenance. The downpipe to the left of the main roller shutter has completely corroded away at the top where it joins the concrete gulley.

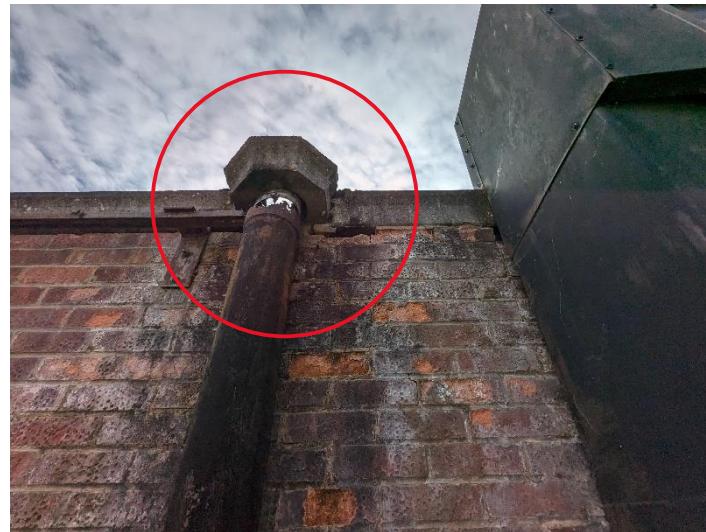
3.4.8 The external masonry was generally weathered with some significant mortar loss in some areas. The bricks appeared to be an LBC common type known to be of poor resistance to frost and moisture. The guttering has overflowed causing staining and mortar loss and the corners of brickwork have been damaged by impact from vehicles.

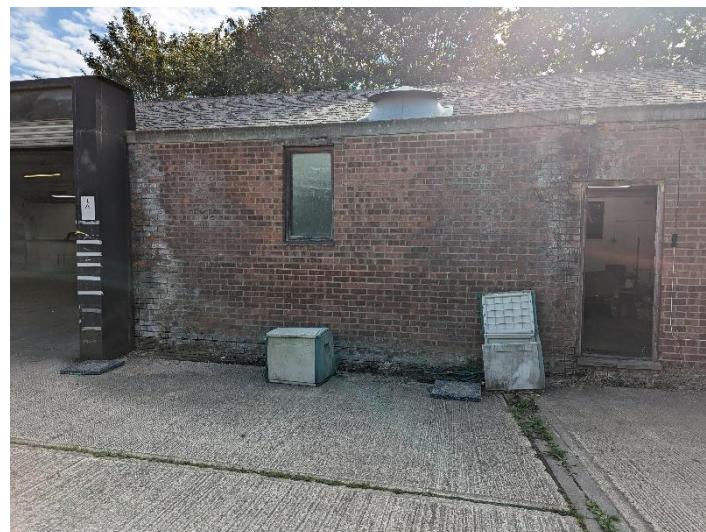
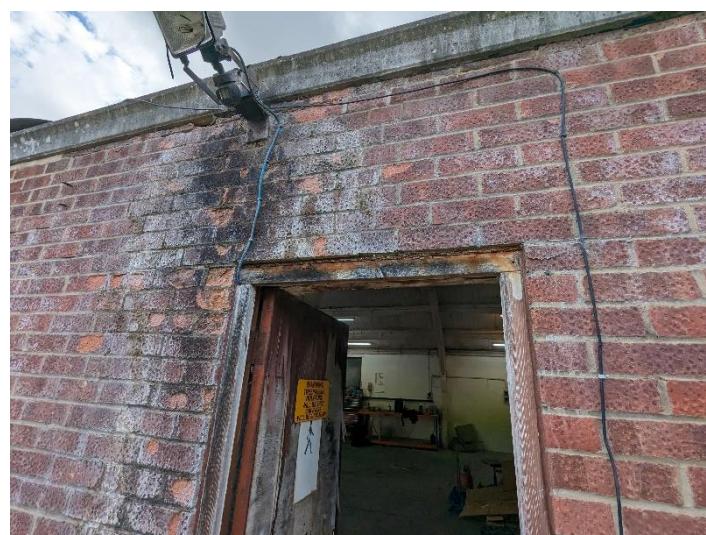
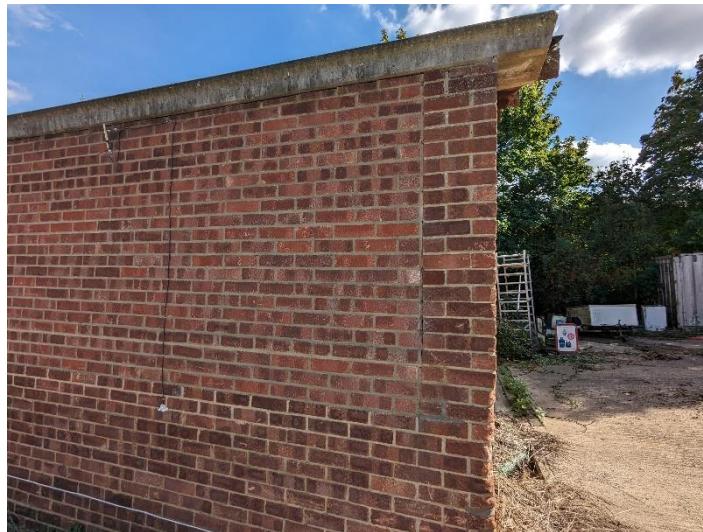
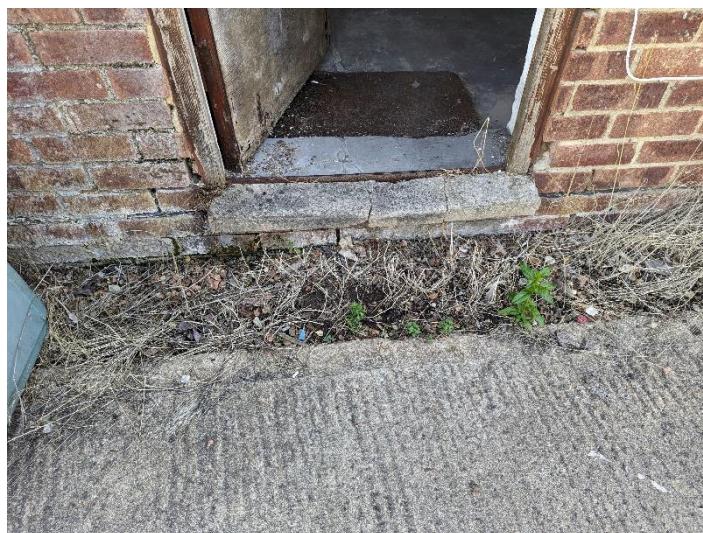
3.4.9 Cracking was noted to the southeast corner adjacent to a window opening. There is cracking internally in this position but not a direct reflection of the external. The pattern of the cracking indicates some minor settlement of the southeastern most corner relative to the remainder of the building. The foundations should be exposed in this area to confirm the underlying ground conditions and how the masonry is supported relative to the main frames.

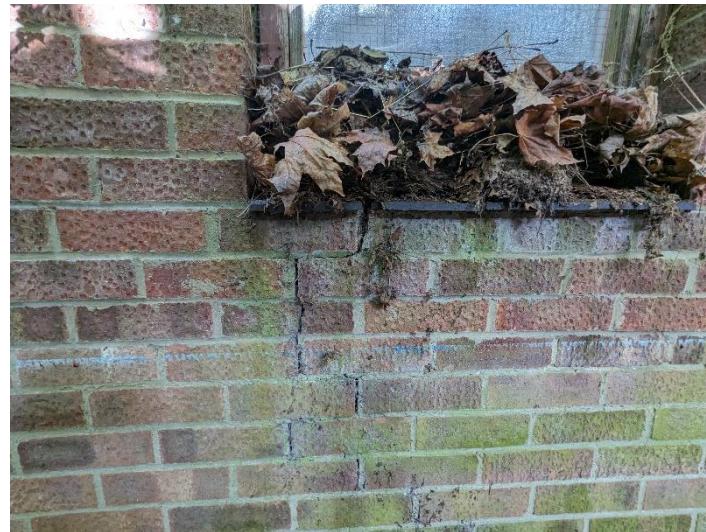
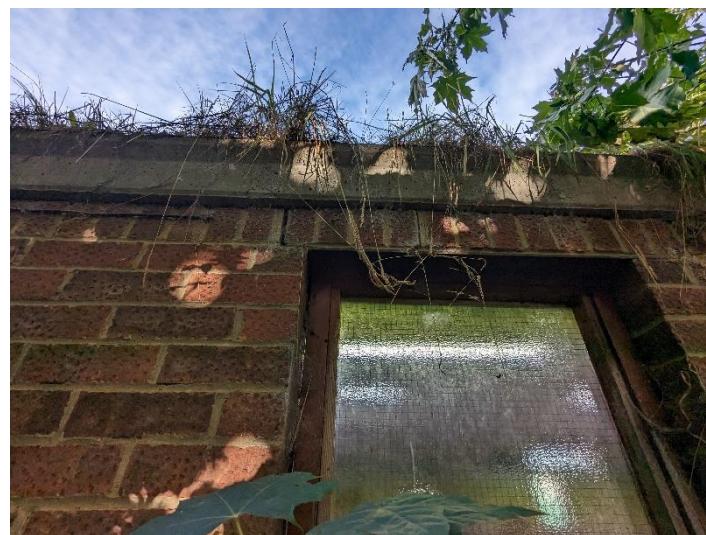
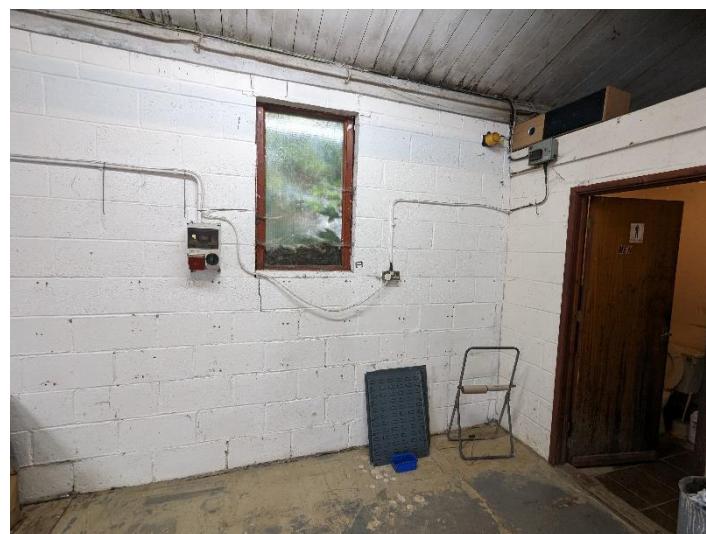
3.4.10 The concrete frames themselves appeared in sound condition throughout. No testing of the concrete was undertaken and there was no specific cause to lead us to propose such testing. The frames are the type commonly associated with Atcost who produced large numbers of reinforced concrete portal sheds between the 50s and 70s. Concrete issues

such as high alumina cement or poor-quality materials/construction is not known to be associated with this type of frame.

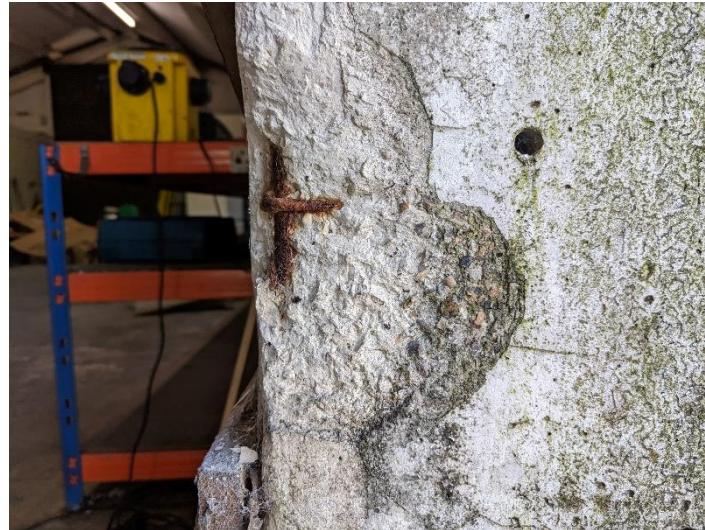
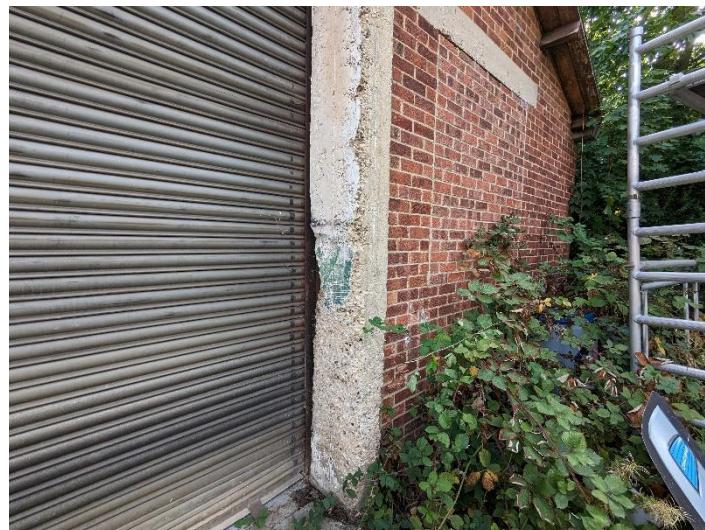
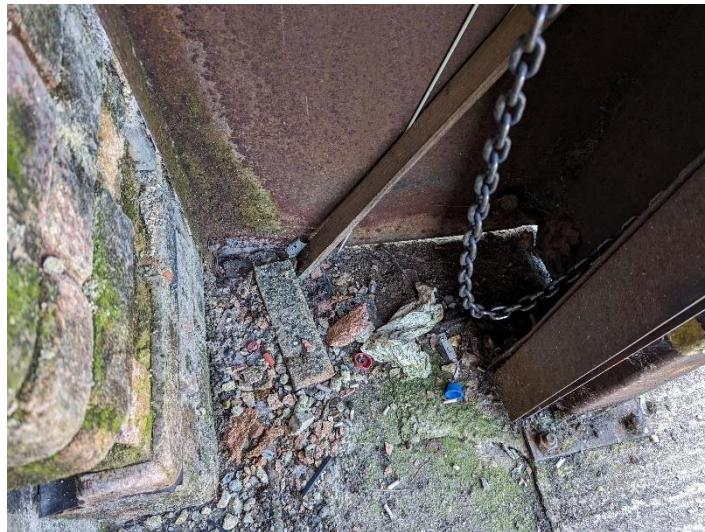
3.4.11 One column was damaged adjacent to the main roller shutter doors, likely caused by vehicular impact. A similar problem has occurred to the concrete frame surrounding the openings at each gable end. The metal cladding around the roller shutter housing a support frame is damaged and the frame is corroded at the base.

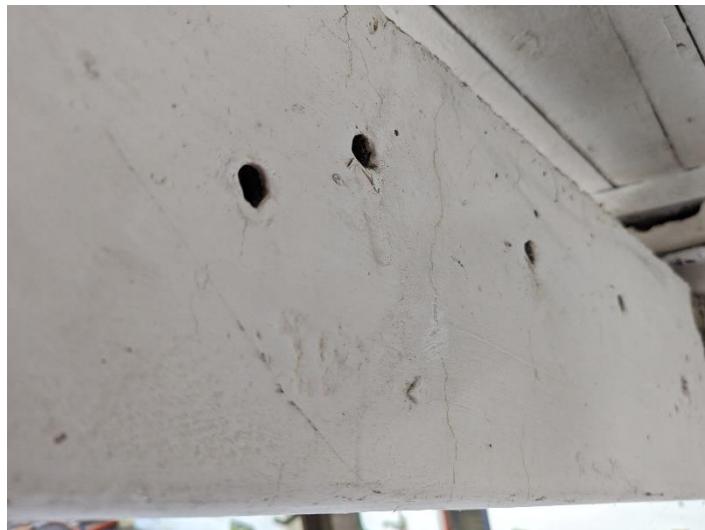
3.4.12 When viewed from ground level the frames do appear to have a number of cracks however, on closer inspection these appeared to be cobwebs or superficial cracking to the paint finish that could be rubbed or scratched away. It was not possible to reach all areas of the frames with the cherry picker to confirm this but nothing that appeared to be significant structural cracking within the concrete frames was noted.

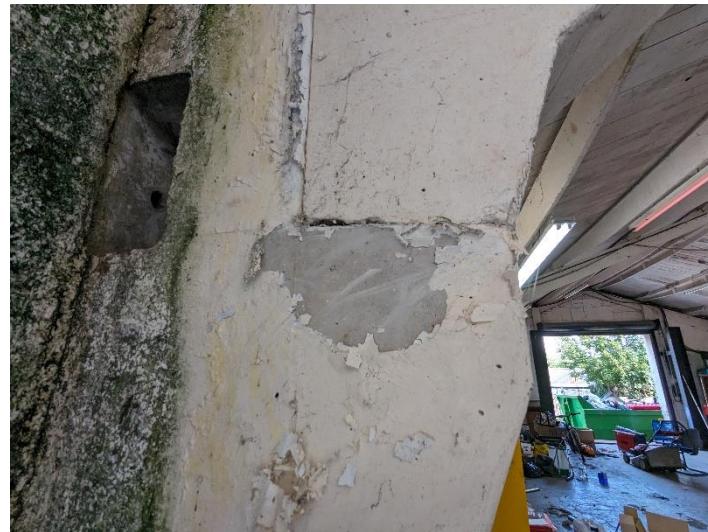
3.4.13 The frames have a number of coats of paint applied, this has flaked in some places revealing the concrete beneath. Where exposed the concrete appeared to be of sound quality. Green staining from moisture and lack of damp proofing to the columns either side of the roller shutter door is present. This must be cleaned off, the paint removed so that the condition of the concrete beneath can be assessed.

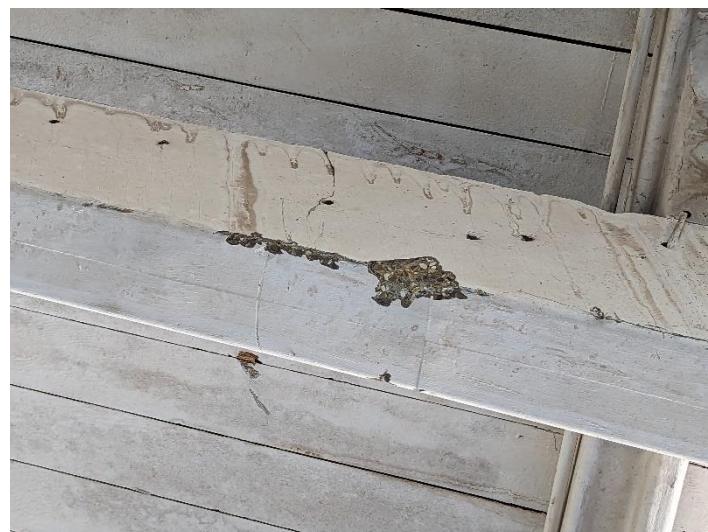
3.4.14 The underside of some of the primary concrete rafters have been hit, presumably with equipment or machinery. This has resulted in minor spalling of the concrete. No reinforcement is exposed although the cover is now reduced.

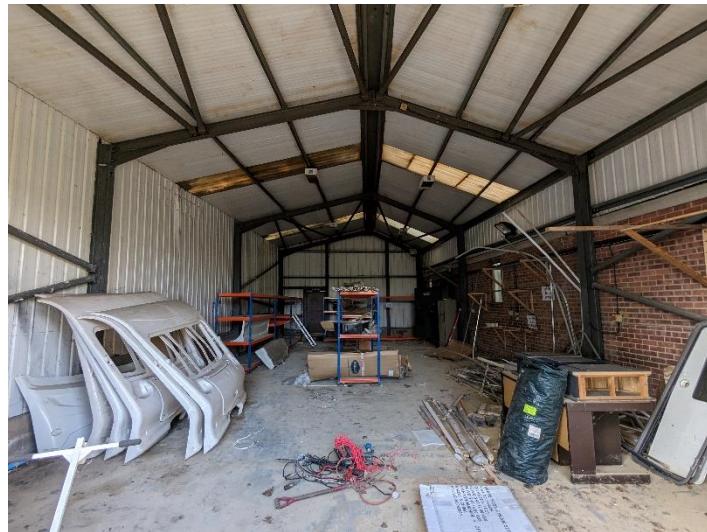
West Elevation abuts building 3 to right of photo

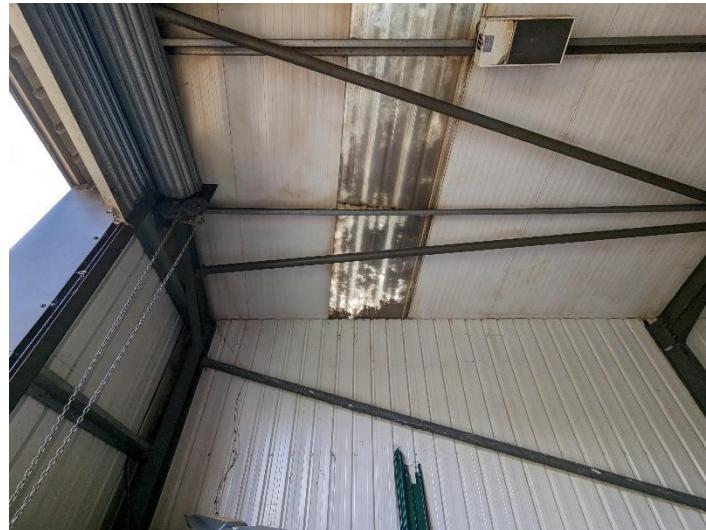
3.5.2 At the southern end of the main frame a doorway in the cladding leads to a small monopitch steel framed shed with roller shutter to the southern elevation and further roller shutter and door into building 3. I was not able to open the roller shutters or door.

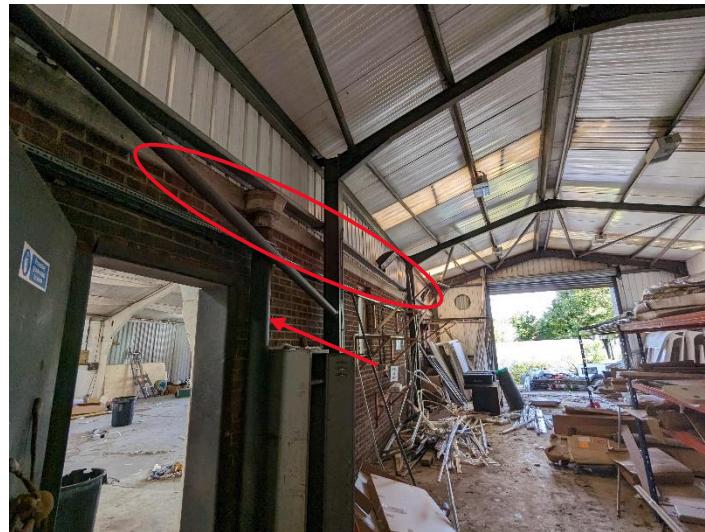
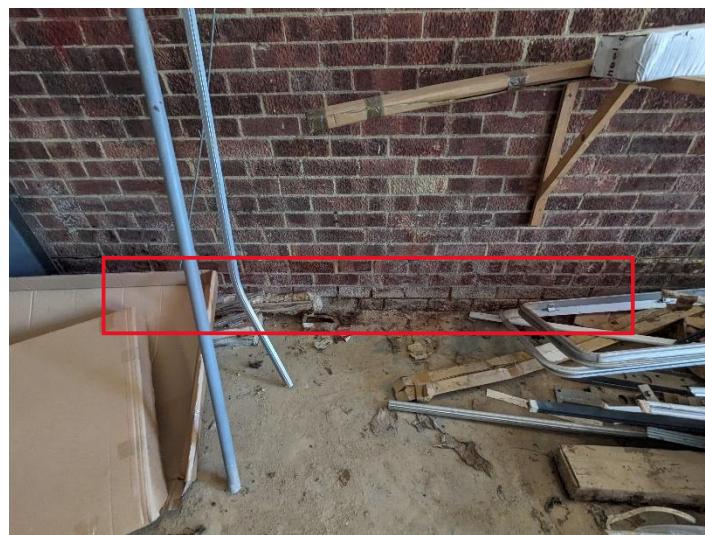
3.5.6 The paintwork to the steel frame was unusual in so much that some of the primary steel members along the eastern (skewed side) appear to be coated in a thick layer of textured paint. This has flaked off in some areas revealing and rough primer coat presumably required as a key for the surface finish. Small flecks of rust are noticeable in the primer coat. The remaining steelwork appears to be coated in standard paint. My inference from this evidence is that the framework for building 4 has been repurposed from another site where possibly the eastern elevation was exposed externally and therefore required no purlins or eaves beam to fix cladding and treated with a more ‘attractive’ finish.

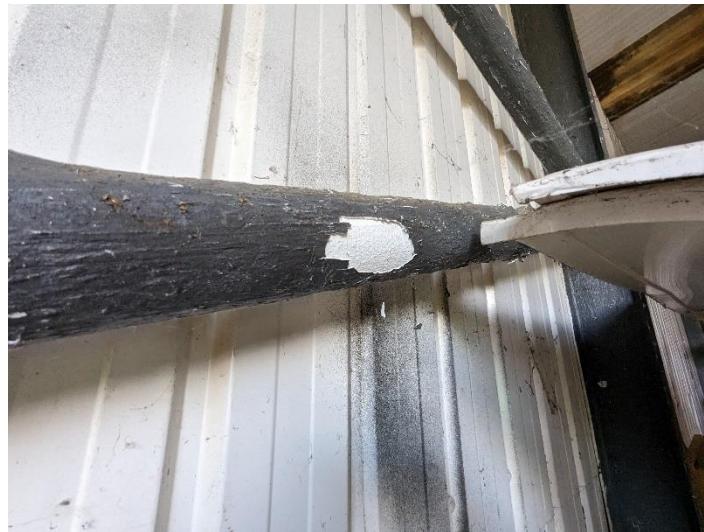
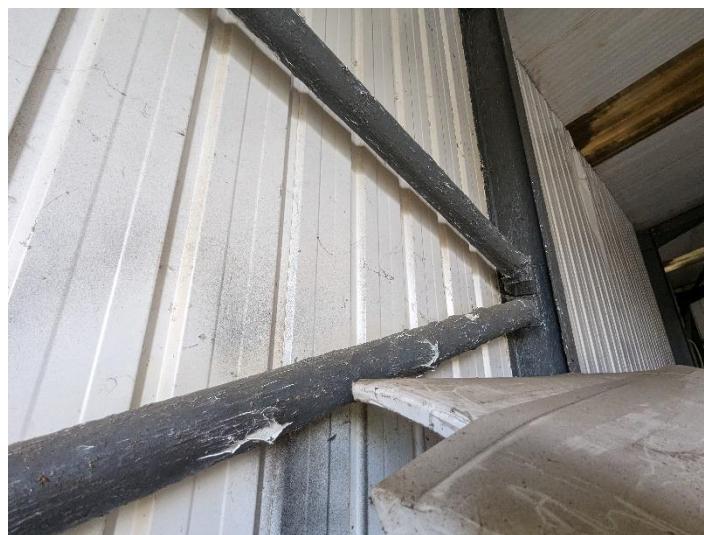
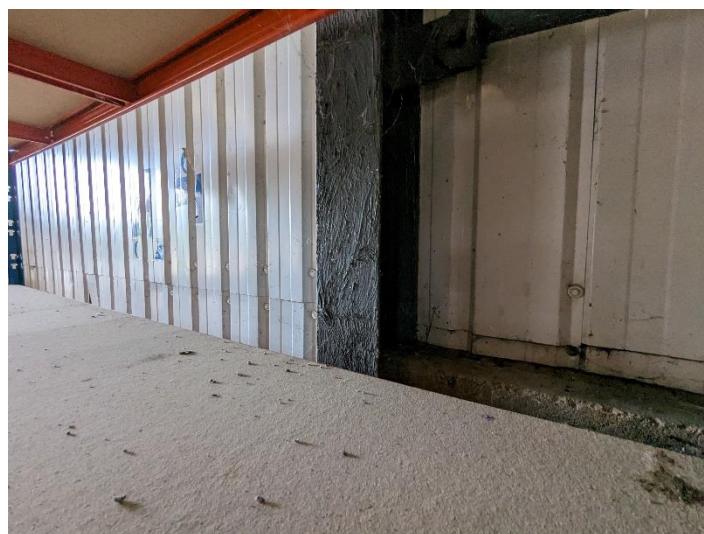
- 3.5.7 The primary steel members, other than the unusual paint finish appeared in good condition overall. No section loss, significant damage or displacement was noted.
- 3.5.8 As far as could be seen the ridge line was straight. The sealant strips to the ridge capping are dislodged in places.

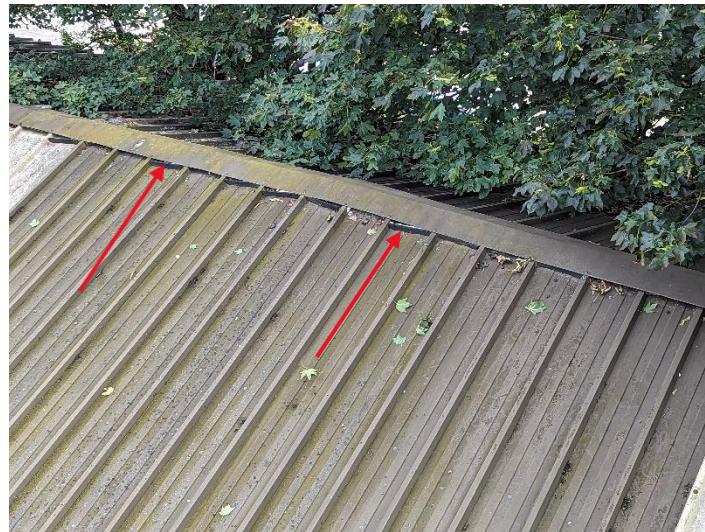
3.5.9 The monopitch frame to the southern end appears to have been built to fit the space in an ad-hoc manner. Despite some non-standard detailing it appears generally in good order. The external surfaces including were almost entirely inaccessible and obscured with vegetation.

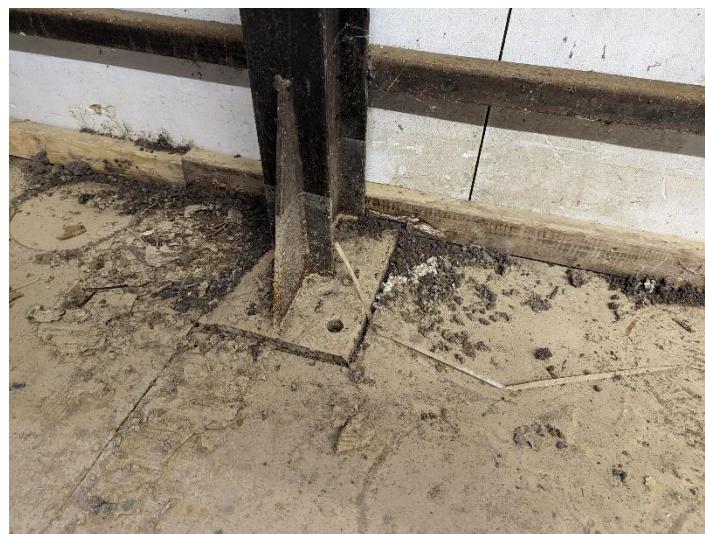
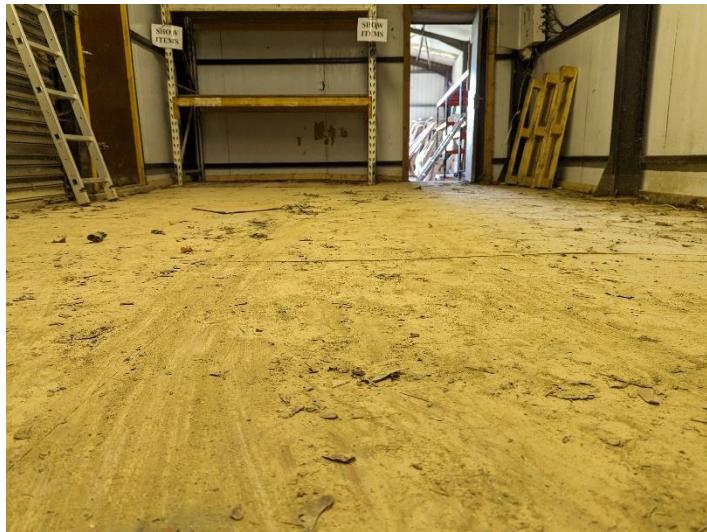
3.5.10 Some bolts are missing from base plates and the floor is uneven with the timber decking undulating between support points. The overall floor makeup is unknown.
