**Phase 1 Land Contamination
Risk Assessment**

**The Extension and Change of use
of Former Working Men's Club to
Mixed Residential (9 No. Flats)
and Commercial Usage**

**The Vixen, Millfields Way,
Haverhill, Suffolk CB9 0JB**

3926D P1 Patel Construction - Haverhill

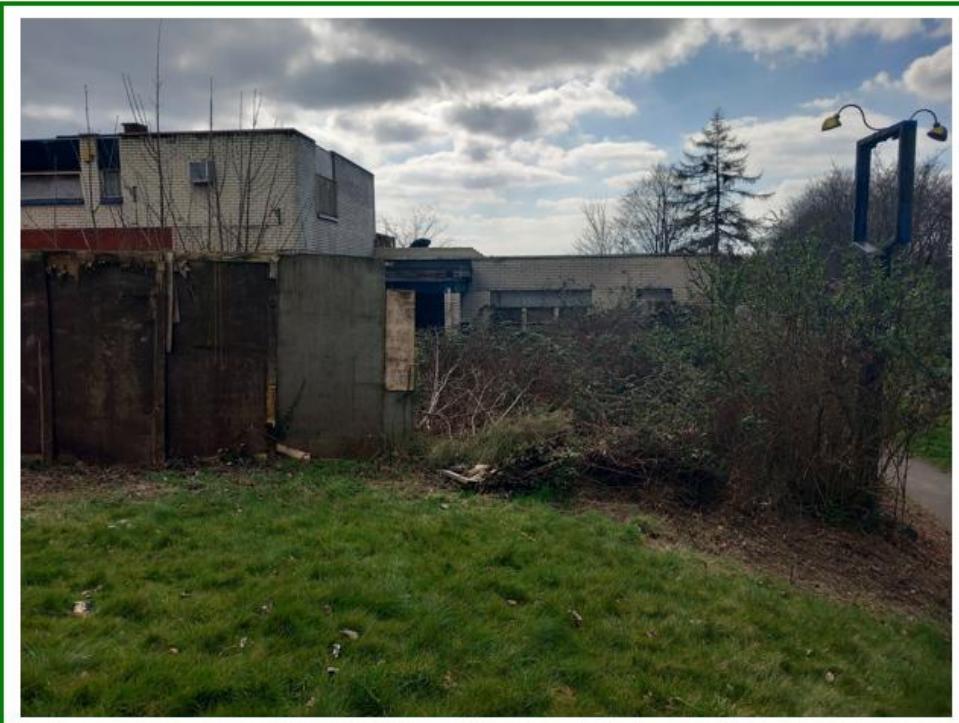
Photo No.4: Facing SW from the same location showing the heavily overgrown NE extent of site, enclosed by hoarding

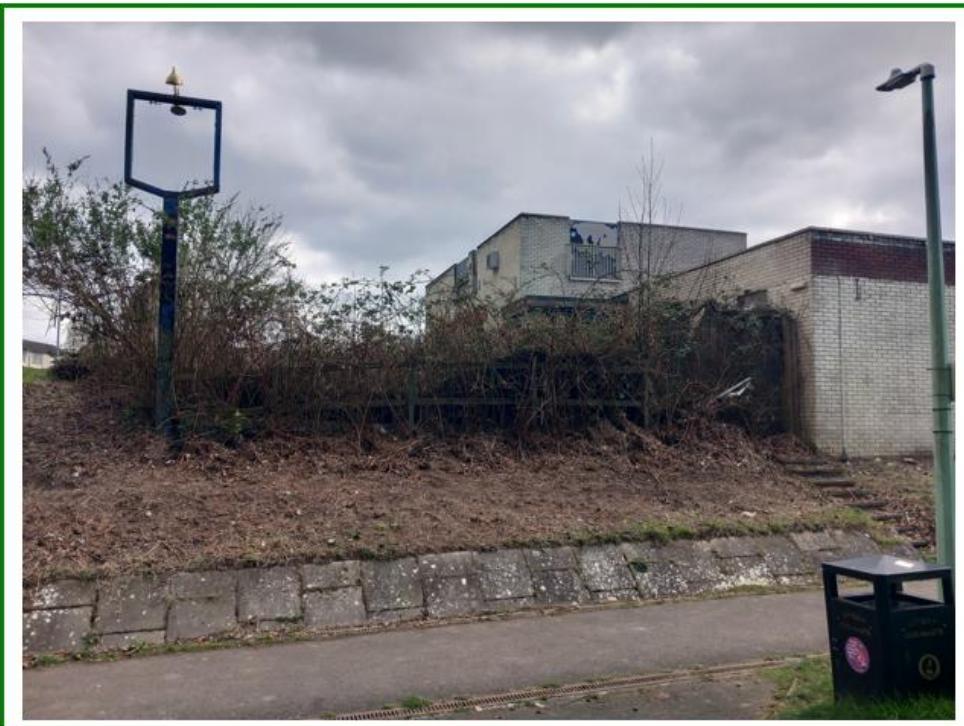
Photo No.5: Facing SE outside the NW face of site showing topographical difference between site and pedestrian alleyway

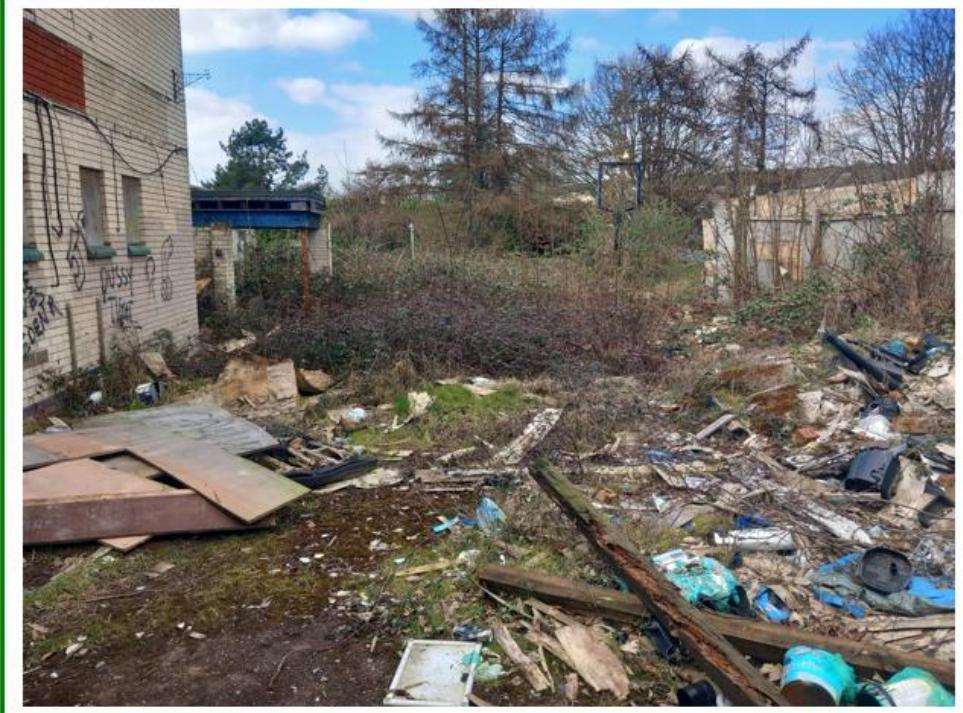
The heaped debris and refuse in exterior areas are considered a potential source of contamination noted on the site walkover. Topographically, the site is level however the areas around site slope from the north east to the south west, with steps providing access around the southern extent of the site, and embankments forming the north western extent, dropping off to the adjacent and sunken alleyway.

Photo No.10: Facing NW inside the hoarding and within the site boundary showing debris occupying NE extent of site

It is not envisaged that any further works or investigation are required, beyond the provision for an asbestos survey (and subsequent professional removal, if required) on the existing structure and the removal of heaped wastes and debris in exterior areas on site for site worker safety.

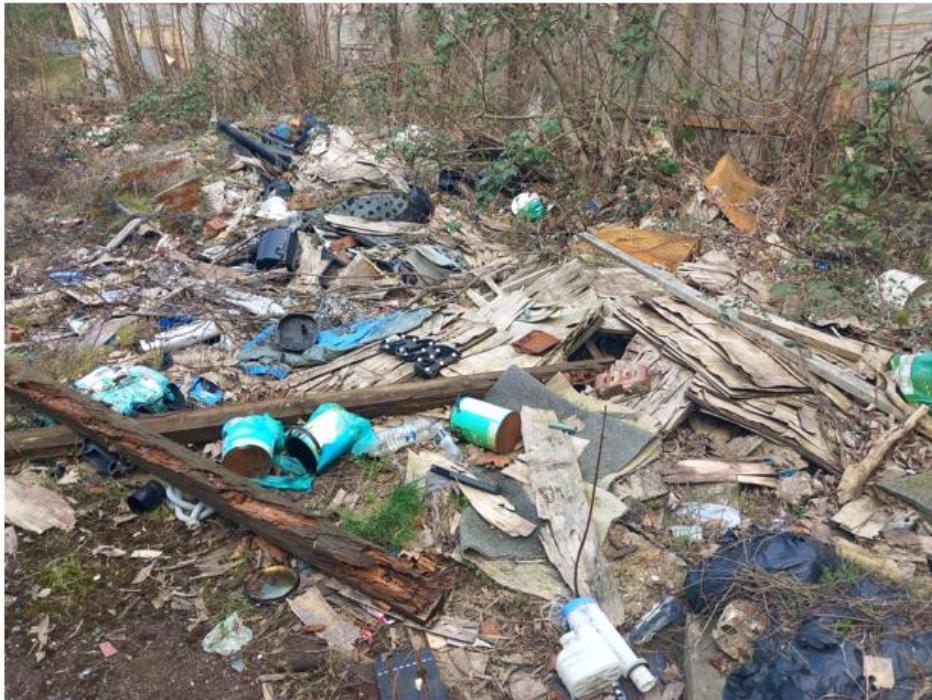
Photo No.11: Further photograph showing the heaped debris and refuse noted in the exterior, NE extent of site

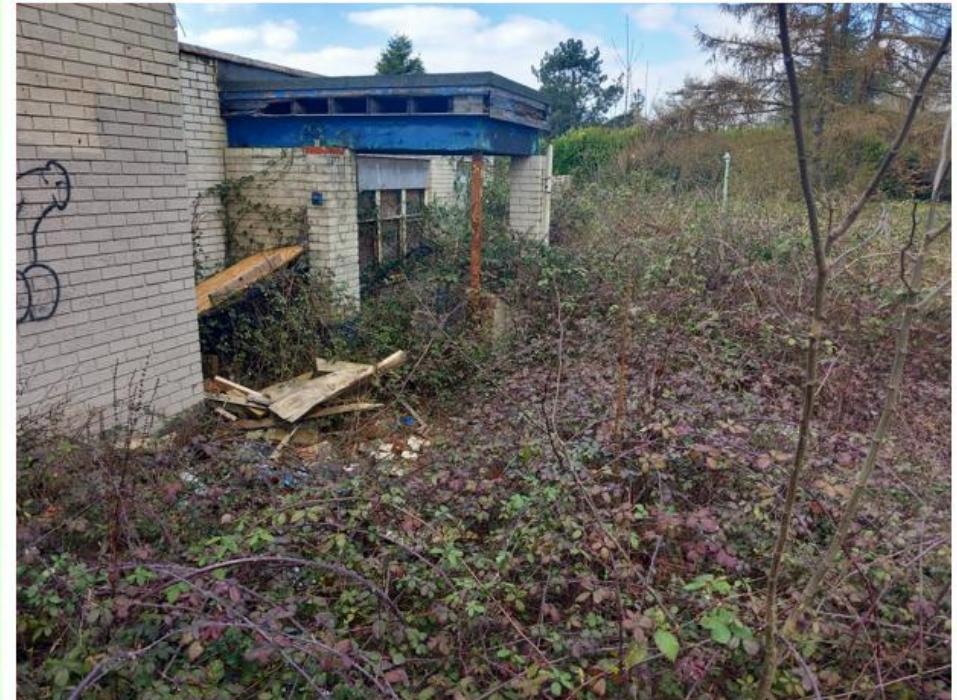
Photo No.12: Facing NW showing the far northern corner of site and the heavily overgrown debris & refuse here

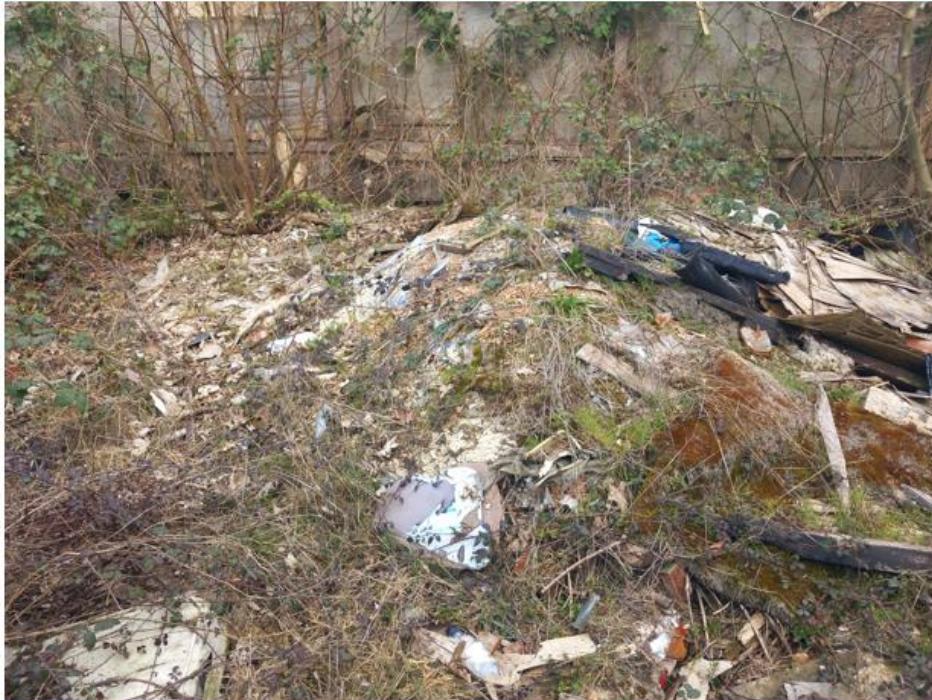
Photo No.13: Further shot of the debris and refuse noted in the northern and NE exterior extents of site

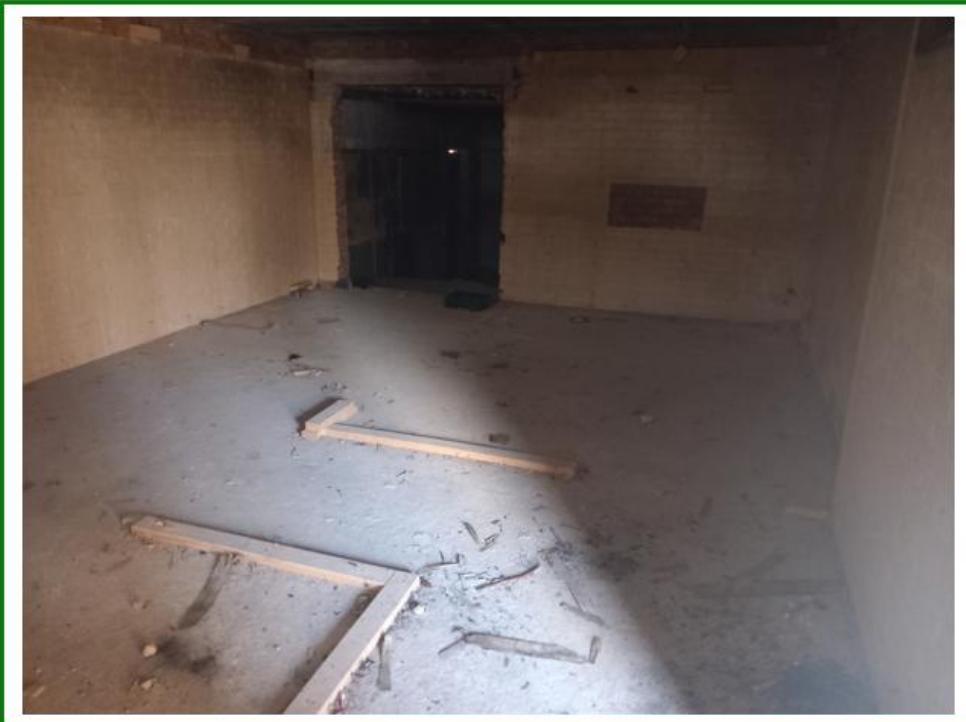
Photo No.15: General shot of the interior of the NE extent of the building showing fittings and furnishings removed

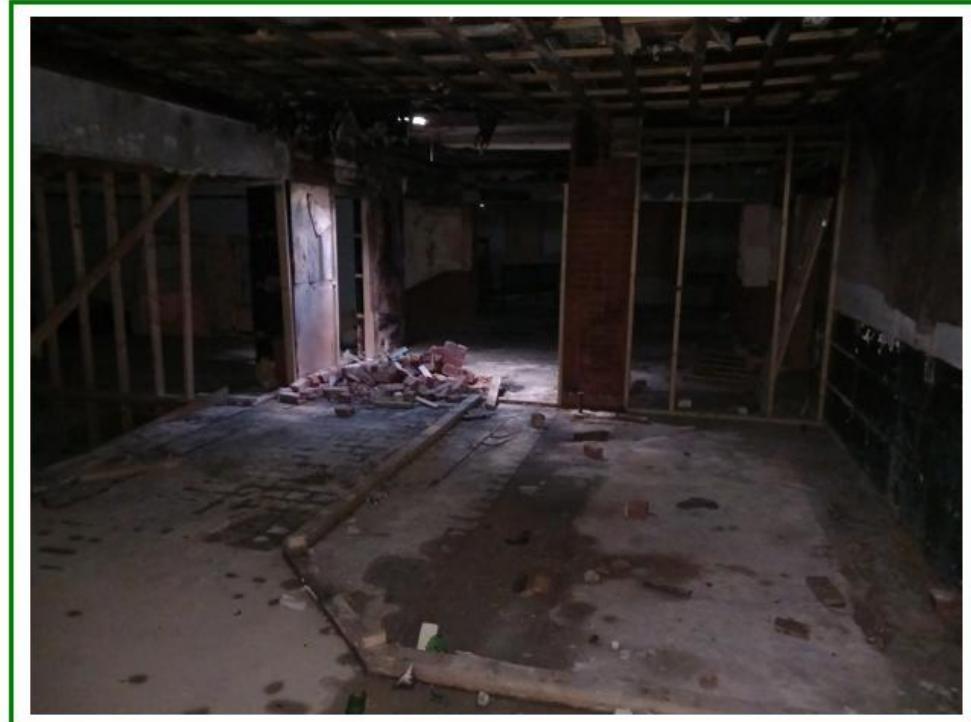
Photo No.16: Further shot of the interior showing the dilapidated, stripped nature of the interior of the onsite structure

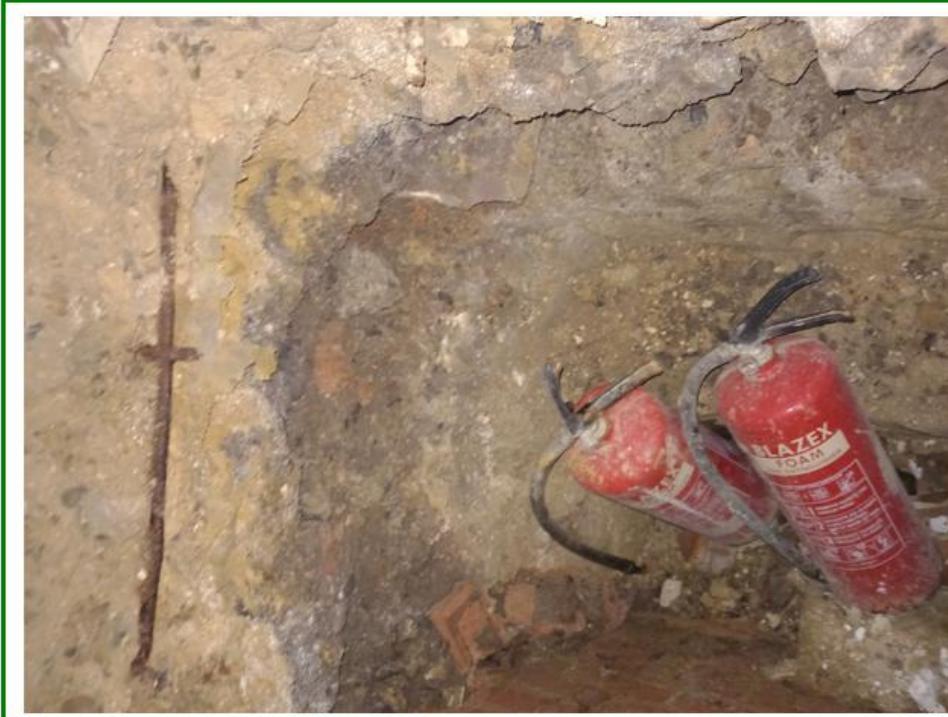
Photo No.17: Inspection pit noted within the structure (likely from structural survey) showing limited made ground deposits

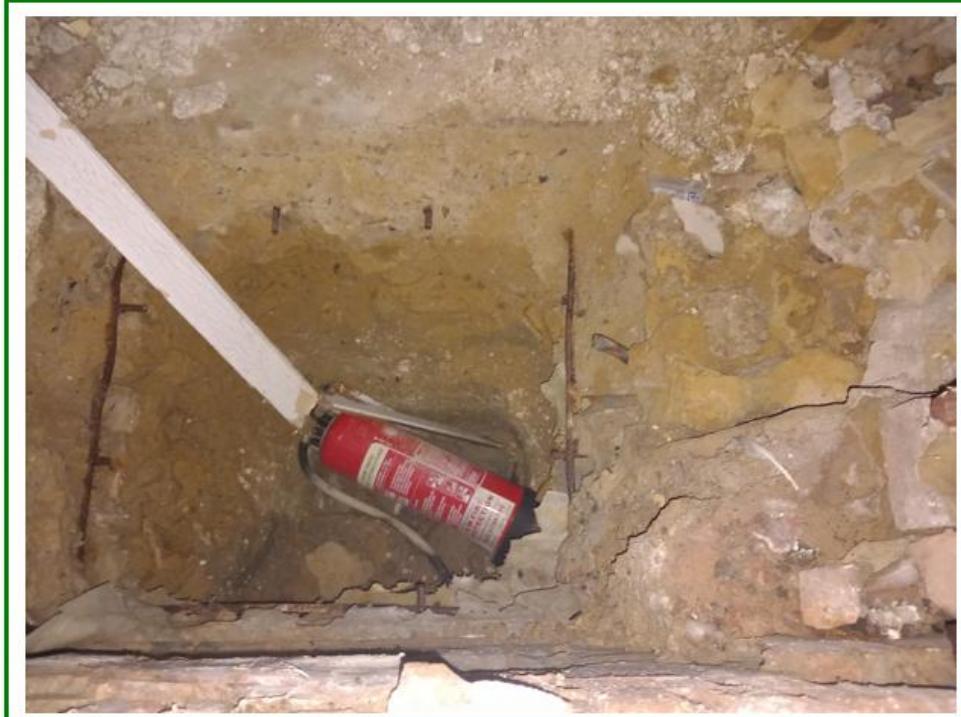
Photo No.18: Second inspection pit noted within the structure showing limited made ground deposits atop gravelly sands

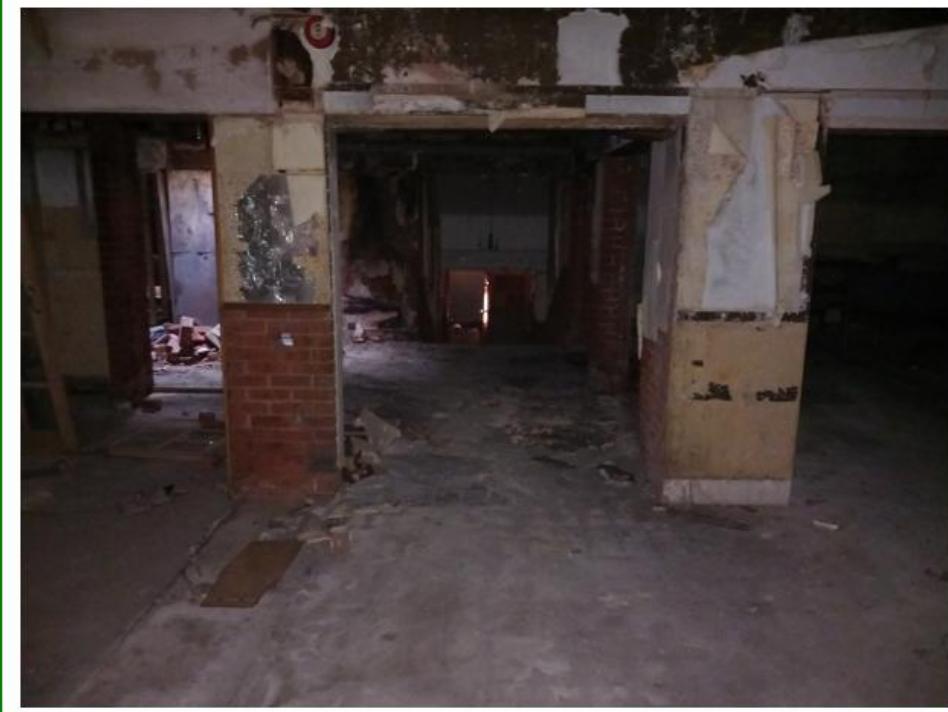
Photo No.19: Further shot evidencing the state of the interior

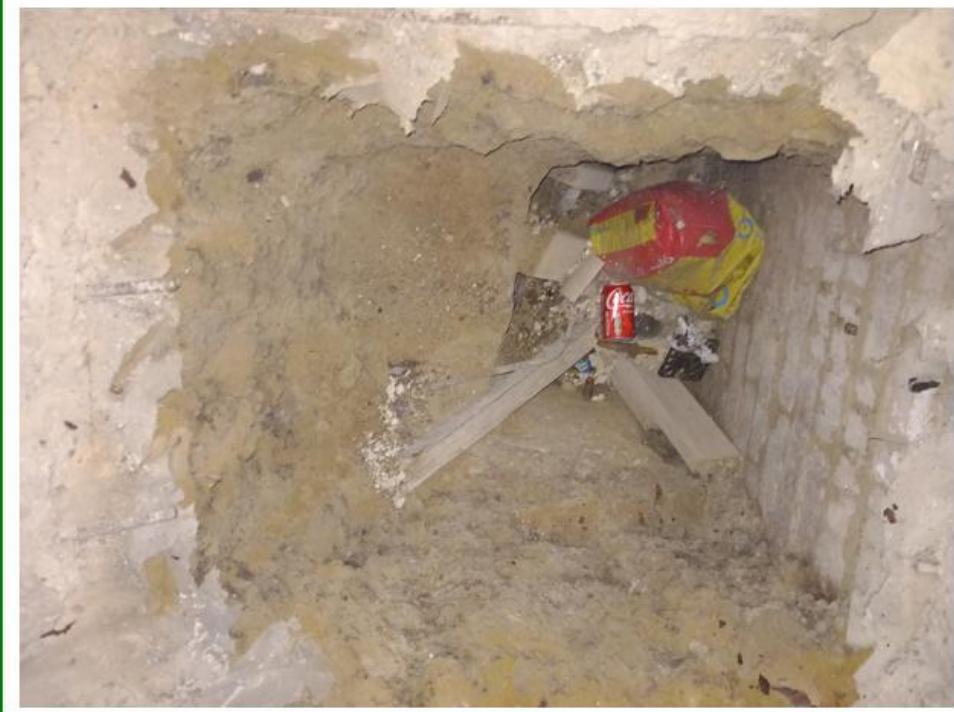
Photo No.20: Third inspection pit noted within the structure showing limited made ground deposits atop gravelly sands

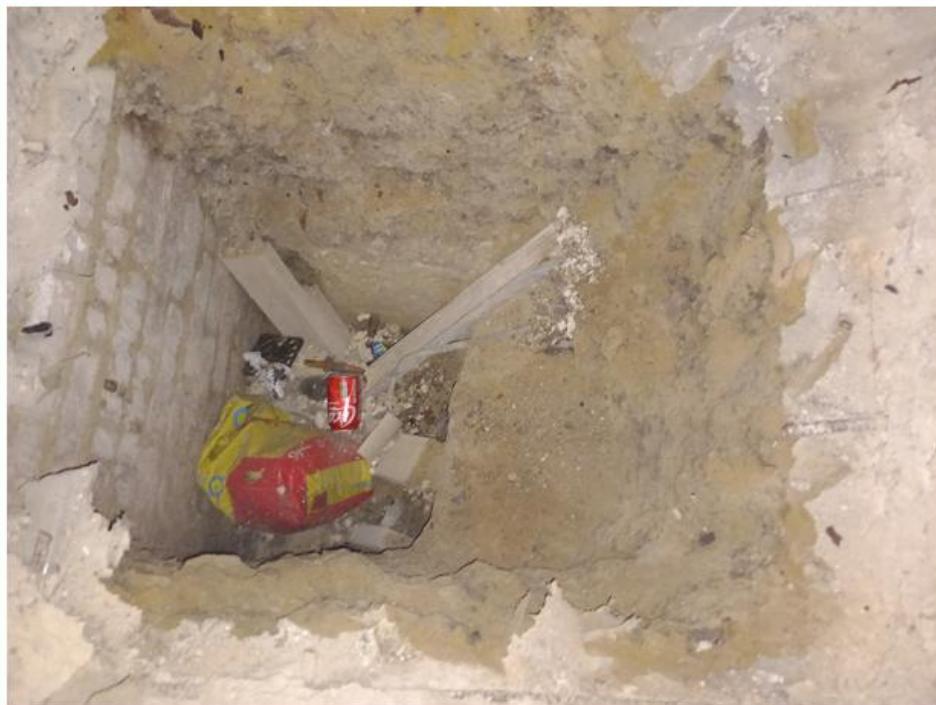
Photo No.21: Fourth inspection pit noted within the structure showing limited made ground deposits atop gravelly sands

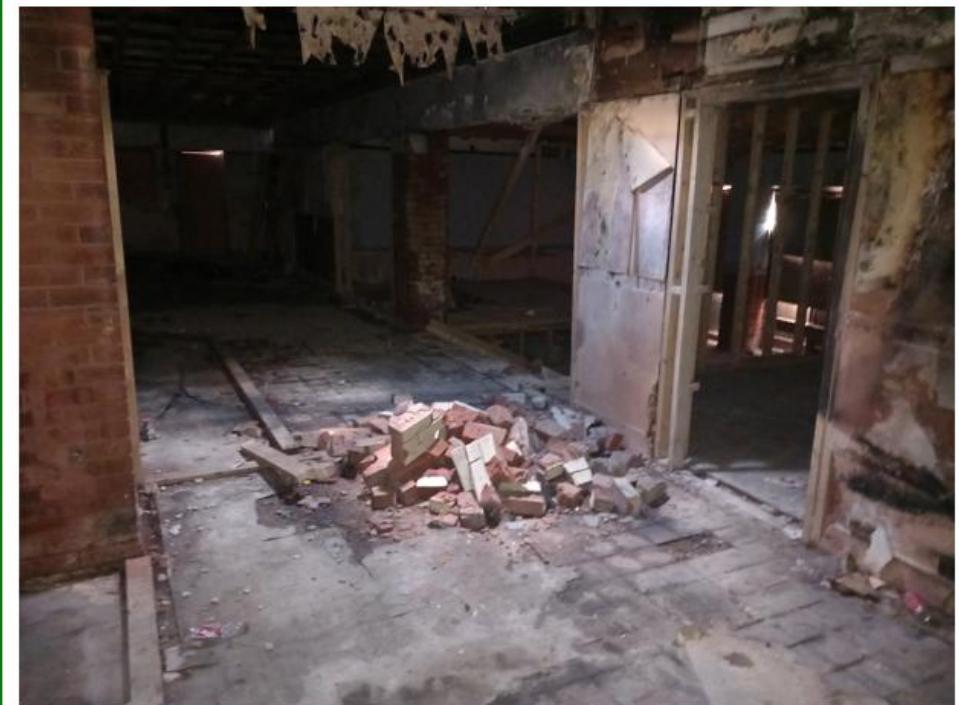
Photo No.22: Further shot evidencing the state of the interior
