Arboricultural Impact Assessment

Former Woodlands Hotel, Coupals Road,
Haverhill

OAS 22-187-AR01

June 2023

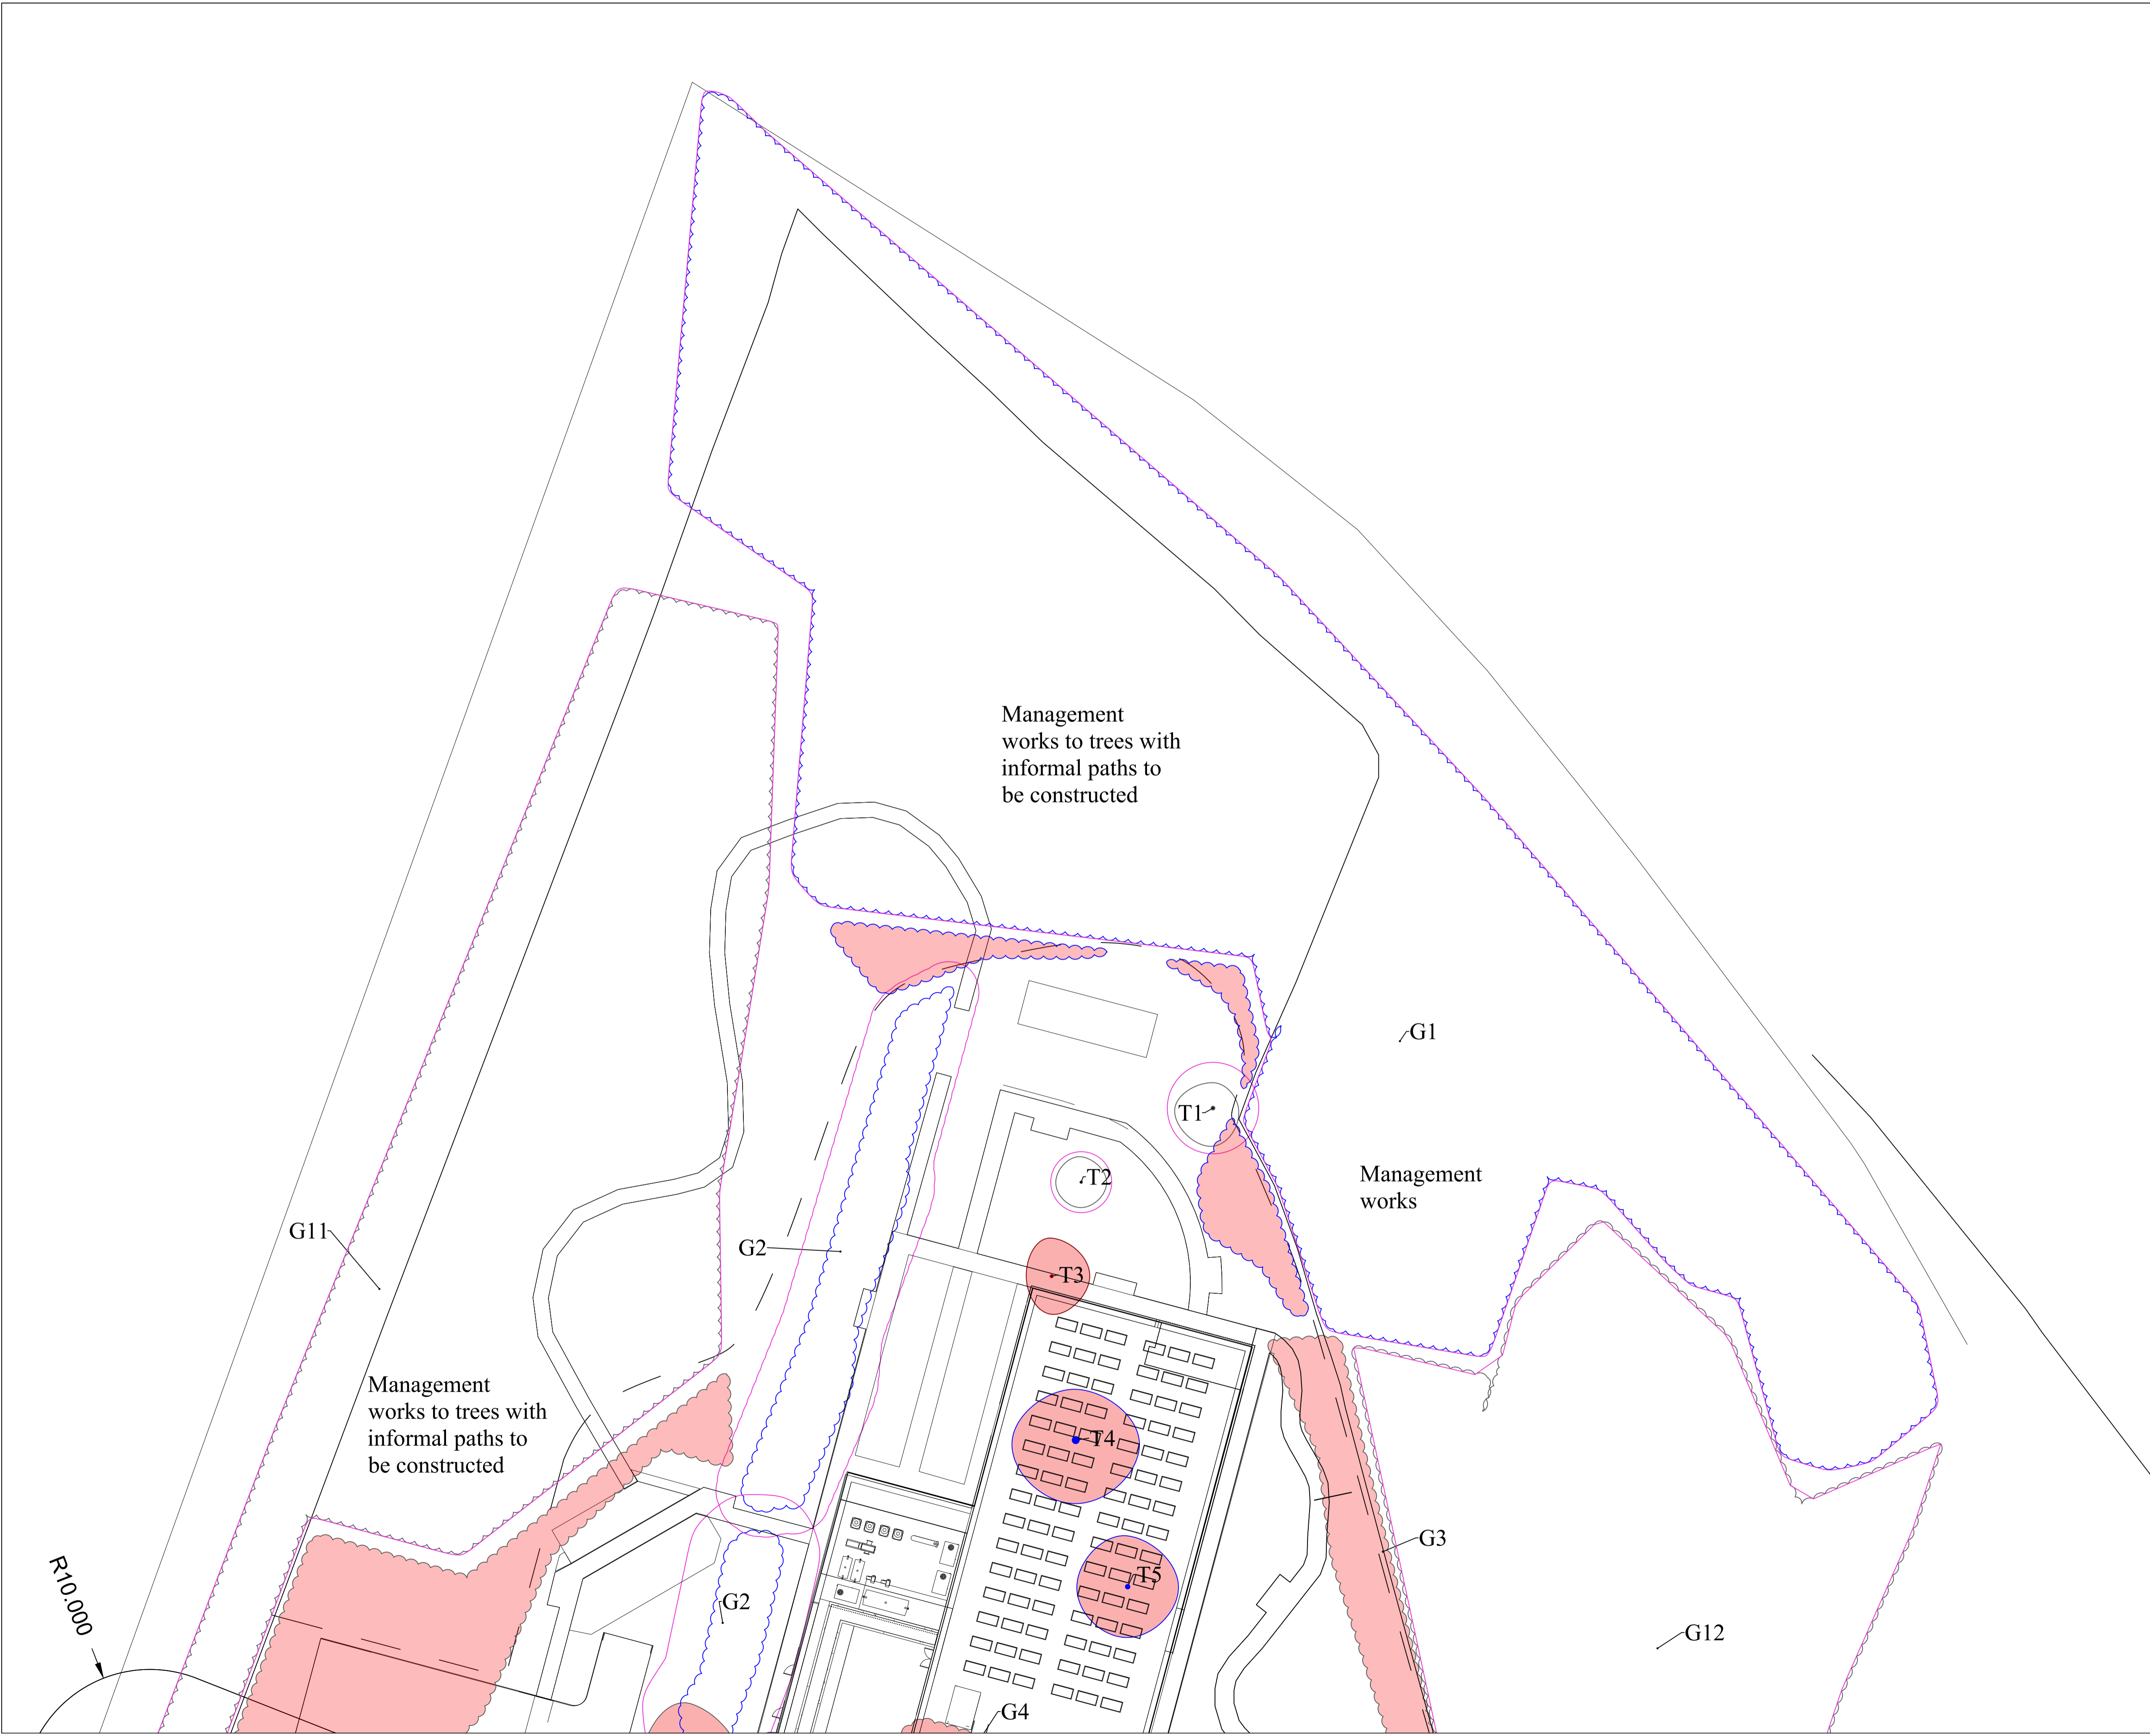
CLIENT c/o Freeths		DWG. TITLE Tree Removal Plan	
SITE: Former Woodlands Hotel, Coupals Rd, Haverhill			
DRAWN BY SPM	CHECKED BY SPM	SCALE 1:250 @A1	DATE May 2023
		DWG. NO. OAS 22-187-TS02	REV.

3.1.2 The proposal will see the removal of the following trees, see tree layout plans OAS 22-187-TS02/ TS03 for tree removals details.

Removals of parts of groups are also required including G1, G10 and G11.
