Redrow Homes Limited

**Great Wilsey Park, Haverhill**

**Arboricultural Assessment**

March 2019

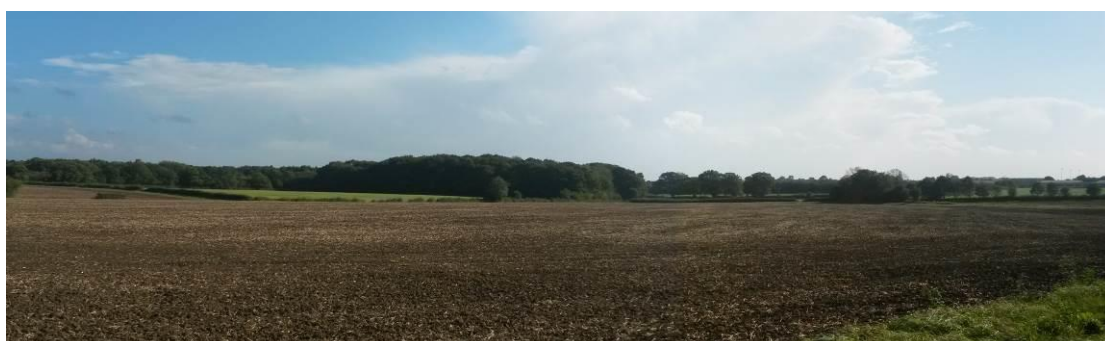
- 3.17 Woodland parcels W5 and W7 towards the north formed the largest portions of continuous tree cover within the site. W5 was surrounded by numerous high-quality mature specimens positioned along the western edge which, due to their linear position, had possibly been planted as part of the original landscape. Research of mapping of 1886 identifies these mature specimens positioned around an open field compartment which had since formed a framework within which younger tree planting had been established as Great Field Plantation. The eastern portion of the new woodland was planted around 1900 with an addition of further planting to the west of this group following the cessation of the First World War. The extent of the woodland has not changed since and the species content was predominantly conifer offering limited value in terms of ecological habitats.

- 3.18 Immediately to the east and adjacent to woodland W5 was W7. Although these two areas of woodland had merged together there was a clear distinction between the two when observed from an elevated view point. Trees within W7 displayed younger proportions in comparison to the neighbouring specimens of W5 along with a more regular spaced pattern giving the impression that this woodland was planted at a later date. Discussions with the land owner confirmed that this plantation was intended to produce a crop of Christmas trees which had never been harvested and had subsequently been allowed to outgrow. Species also differed slightly with a higher content of deciduous trees such as common larch *Larix decidua*, grand fir *Abies grandis* and Norway spruce *Picea abies*.

**Photograph 1: Elevated view of W5 and W7**

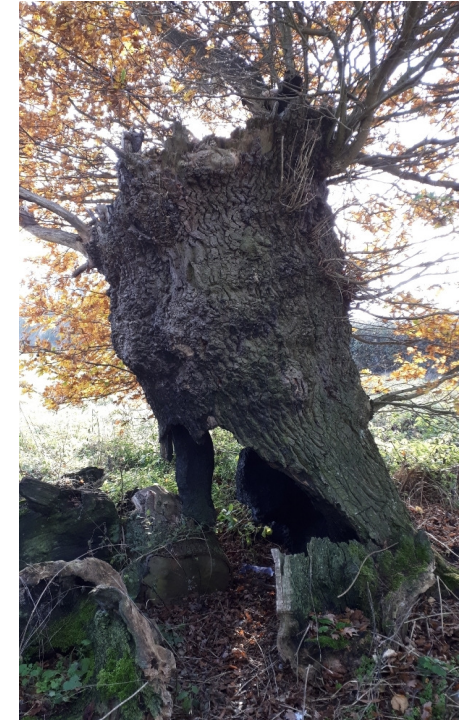
Damage / Threats	Previous Management
Vandalism, Fire damage	None

Management Recommendations	Phasing	Priority
No pruning works required to the tree at present. During the development phase the tree will need to be protected with tree protection fencing.
