Arboricultural Impact Assessment

The Vixen, Ingham Road, Haverhill, Suffolk

Project Number: P2610.1.0

Date: 5 December 2016

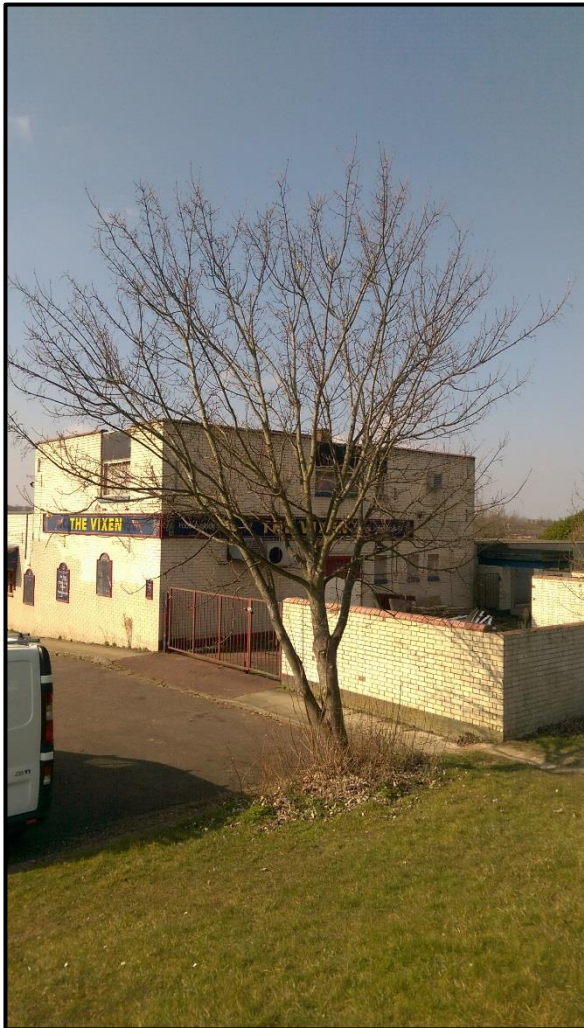
The site contained few trees. A single sycamore, T1, stands next to the car park on the verge below Millfields Way. This tree had unremarkable form and several minor defects that may limit its retention span. In addition, if retained in its current location, it would cause damage to the car park surface and kerbing. As a consequence of defects and potential for future damage, this tree was considered to be of low quality, Category C.

Plate 1. T1, sycamore, viewed from Millfields Road.

T1, sycamore, will require removal due to conflict with the extended parking provision.

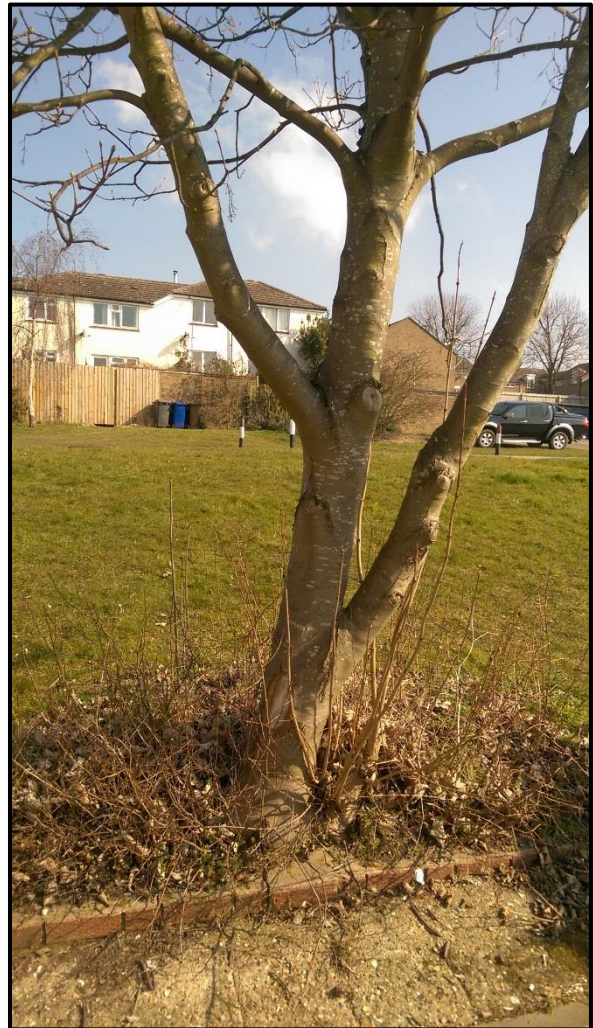
T1 is a low-quality tree exhibiting a range of structural defects, which would reduce the potential for long-term retention in the absence of development. Its removal would be readily compensated by proposed new tree planting, which offers good potential to deliver an enhanced tree stock of increased value and longevity.

Plate 2. The base of T1, as viewed from within the car park, showing the area of bark loss and the V-shaped primary union.

Tree No.	Species	Work Required Irrespective of Development	Work Required to Facilitate Development
T1	Sycamore	None.	Remove due to conflict with the development.

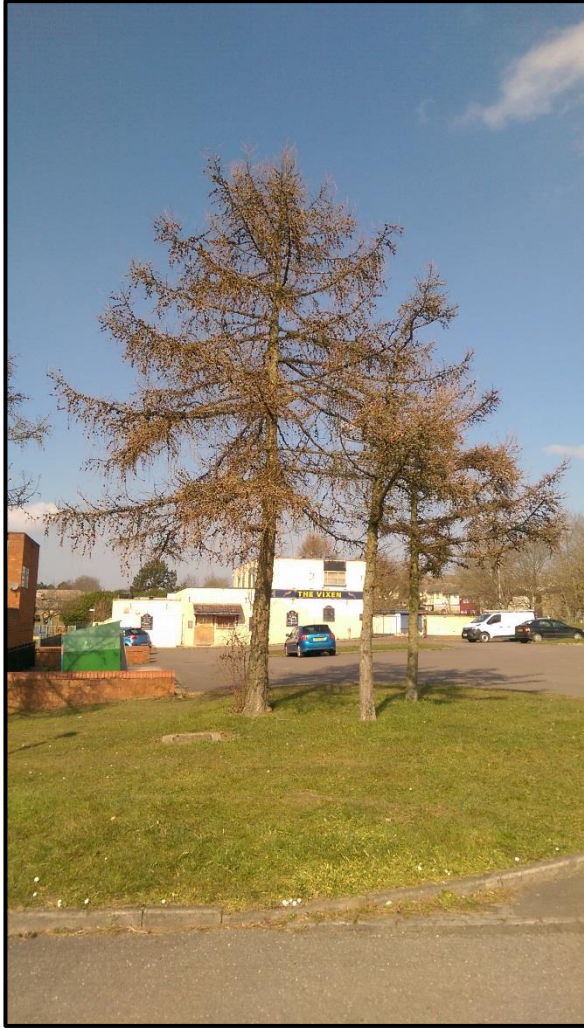
To the south of the vehicular access were three groups of conifers. G1 and G2 both consisted of three larch trees, which had typical form but did not appear to be thriving, with somewhat reduced extension growth. Both groups were considered of moderate quality, Category B.

Plate 3 (left). G1, three larch trees, forming a group by the Ingham Road car park entrance.

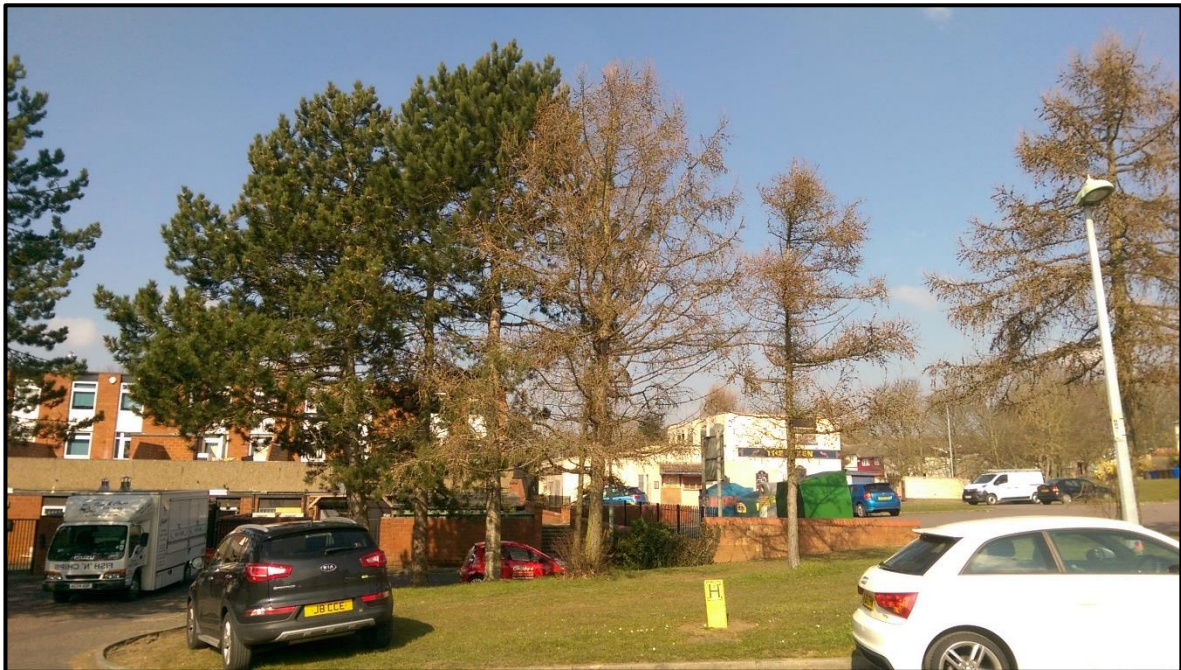
G2 had partial mutual crown development with G3, which consisted of three Corsican pines. These trees appeared better suited to the local conditions and were thriving. As a consequence, G3 was considered to be of high quality, Category A.

Plate 4 (below). G2, three larch trees (centre right) and G3, three Corsican pine trees, as viewed from Ingham Road looking west.
