Veteran Tree Management Plan

Project No 12041	Parcels A9, A14, A15, B2 & E2, Haverhill, Suffolk, CB9 7UN		
Client:	Bloor Homes Eastern		
Prepared by:	Stephen Hayden & Lewis Alexander		
Date of Report:	17/10/2025	Revision:	Original

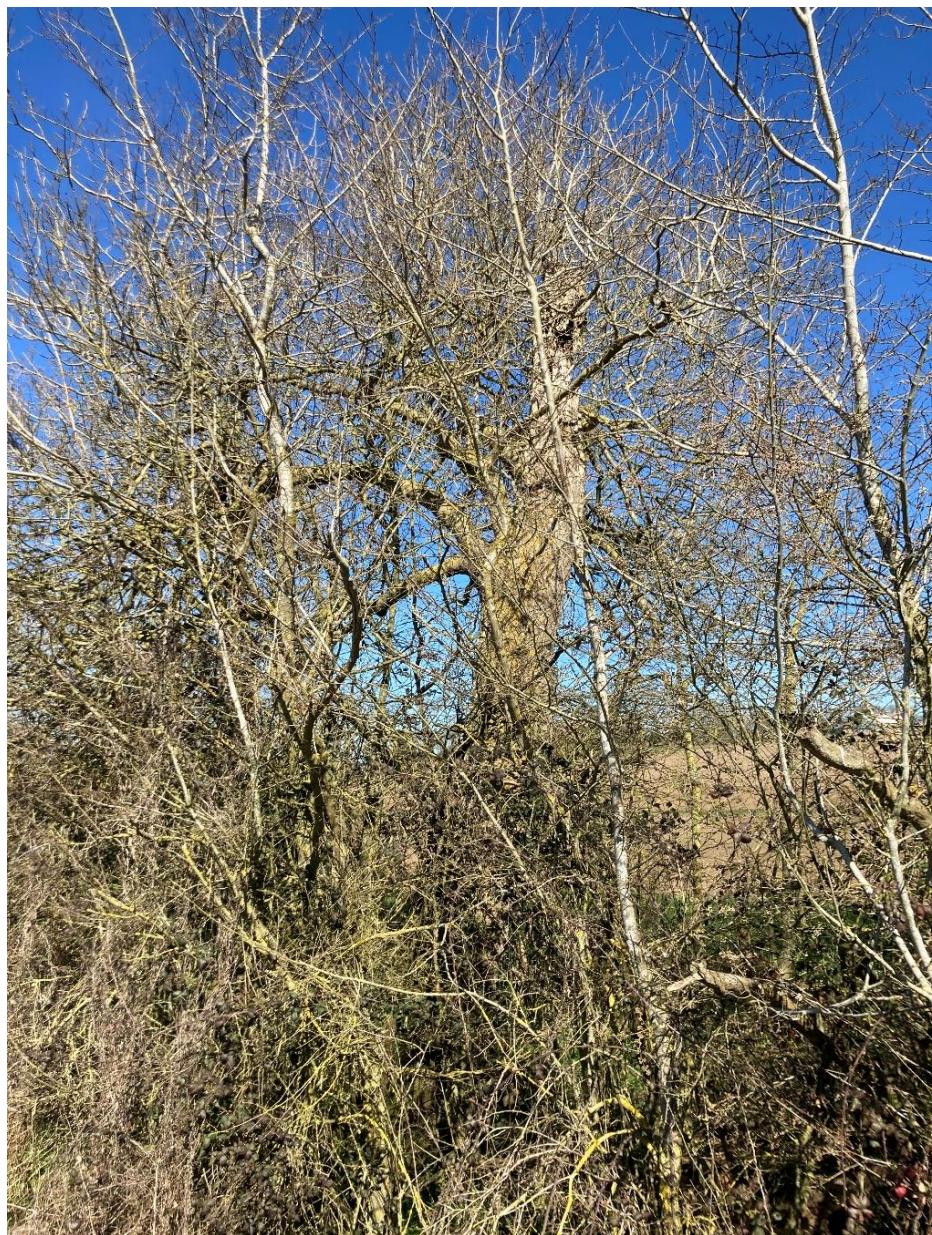
Image 1 – T022 viewed from the south

Tree Number	Species	Stem Diameter (mm – estimated)	Features
T022	<i>Fraxinus excelsior</i>	1000	<ul style="list-style-type: none">- Fracture of stem, with associated decay- Adventitious growth reestablishing secondary crown- Deadwood on ground
T026	<i>Populus nigra</i> subsp. <i>betulifolia</i>	2300	<ul style="list-style-type: none">- Mycelium and saprophytic brackets- Fragmented collapsed stem- Incomplete residual wall- Heartwood decay
T028	<i>Populus nigra</i> subsp. <i>betulifolia</i>	1800	<ul style="list-style-type: none">- Recent tear out of primary branches, much of crown lost- Deadwood on ground- Exposed, degrading inner stem wood

Tree number	Description of Works Required
T028	<ol style="list-style-type: none">1. Sever ivy at 3m height1-2m overall reduction to promote adventitious growth lower in crown.2. Installation of Construction Exclusion Zone
T022 & T026	<ol style="list-style-type: none">1. Installation of Construction Exclusion Zone2. None – (Protect & Monitor)

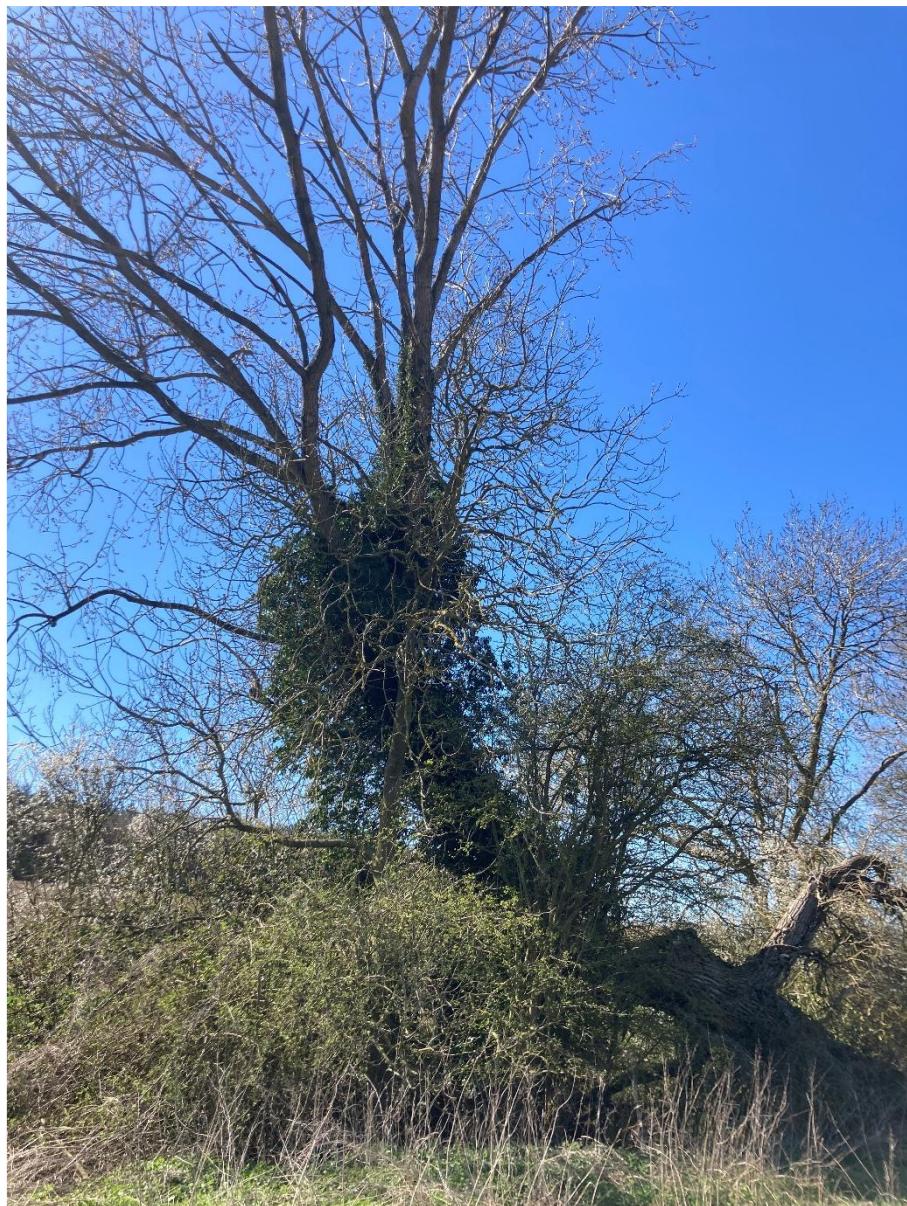
Image 4 – T028 viewed from the northeast

15	0.5		A	High				
Yes		706.9			40+ years	Water, Light undergrowth, Bare earth				
T028	Poplar Sp	1800	20		Moderate	N1, E10, S11, W8	An off-site tree located at northeast boundary. Veteran Poplar. Very large inaccessible single stem. Once divided in two at 3 metres, the north half of crown has collapsed north east. Remaining tree has a very large wound exposing degraded heartwood and central hollowness. Stem cavity approx. 200mm wide from ground to 2 metres on east face. Ivy clad stem. Asymmetric live crown. Budding well, some dead secondary branches. Dense undergrowth prevents access to base.	B3	1.Sever ivy at 3m height 1-2m overall reduction to promote adventitious growth lower in crown. 2.Installation of Construction Exclusion Zone. See report ref. 12041, Section 5.0.	3
		15	3		V	High				
Yes		706.9			20+ years	Dense undergrowth, Water

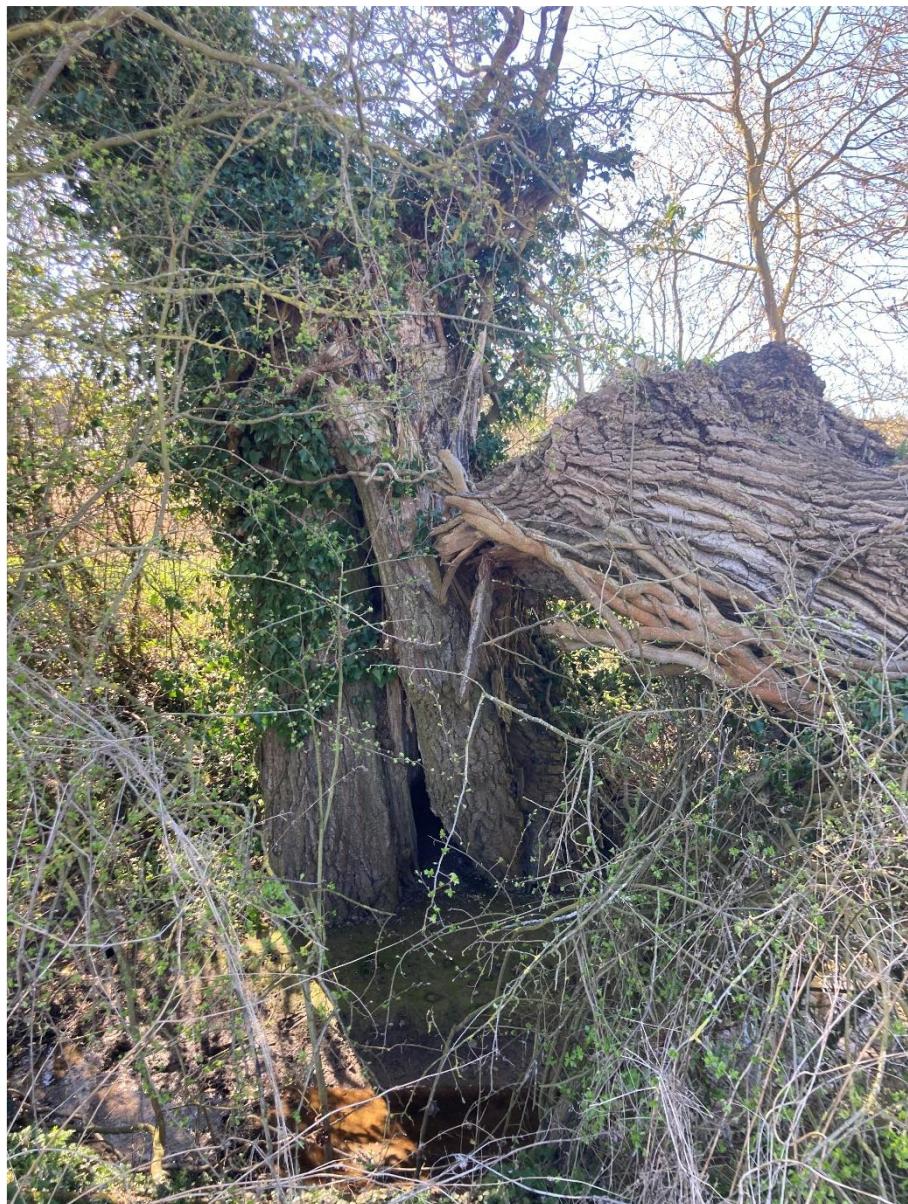
Image 5 – T028 stem, recent stem failure shown
