Arboricultural Report and Arboricultural Implications

Site – The Fox PH, Haverhill Road,

Client – Rutherford Holdings Ltd

Date - 23-11-2023

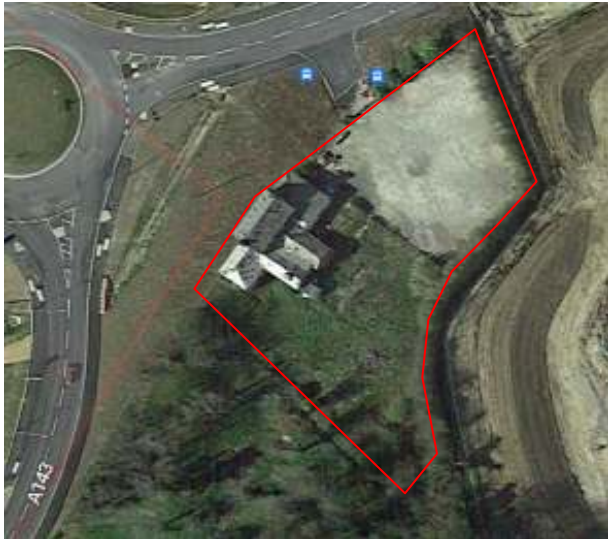
Fig 1 – the site

2.1 The site is the former Fox Public House and car park. The pub is now derelict, and the ground are significantly overgrown with blackberry scrub and ruderal vegetation, making access difficult. There are no significant trees within the site. Around the boundary of the site are hedges but there are no significant trees in the site. To the west of the site is an area of secondary woodland. There is a water filled ditch and stream approximately 1m lower than ground level running along the boundary and the woodland. The majority of the trees are over 8m from the stream but there are a small number of trees along the bank. These are included in the survey, and several were of poor quality. The stream at 1m deep would be expected to act as a root barrier or at least partial root barrier along the boundary. The ground water level under the stream, would result in the soil being at a permeant field capacity. This would result in low air levels within the soil structure which would not be conducive with good root growth.
