**Tree Survey, Arboricultural Impact Assessment
Arboricultural Method Statement & Tree Protection Plan
In Accordance with BS 5837:2012**

Proj. No 10924	Haverhill Waste Development, North West of Falconer Road, Haverhill, CB9 7BG		
Client:		Leivers Consultancy Ltd	
Date of Report:	30/05/2024	Revision:	Original

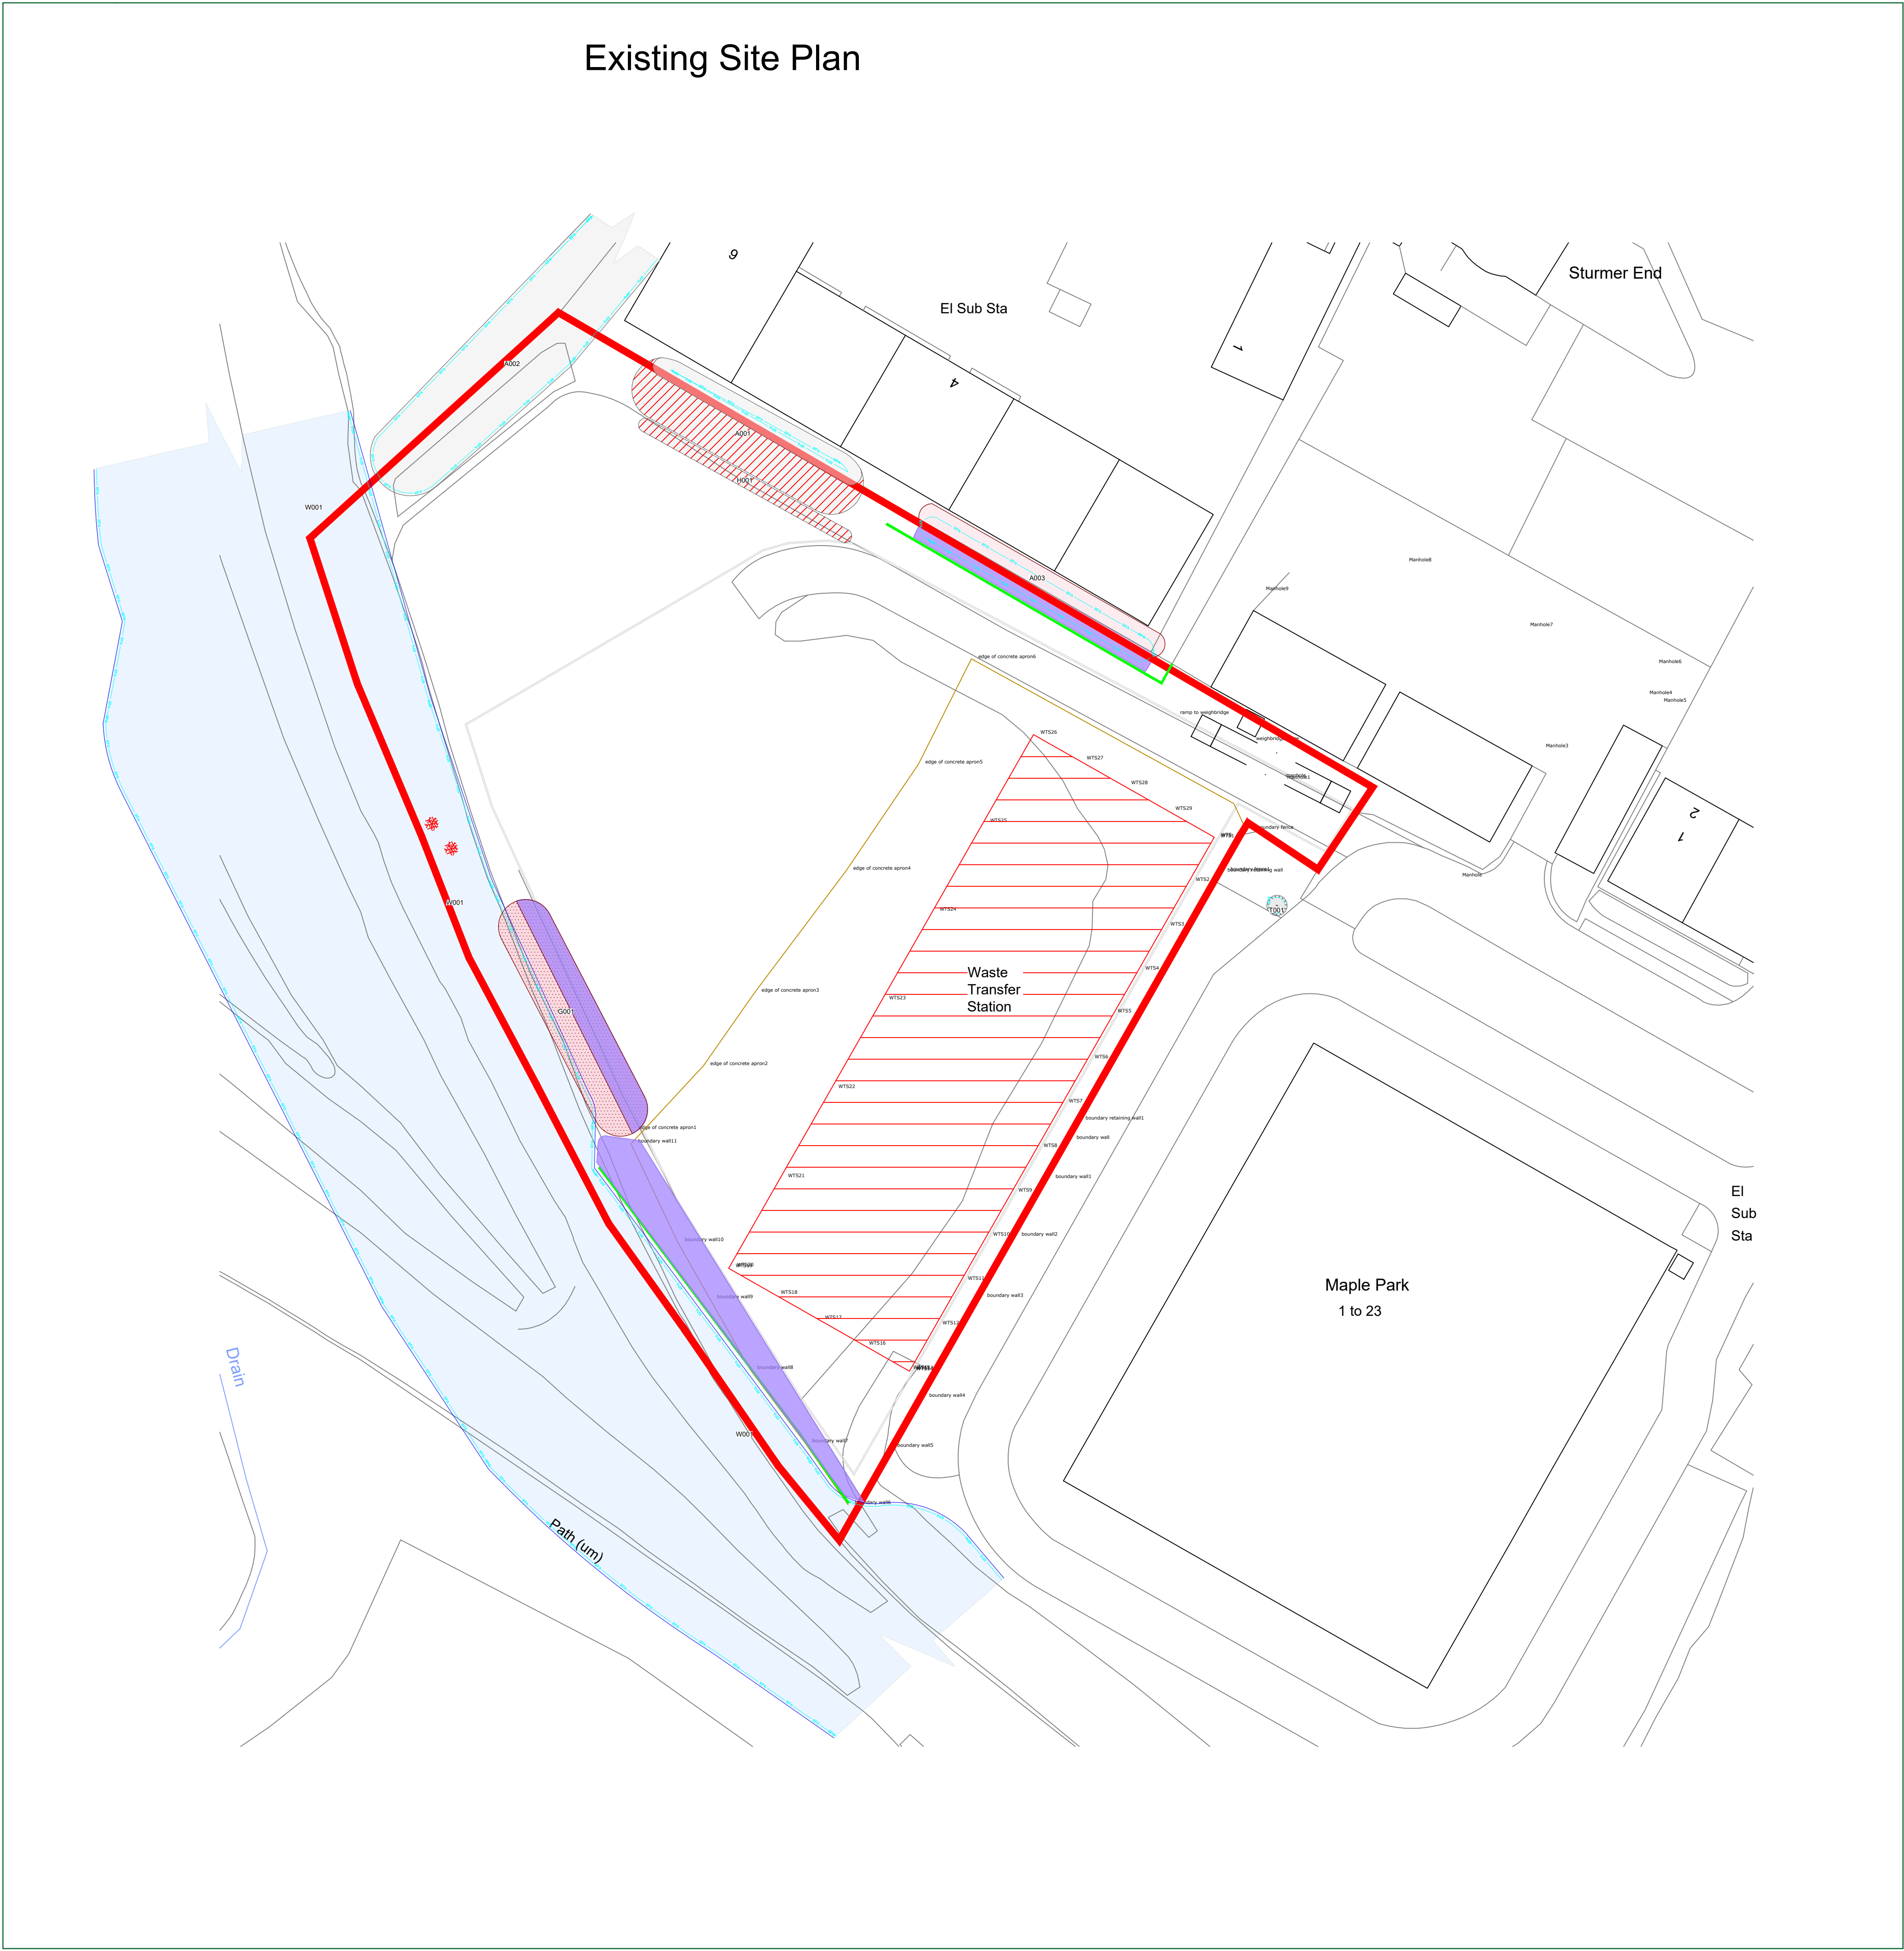
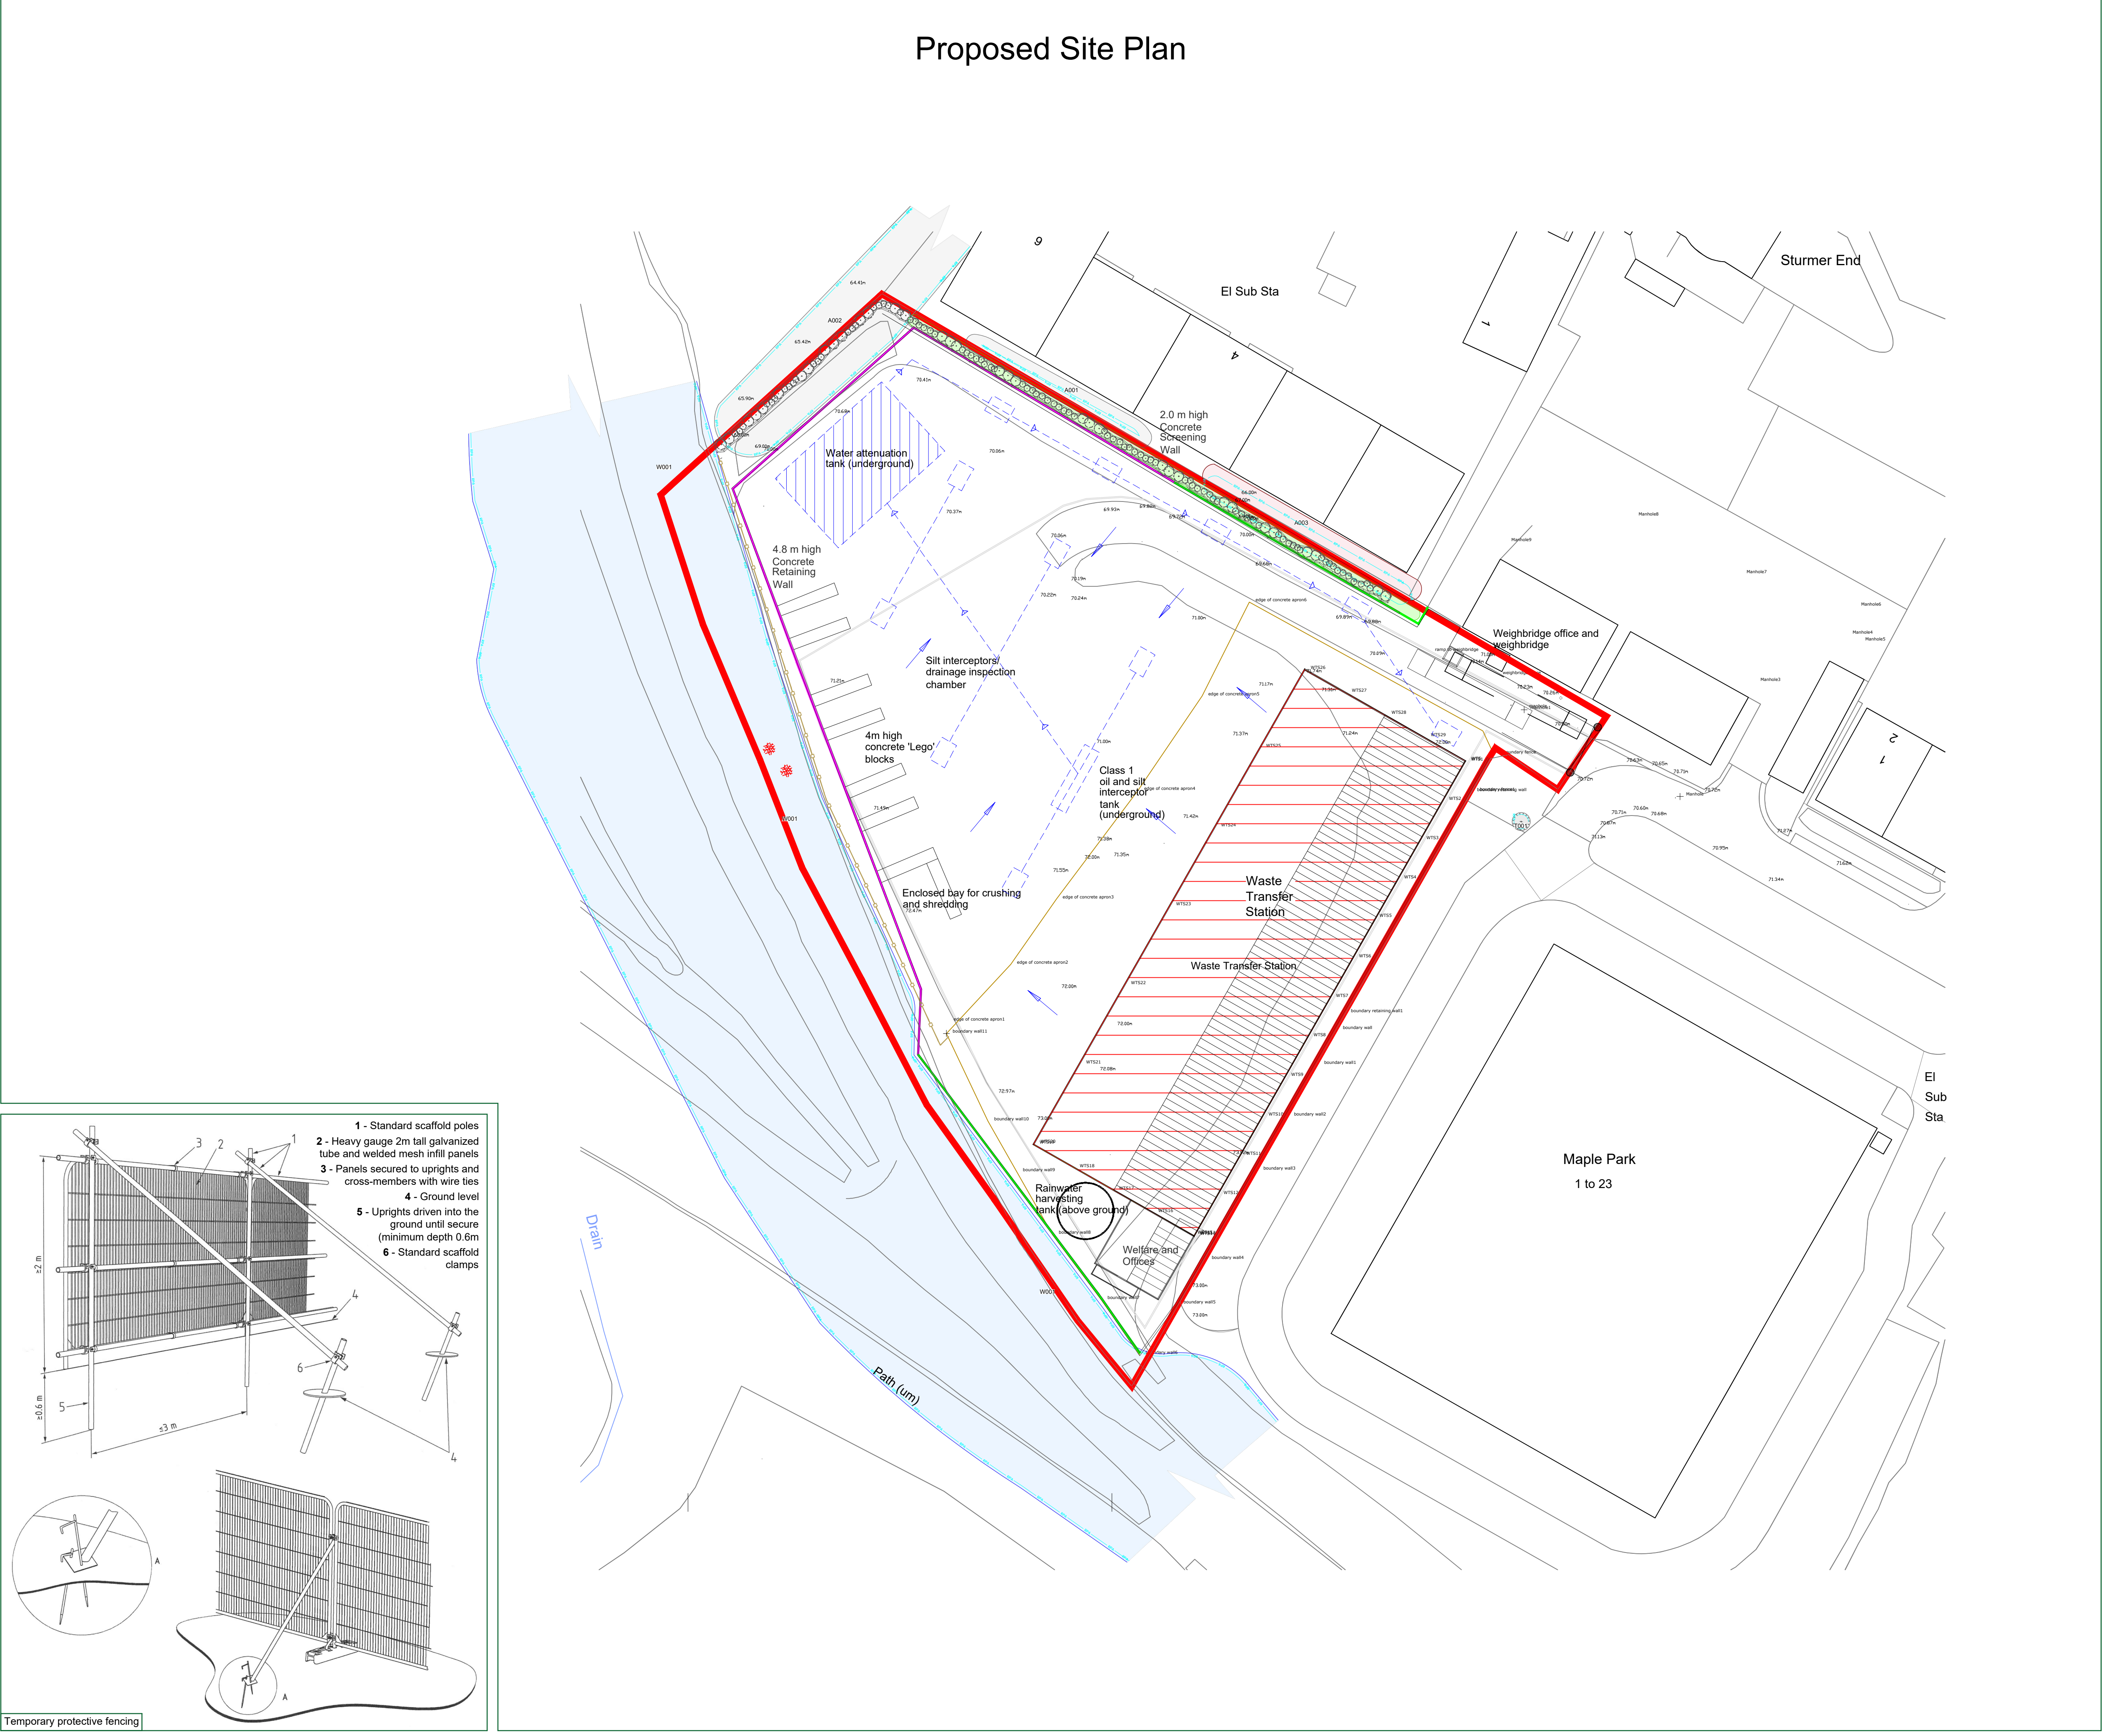
Scale: 1:500 (A0) Checked By: LA Drawing No: 10924-D-AIA Rev: -

- 4.4.2 Construction of footings for a section of boundary wall near to the weighbridge has encroached into the RPAs of a retained feature- A003. It was not possible to access the base of these trees, as such they were surveyed at distance. Although it is probable that a large proportion of the rooting environment has been affected by this construction, it has not been possible to quantify the incursion into the RPAs. The feature consists of an informal mixed species area. The crowns appear to be in a fair to good condition. As the full impacts of construction may not yet be manifesting in visible parts of the trees, it is recommended that the area be monitored annually for a period of five years. Future assessments should evaluate the condition and inform future management decisions.

- 4.4.3 Construction of footings for a section of boundary wall at the southeast of the site has encroached into the RPAs of a retained feature- W001. It was not possible to access the base of these trees, as such they were surveyed at distance. Although it is probable that a large proportion of the rooting environment has been affected by this construction, it has not been possible to quantify the incursion into the RPAs. As the full impacts of construction may not yet be manifesting in visible parts of the trees, it is recommended that the area be monitored annually for a period of five years. Future assessments should evaluate the condition and inform future management decisions.

- 4.5.1 Cut and fill operations have incurred into 50% of the RPAs of the retained trees of G001. This has impacted the east aspect, up to the stem bases, severing the structural roots in this area. As a result, the fourteen individuals have been rendered structurally unsound and are at risk of sudden collapse. It is not viable to retain these trees, so their removal is recommended, as soon as possible.

- 4.5.2 Addition soil has been added to the northwest bank, within the RPA of A002. It was not possible to access the base of these trees, as such they were surveyed at distance. Although it is probable that a large proportion of the rooting environment has been affected by this construction, it has not been possible to quantify the incursion into the RPAs. As the full impacts of construction may not yet be manifesting in visible parts of the trees, it is recommended that the area be monitored annually for a period of five years. Future assessments should evaluate the condition and inform future management decisions.

G001	Fell to ground level.
------	-----------------------

- 4.6.1 The boundary wall is not shown to encroach further into the RPA of woodland W001. Therefore, from an arboricultural perspective, no specialised construction or foundation techniques will be required to protect tree roots. However, dependent on the soil type, species and topography, trees may have an influence on the soil beyond their calculated RPA. Given the proximity of the proposed construction to the trees to be retained, it is recommended that a Structural Engineer is consulted to assess the implications of the tree retention on the required foundation design.
