Arboricultural Impact Assessment

***The Vixen, Ingham Road, Haverhill,
Suffolk***

Client Name: Radford Interiors

Date: 5 December 2016

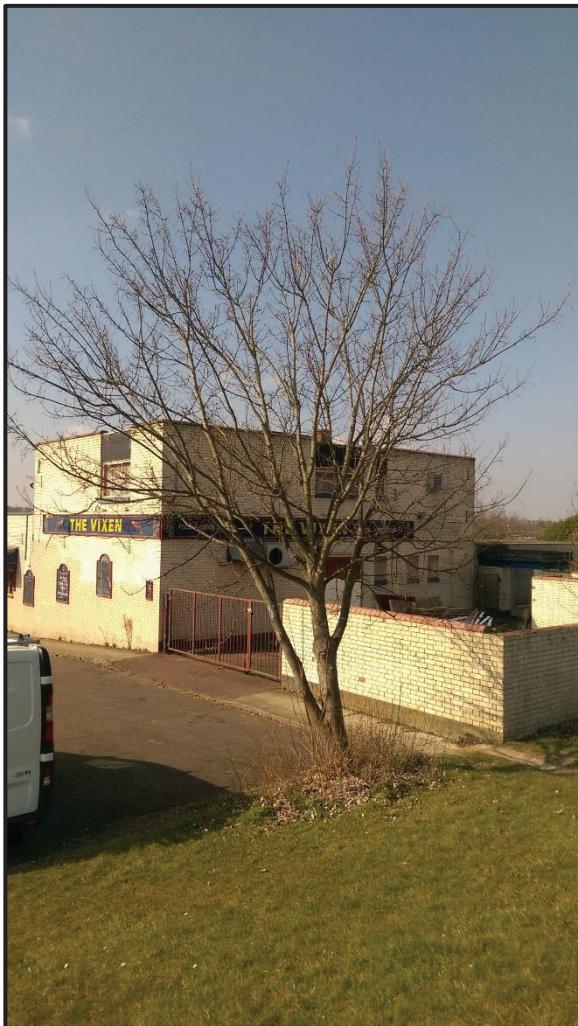
The site contained few trees. A single sycamore, T1, stands next to the car park on the verge below Millfields Way. This tree had unremarkable form and several minor defects that may limit its retention span. In addition, if retained in its current location, it would cause damage to the car park surface and kerbing. As a consequence of defects and potential for future damage, this tree was considered to be of low quality, Category C.

Plate 1. T1, sycamore, viewed from Millfields Road.

T1, sycamore, will require removal due to conflict with the extended parking provision.

Tree No.	Species	Work Required Irrespective of Development	Work Required to Facilitate Development
T1	Sycamore	None.	Remove due to conflict with the development.

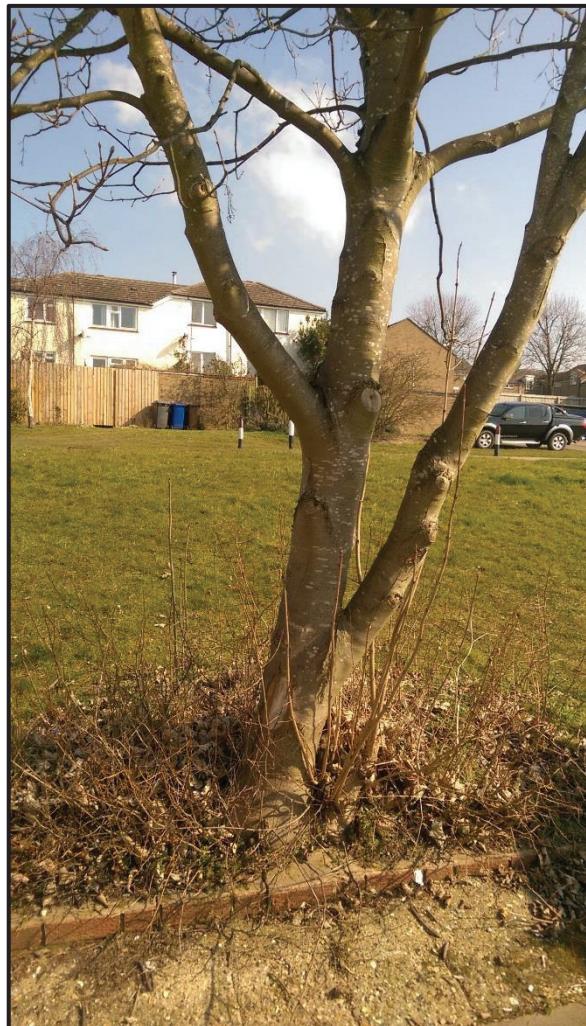
T1 is a low-quality tree exhibiting a range of structural defects, which would reduce the potential for long-term retention in the absence of development. Its removal would be readily compensated by proposed new tree planting, which offers good potential to deliver an enhanced tree stock of increased value and longevity.

Plate 2. The base of T1, as viewed from within the car park, showing the area of bark loss and the V-shaped primary union.

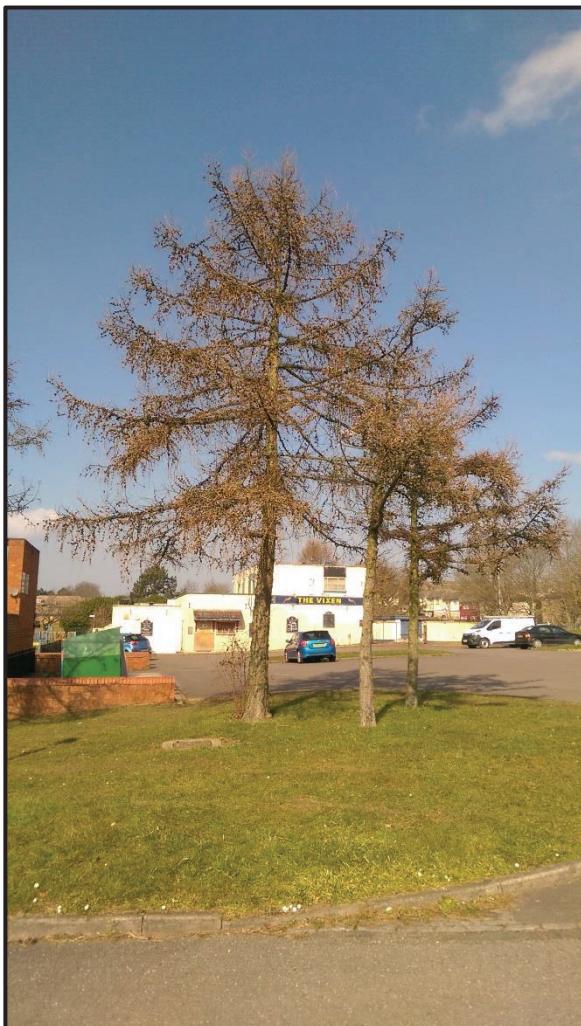
To the south of the vehicular access were three groups of conifers. G1 and G2 both consisted of three larch trees, which had typical form but did not appear to be thriving, with somewhat reduced extension growth. Both groups were considered of moderate quality, Category B.

Plate 3 (left). G1, three larch trees, forming a group by the Ingham Road car park entrance.

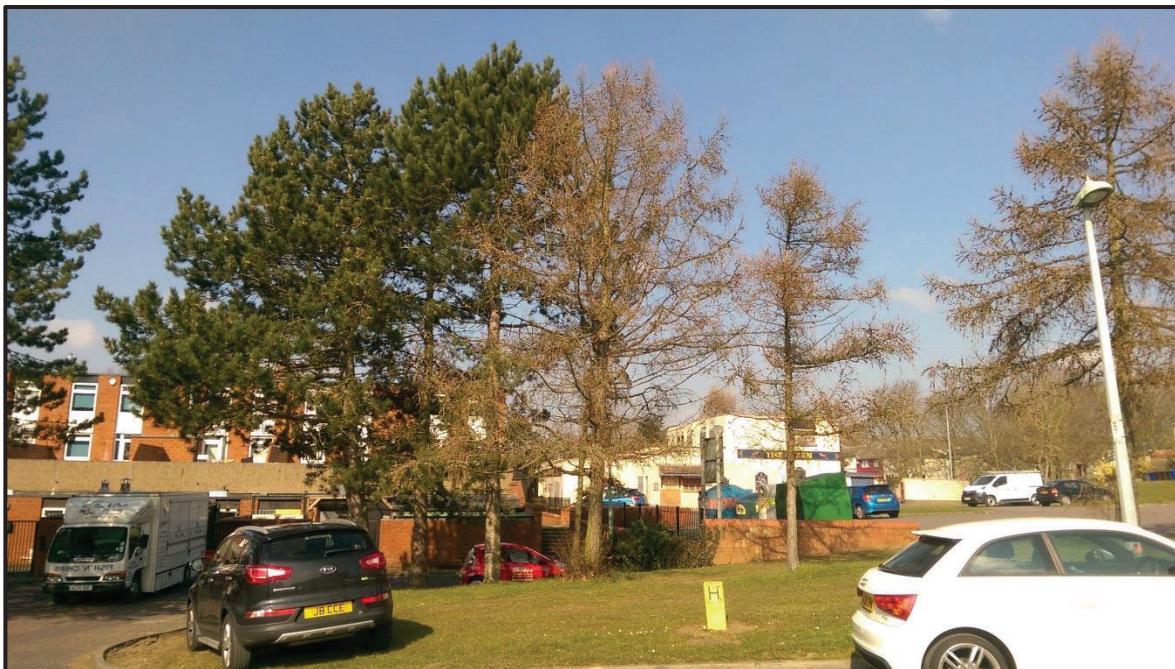
G2 had partial mutual crown development with G3, which consisted of three Corsican pines. These trees appeared better suited to the local conditions and were thriving. As a consequence, G3 was considered to be of high quality, Category A.

Plate 4 (below). G2, three larch trees (centre right) and G3, three Corsican pine trees, as viewed from Ingham Road looking west.
