Proposed Residential Development

Rose Bank
Burton End
Haverhill
Suffolk
CB9 9AD

Phase 1 Desk Study Report

October 2023

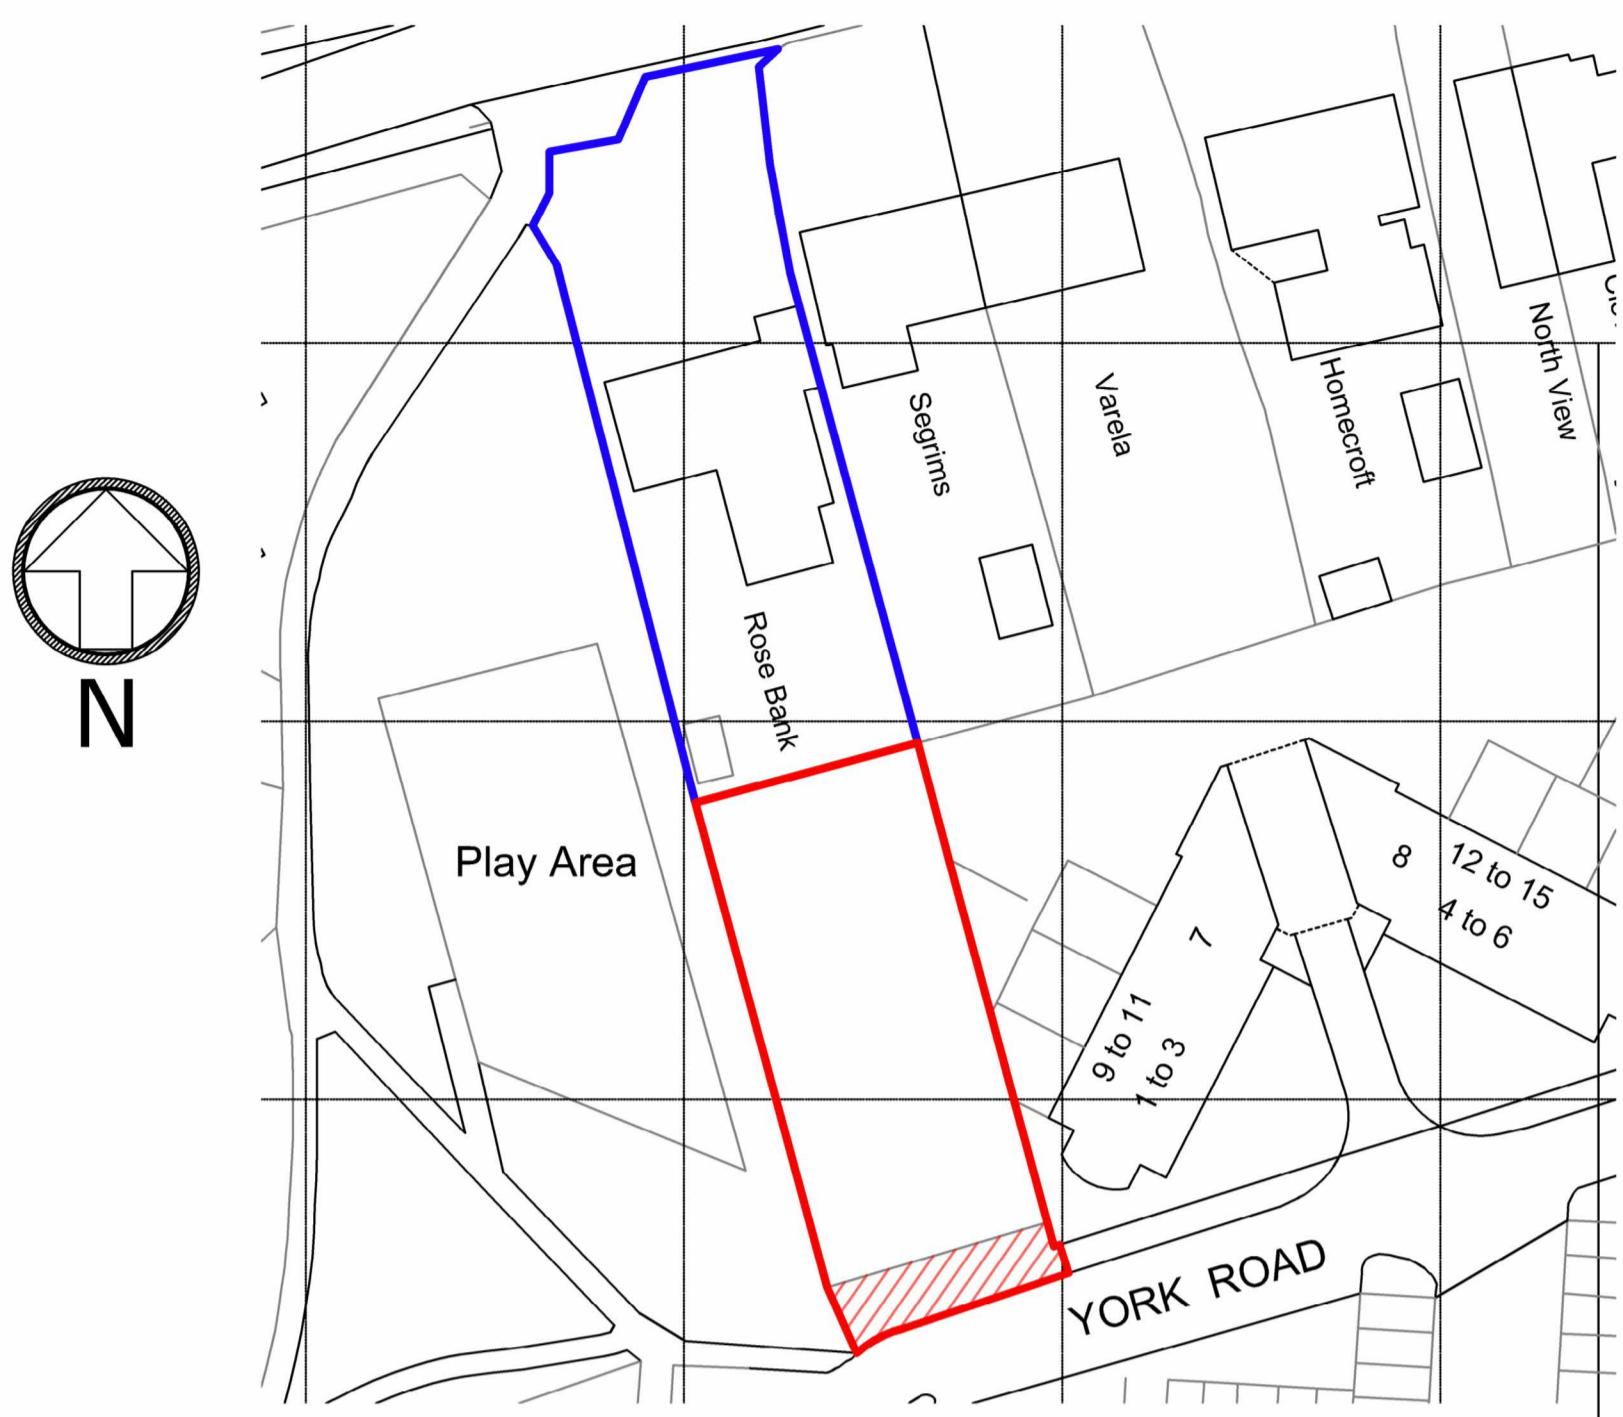
EXISTING SITE PLAN (1:500)

SCHEDULE OF AREAS	
BLUE LINE AREA	1210
RED LINE AREA (EXCLUDING HATCH)	538
RED LINE AREA (INCLUDING HATCH)	535

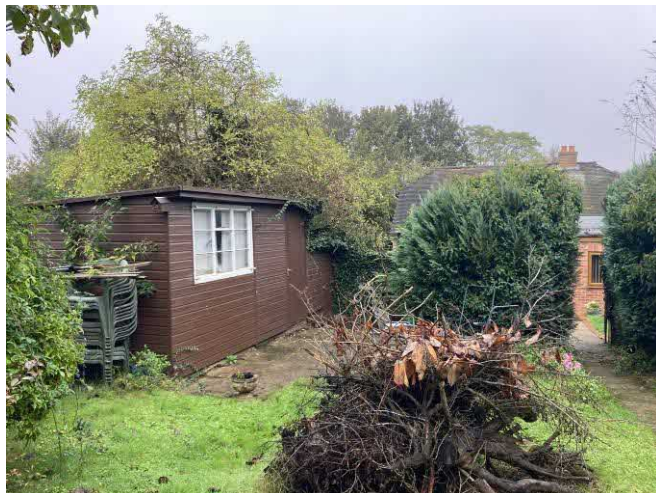
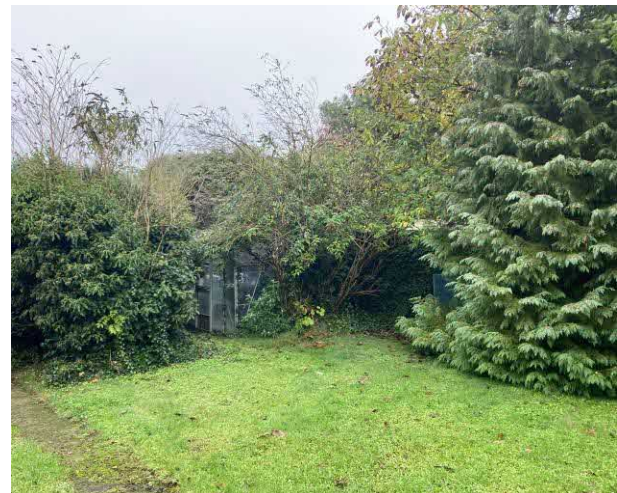
VIEW NORTH TOWARDS ROSE BANK WITH SECTION OF REAR GARDEN CONTAINING SHED AND GREENHOUSE TO BE RETAINED

A garden shed and greenhouse are present within the section of garden to be retained by Rose Bank.

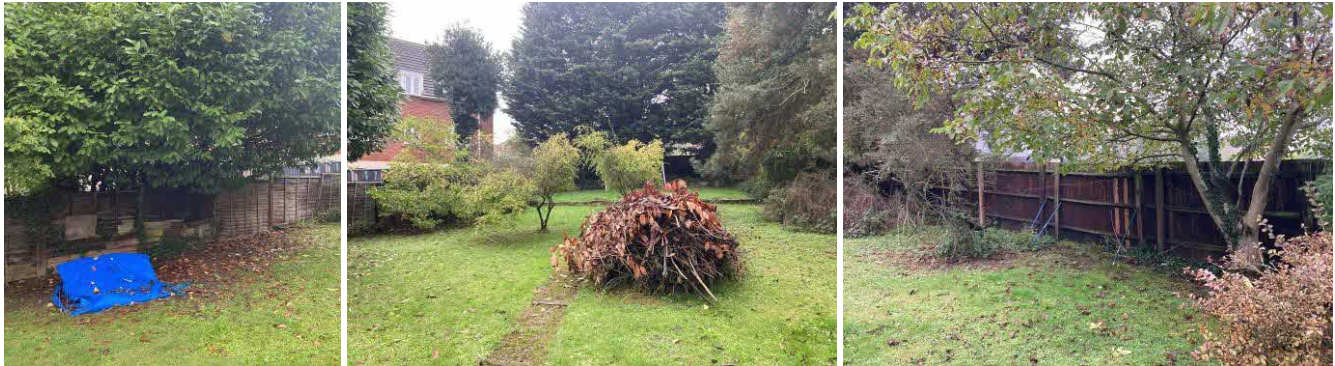
VIEW SOUTH FROM THE NORTHERN BOUNDARY OF THE SITE

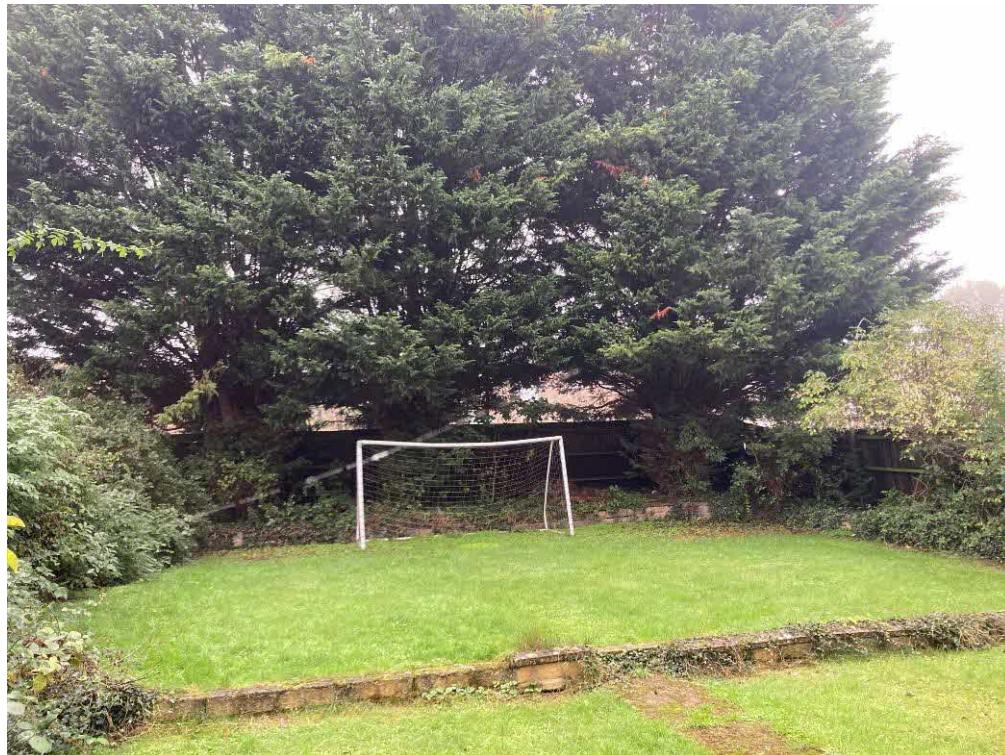
VIEW SOUTH OVER UPPER TERRACE TO FIR TREES BOUNDING YORK ROAD

A central concrete path rises through the rear garden, terminating at a low block wall/terrace with lawn beyond. Three mature fir trees are present along the southern boundary (York Road).
