Redrow Homes Limited

Great Wilsey Park, Wilsey Road, Little Wratting, Suffolk

Arboricultural Method Statement – INFRASTRUCTURE

December 2019

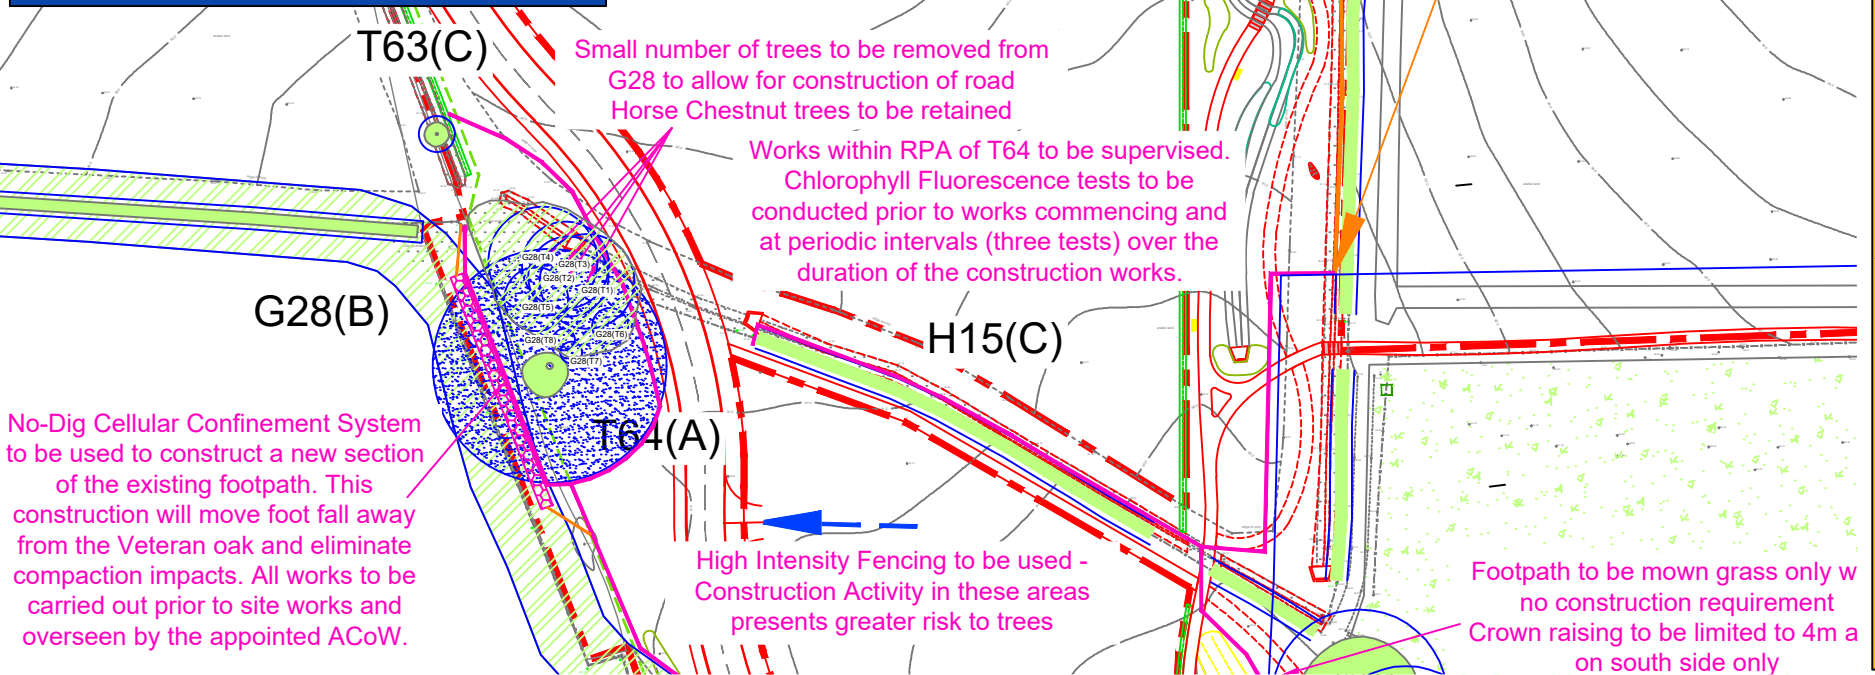
INSTALLATION OF NO-DIG CELLULAR CONFINEMENT - WORKING METHODOLOGY

The use of "no-dig" industry led specialist engineering solutions i.e. three dimensional load bearing cellular confinement systems shall be used to construct the footpath within the RPA's of trees T66-T71.

The use of a geotextile membrane will help support the sub-base and form a partial filter (a last line of defence) for contaminants such as oil and road salt. The sub-base will be porous to enable gaseous exchange and water infiltration. A suitable material is washed angular stone with a diameter between 20 - 40mm with no fine aggregates. Aggregates or stones must have a near neutral PH. The surface material will be permeable paving.

- Infill the cells with the clean angular stone, working towards the tree and using the infilled panels as a platform - working from one end to the other. Minimum 25mm overfill of clean angular stone when used in conjunction with a hard surface. No compaction is required of the infill. Do not use a whacker plate or other means of compaction.

- Encourage settlement of the stone with the use of a light roller or with 2-3 passes of the construction plant used for installation.
- Where edging is required for footpath and light structures, the edge will comprise treated timber boards pegged every 500mm with a wooden peg on the outside.

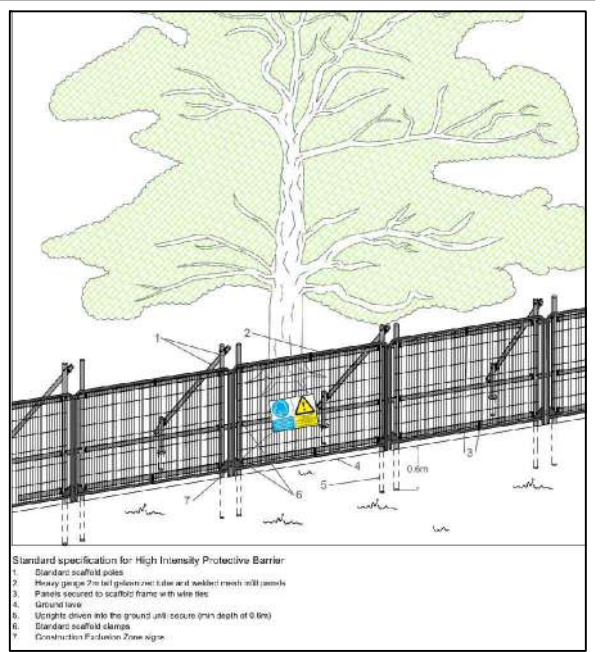
HIGH INTENSITY TREE PROTECTIVE FENCING - WORKING METHODOLOGY

Tree Protection Fencing will be installed as detailed on the Tree Protection Plan at, where possible, the extent of the root protection areas or the edge of the crowns of the retained trees. The positioning of the Tree Protective Fencing shall be measured out with assistance from the Arboricultural Clerk of Works and, where deemed necessary, with the Site Manager present. Highly visible fluorescent paint and / or marker pegs / stakes will be used to assist in identification.

- Heras Fence Panel to be supported by rubberised stabiliser blocks with a base plate which is secured to the ground using ground pins (as shown).
- No fixing shall be made to any tree and all possible precautions shall be taken to prevent damage to tree roots when locating posts.

Tree Protection Fencing and work exclusion zones will be clearly marked using appropriate signage. These signs shall be laminated to ensure they last the duration of the construction works and shall be fixed to the fencing panels every 10 metres along its length.

All Tree Protective Fencing will remain rigid and in place for the duration of the development and should be inspected at weekly intervals by the Site Manager alongside regular inspections to be carried out by the Arboricultural Clerk of Works.

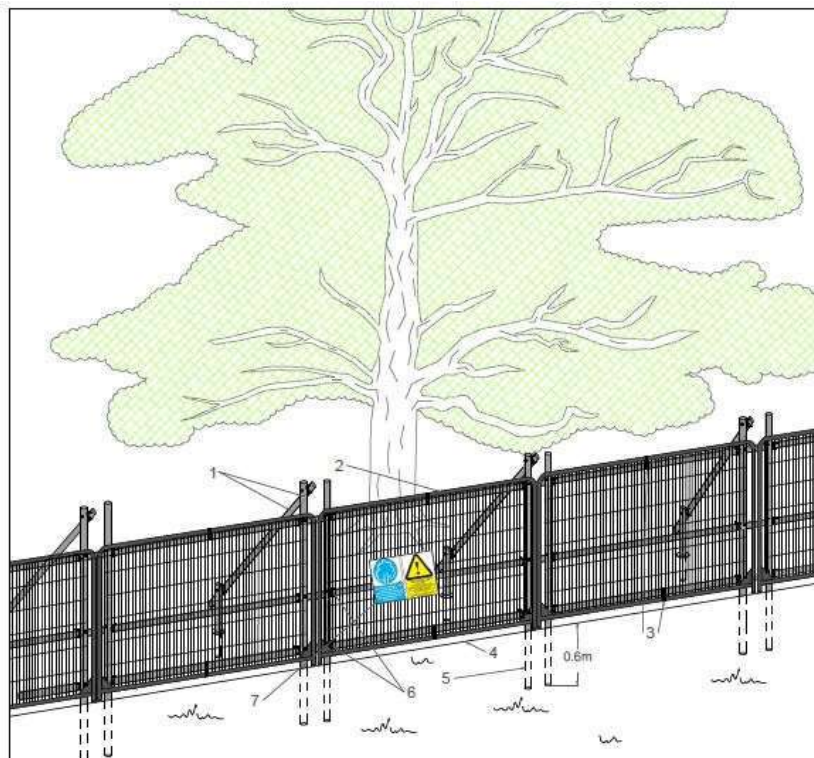
Standard specification for High Intensity Protective Barrier

Unless stated below, Protective Fencing will comprise a Heras HSG151 panel framework supported by scaffold poles driven into the ground. An example of this has been illustrated below.

1. Standard scaffold poles
2. Heavy gauge 2m tall galvanized tube and welded mesh infill panels
3. Panels secured to scaffold frame with wire ties
4. Ground level
5. Uprights driven into the ground until secure (min depth of 0.6m)
6. Standard scaffold clamps
7. Construction Exclusion Zone signs

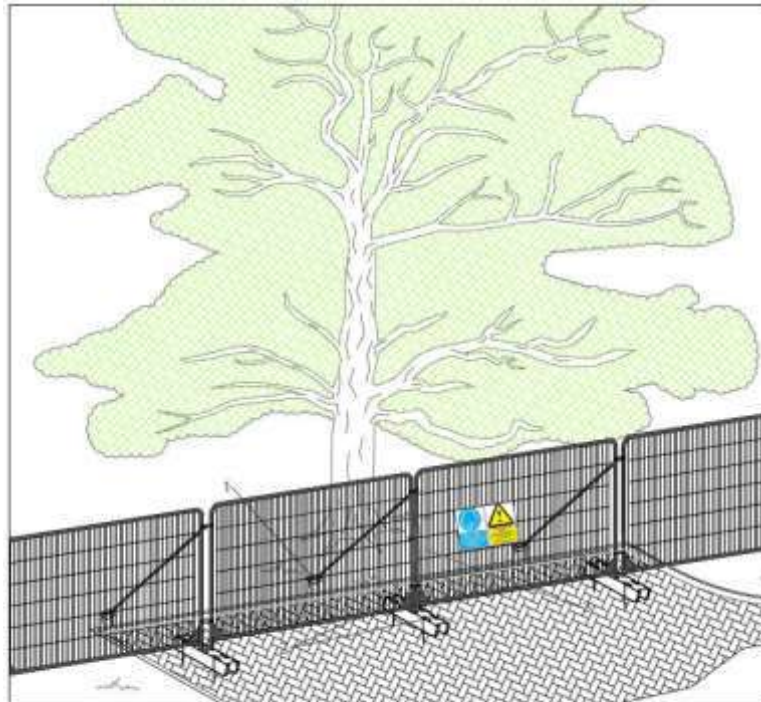
Standard Specification for Above Ground Stabilizing Systems

This fencing specification shall only be used where specified on the relevant Tree Protection Plans as is not to be used as an alternative to the standard specification unless determined by the Arboricultural Clerk of Works.

1. Stabiliser post with base plate secured with ground pins
2. Feet blocks secured with ground pins
3. Construction Exclusion Zone sign

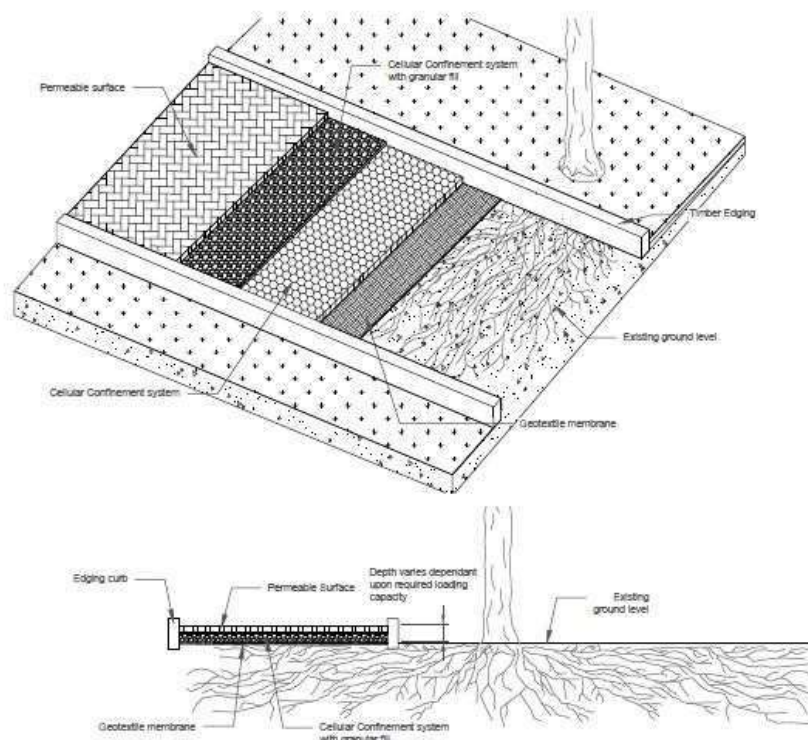
Figure 1: No-dig Footpath Construction

Figures 1 and 2 demonstrate the specification for No-dig Footpath Construction and No-dig Permanent Road Construction (further details and product specifications are available upon request).

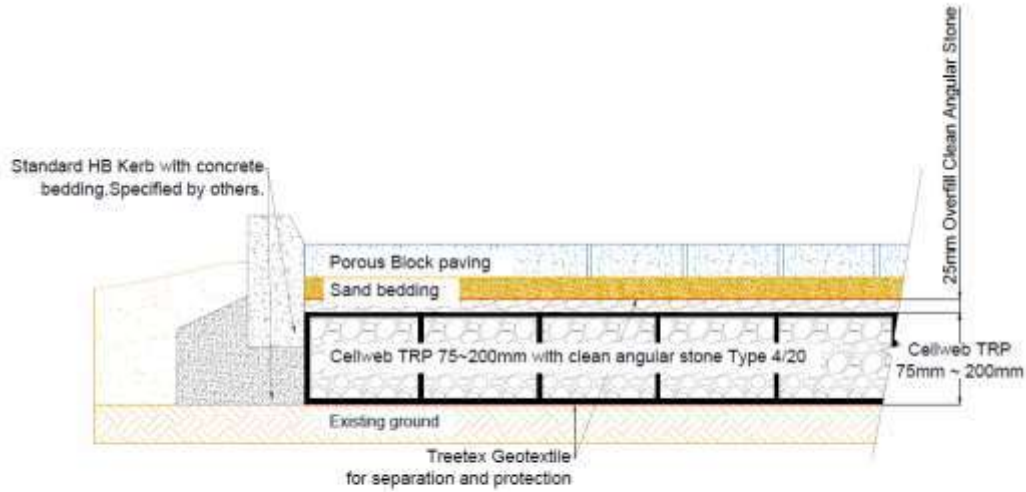
Figure 3: Geosynthetics Cellweb 75-200mm Block Paving Standard Detail

Figure 3 and Appendix E provides information from a reputable supplier (Geosynthetics Ltd).

Note: Subbase could be required depending on the existing ground CBR % and the type of traffic on the surface.

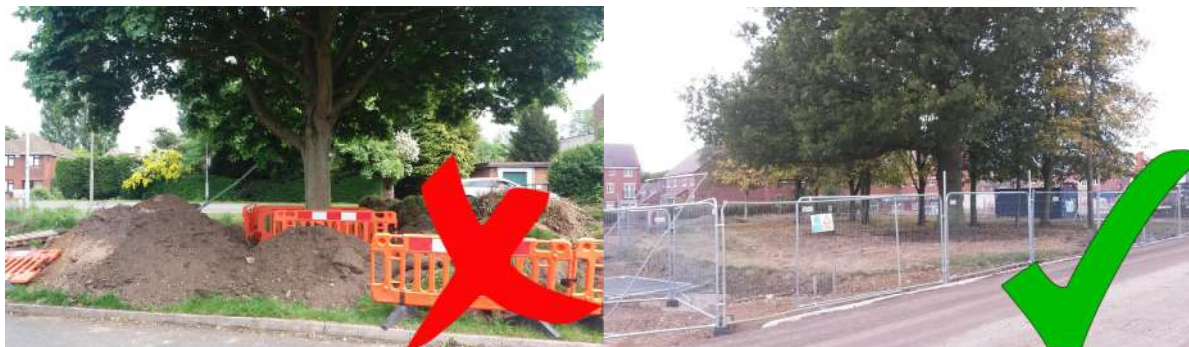
3. **Report** any instances where the fencing has been removed, repositioned, damaged or is not fit for purpose (see images below) to the Site Manager. This shall help the Site Manager to ensure that the fencing is maintained throughout the construction process. It will also reduce the risk of any staff and contractors accidentally and inadvertently causing damage to trees as a result.

Unacceptable example of tree protection due to a lack of adequate fencing and poor site management. Note mounds of soil have been placed within the Root Protection Area.

Tree Protection Fencing which has been erected prior to the commencement of any site works and the correct signage has been provided to clearly highlight that this is a protected zone.

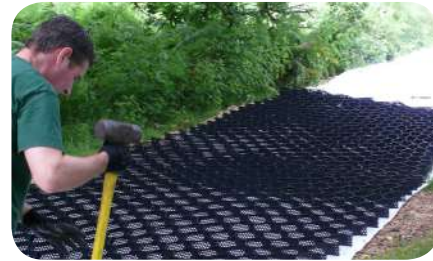
Step 3: Lay out Cellweb® TRP

3. Lay out the Cellweb® TRP Cellular Confinement System

- Lay out the collapsed Cellweb® TRP on-top of the Treetex™.
- Place one of the supplied J pins into the centre cell at the end of the panel and secure into the ground.

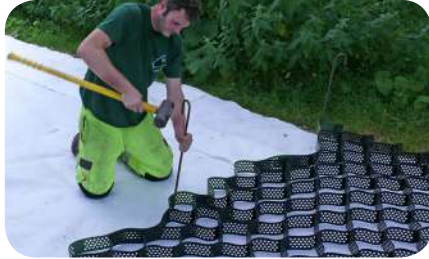
Step 3: Pinning Cellweb® TRP

- Pull out the Cellweb® TRP to its full 8.1m length and secure its length with another J pin.

- Now measure its width to 2.56m and secure in each of the corners with the J pins.
- Use 10 pins per panel to create a panel measuring 8.1m x 2.56m.

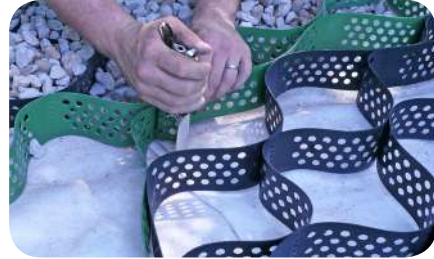
Step 3: Stapling Cellweb® TRP

- This will produce a cell size of 259mm x 224mm which is the required cell aperture. Each cell must be fully extended and under tension.
- Staple adjacent panels together at each cell (see Note 3).
- If a curved path or shape is required, this should be cut when the Cellweb® TRP panel is pinned out to 8.1 x 2.56m, ensuring complete cells remain. Do not try to curve or bend the Cellweb® TRP panels into place.
- When cutting Cellweb® TRP, please bear in mind that you will lose two internal cells per cut. Across a 8.1m long panel, this equates to a loss of 0.224m x 2 along the length or 0.259m x 2 across the width.

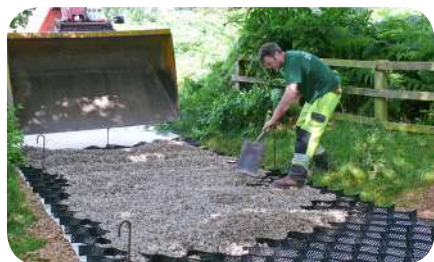
Step 4: Clean Angular Stone

4. Infill the Clean Angular Stone
