Redrow Homes Limited

Great Wilsey Park, Wilsey Road, Little Wratting, Suffolk

Arboricultural Method Statement – INFRASTRUCTURE

February 2020

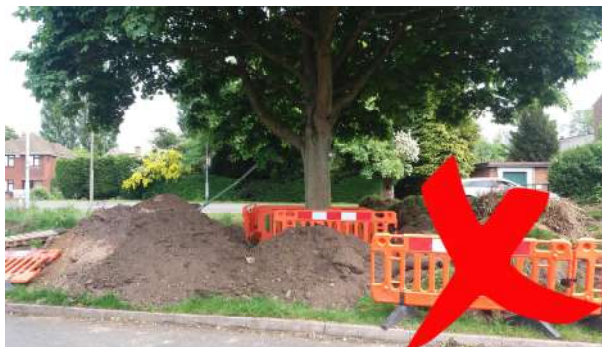
Unacceptable example of tree protection due to a lack of adequate fencing and poor site management. Note mounds of soil have been placed within the Root Protection Area.

3. **Report** any instances where the fencing has been removed, repositioned, damaged or is not fit for purpose (see images below) to the Site Manager. This shall help the Site Manager to ensure that the fencing is maintained throughout the construction process. It will also reduce the risk of any staff and contractors accidentally and inadvertently causing damage to trees as a result.

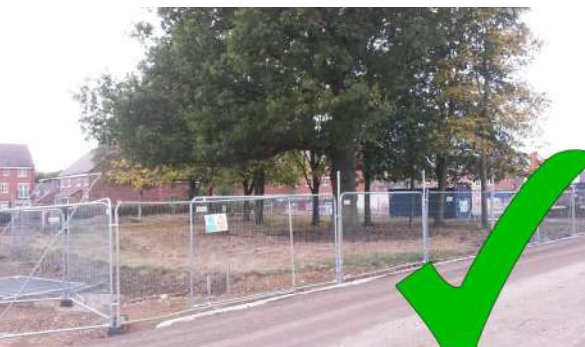
Tree Protection Fencing which has been erected prior to the commencement of any site works and the correct signage has been provided to clearly highlight that this is a protected zone.

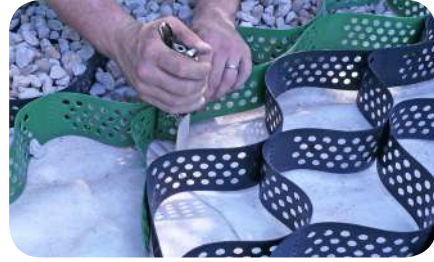
Step 3: Stapling Cellweb® TRP

- Pull out the Cellweb® TRP to its full 8.1m length and secure its length with another J pin.

- Now measure its width to 2.56m and secure in each of the corners with the J pins.
- Use 10 pins per panel to create a panel measuring 8.1m x 2.56m.

- This will produce a cell size of 259mm x 224mm which is the required cell aperture. Each cell must be fully extended and under tension.
- Staple adjacent panels together at each cell (see Note 3).
- If a curved path or shape is required, this should be cut when the Cellweb® TRP panel is pinned out to 8.1 x 2.56m, ensuring complete cells remain. Do not try to curve or bend the Cellweb® TRP panels into place.
- When cutting Cellweb® TRP, please bear in mind that you will lose two internal cells per cut. Across a 8.1m long panel, this equates to a loss of 0.224m x 2 along the length or 0.259m x 2 across the width.

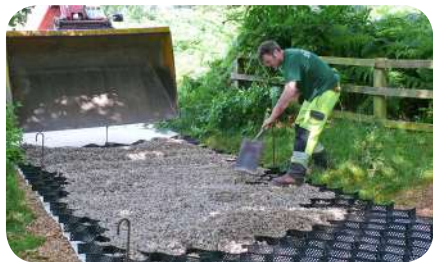
Step 4: Clean Angular Stone

4. Infill the Clean Angular Stone
