Proposed Tiger Crossings, Haverhill, Suffolk

Stage 1 Road Safety Audit

Client: Redrow

Reference: PB8301_HTC_RSA1_F01

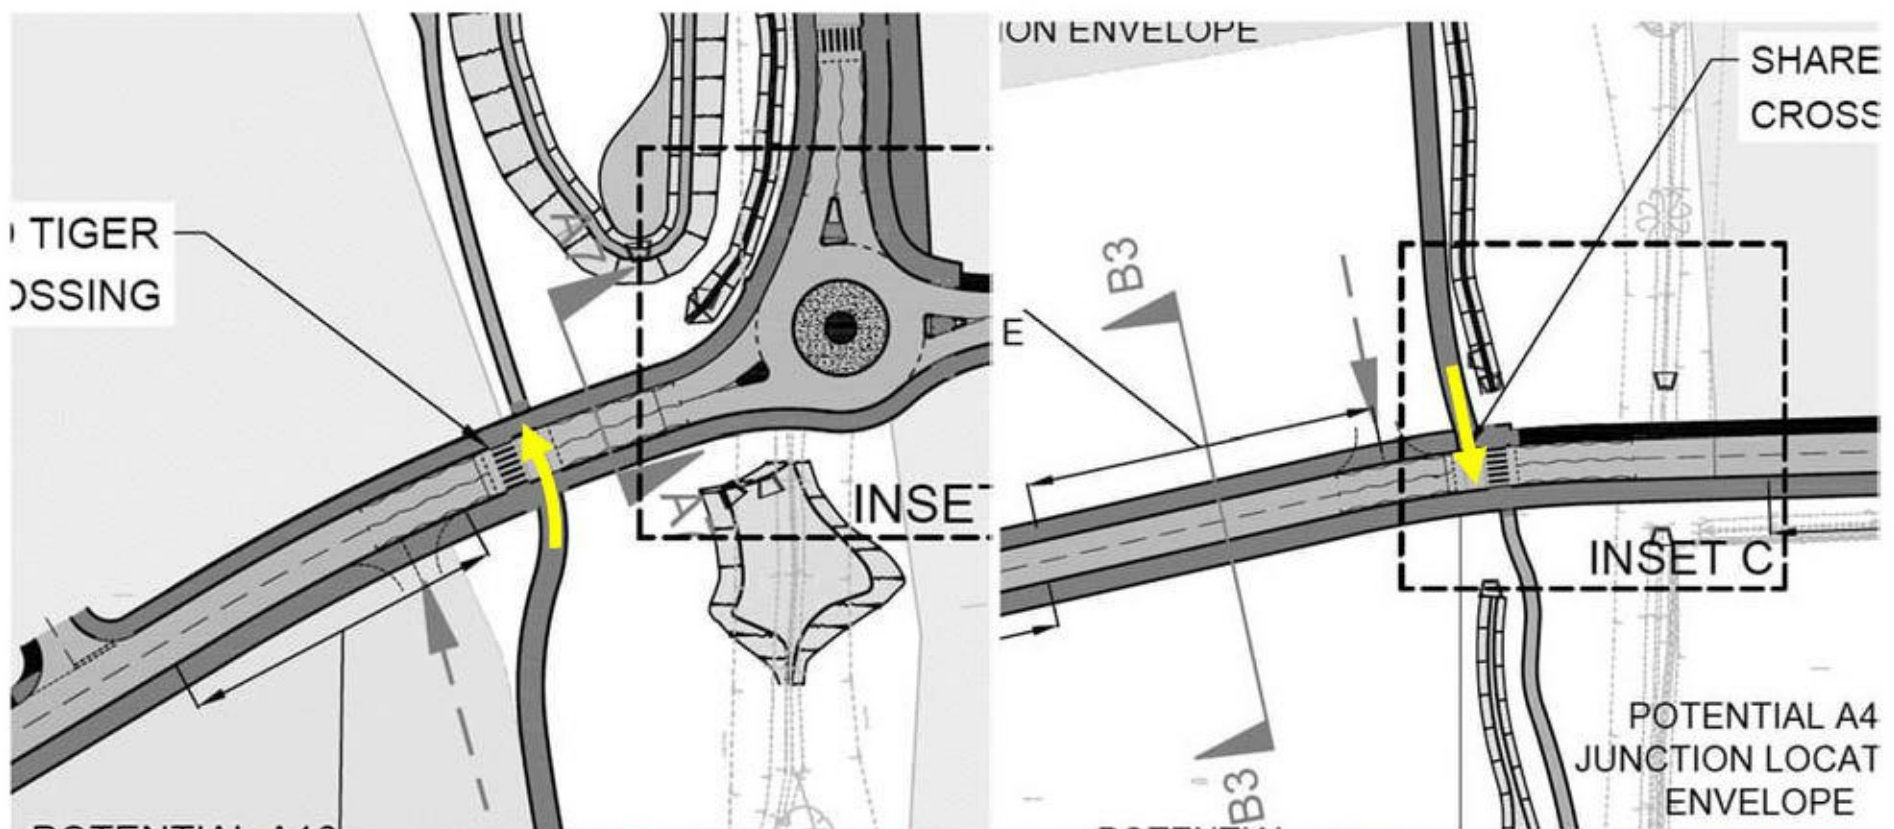
Summary: Absence of deflection on approach to the cycle crossing element of the proposed Tiger crossing could result in inappropriate cycle speeds, leading to collisions between road users or sudden braking and rear end shunts on the main road.

Description: No deflection or deviation of the footway/ cycleway approach to the Tiger crossing has been provided. The cycle element of the Tiger crossing is directly in line with the footway/ cycleway, which allows cyclists to approach and enter the crossing at speeds. Drivers on the main road may brake sharply upon seeing a cyclists approaching the crossing at speed, resulting in rear end shunts.

Furthermore, cyclists approaching the crossing at speed may be unable to slow/ stop sufficiently before entering the carriageway, resulting in collisions with road users on the main road.

Extracts from drawing PB8301-RHD-DE-HI-DR-D-0150, showing absence of deflection on approach to the Tiger crossing for cyclist

Provide deflection on approach to the Tiger crossings to slow cyclists as they approach the facilities. If it is not possible to provide adequate deflection, measures such as bollards or 'SLOW' markings should be installed. The installation of any bollards should consider the footway width requirements of wheelchair users and those pedestrian with additional mobility requirements, such as those with pushchairs/ walking frames.

In conjunction with the above, sufficient forward visibility should be provided on the deflected approaches to the Tiger crossings from the footway/ cycleways, increasing intervisibility between all road users.

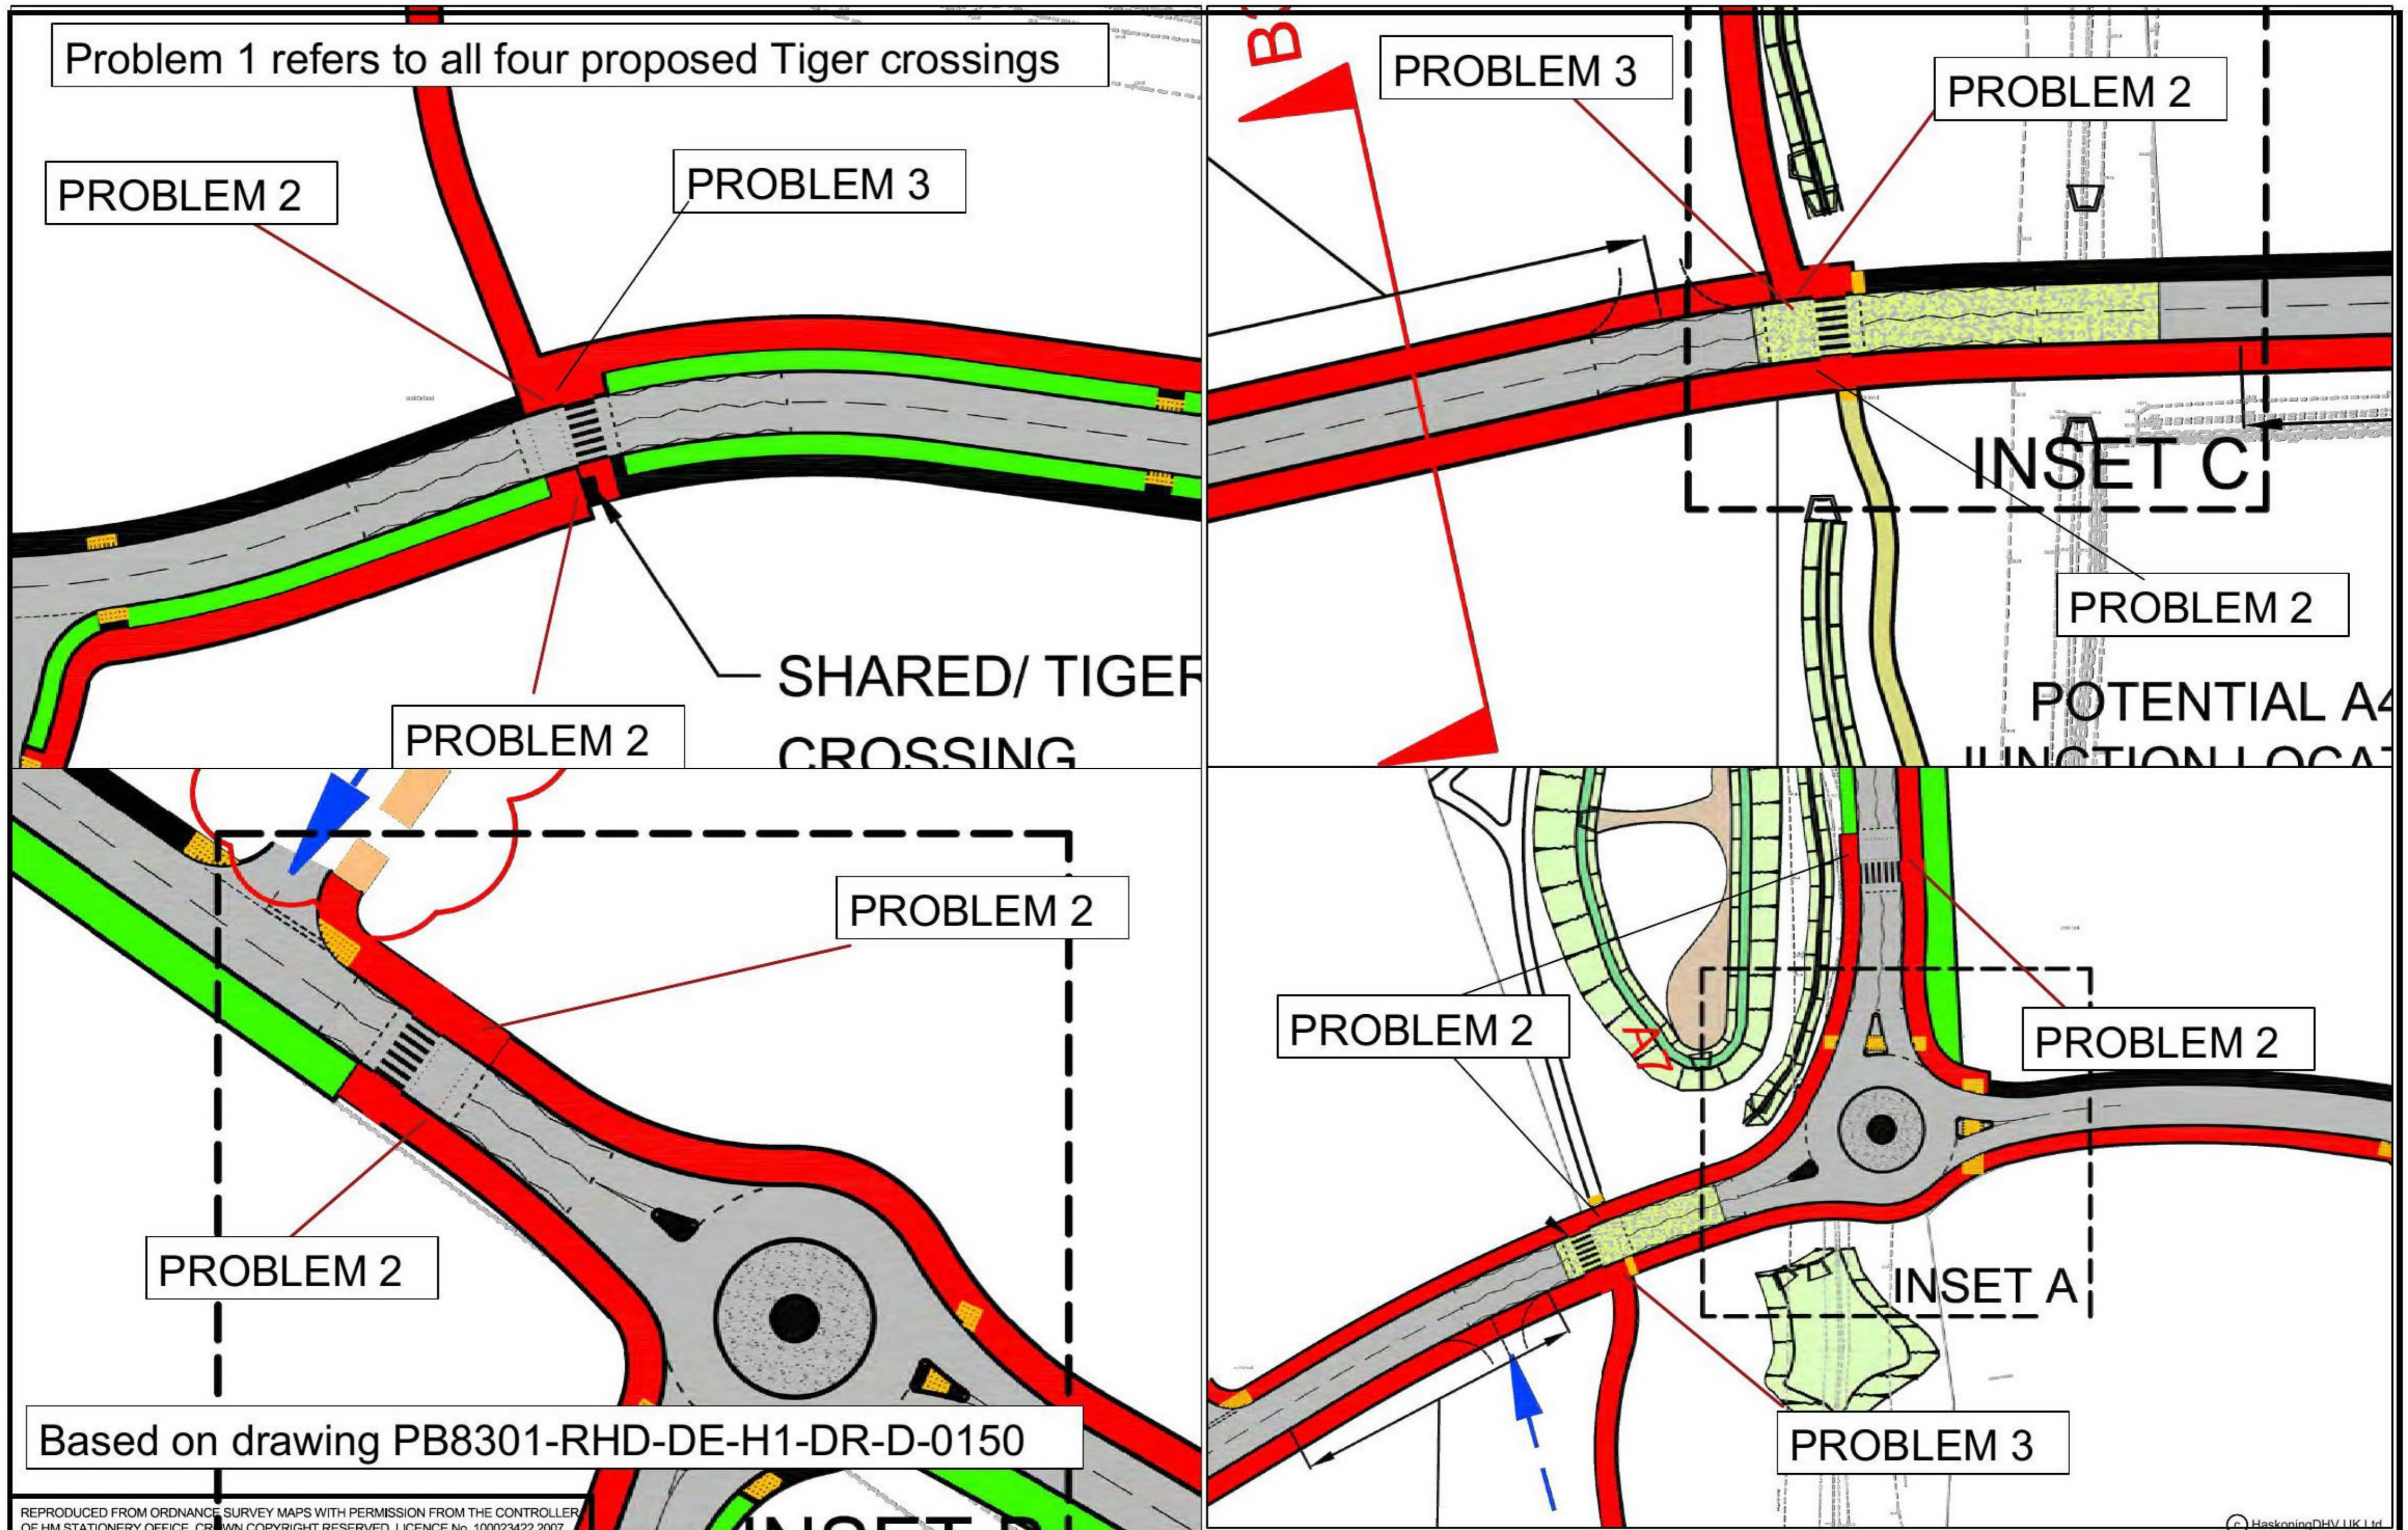
Figure 2 – Problem Location Plan

TITLE	PROJECT
PROBLEM LOCATION PLAN	PROPOSED TIGER CROSSINGS, HAVERHILL STAGE 1 ROAD SAFETY AUDIT
