### **Preliminary Ecological Appraisal Report**

**Little Court, Little Wratting  
[NGR: TL 68513 46990 ]**

**On behalf of:  
CARE (Little Court) Ltd**

**February 2021**

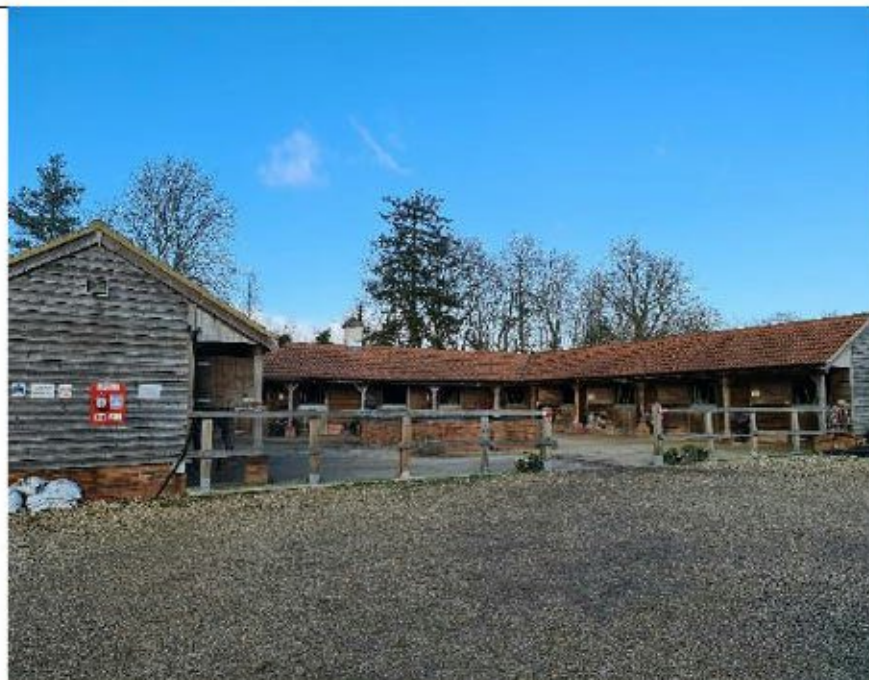
Structure 1- Stable block with timber clad walls and pantile roof. Hard standing present around stable block

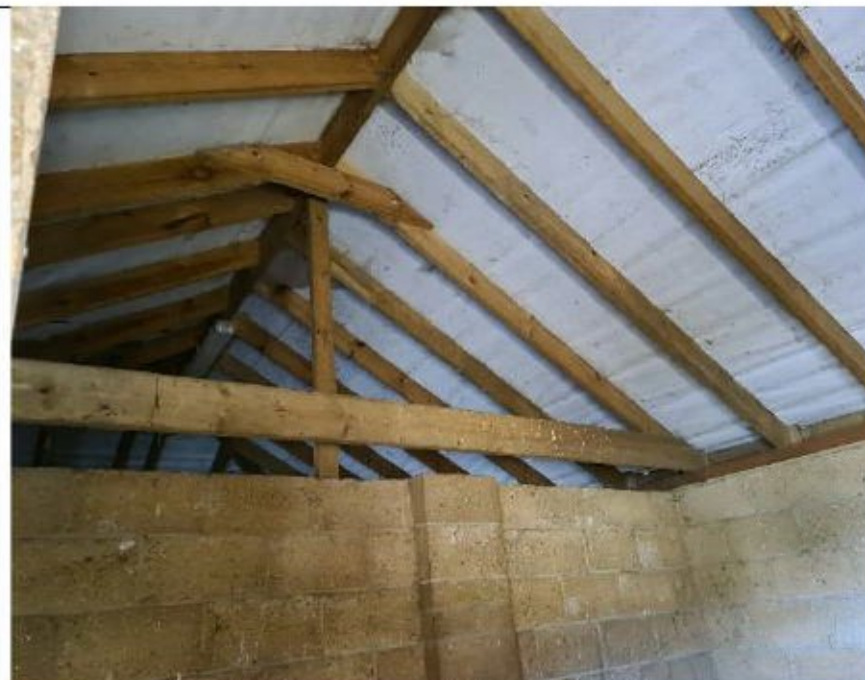
Structure 1- Internal of stable block with breathable roofing membrane visible under roof tiles. No void present

It is recommended that the roofing felt used should be bitumen 1F felt. Non-bitumen-coated roofing membranes (NBCRMs) should not be used due to the risks posed to bats (Essah *et al.*, 2020, Waring *et al.*, 2013). This includes the use of NBCRMs to line any cavity walls, where bats may be able to enter the cavity for roosting purposes.

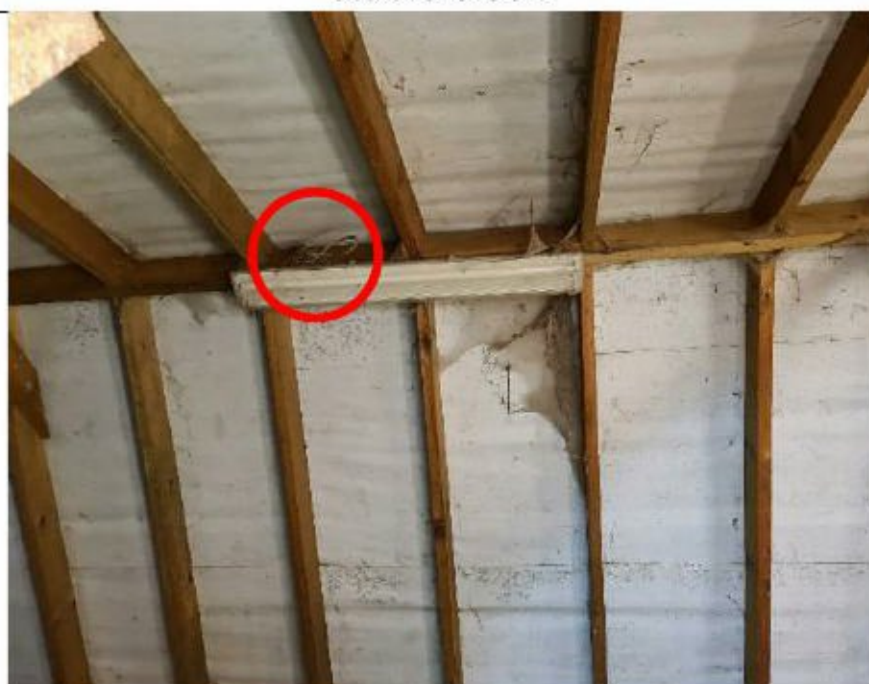
Structure 1- Lighting in stable block with swallow nest present (TN1, circled red)

Any works involving vegetation clearance and any building demolition should avoid the bird breeding season (late February to August inclusive) to avoid damage to nests/ harm to nesting species. For swallows the breeding season is extended to the end of September. If it is not practicable to avoid the bird breeding season, then an experienced ecologist should undertake a breeding bird survey to ascertain the amount of birds using the site and where they are so they can be avoided. Results of nesting bird surveys are only valid for 48hrs and, therefore, multiple surveys may be required for phased works.

It is recommended that the new site plans include mitigation for the loss of swallow nesting habitat, as well as the provision of nesting habitats for other species in the form of nest boxes (see Appendix Four for designs and numbers to be installed). Nesting enhancement is based on the copse and hedgerows being retained. Further mitigation/enhancement measures will be made if the copse and/or hedgerows are not retained.

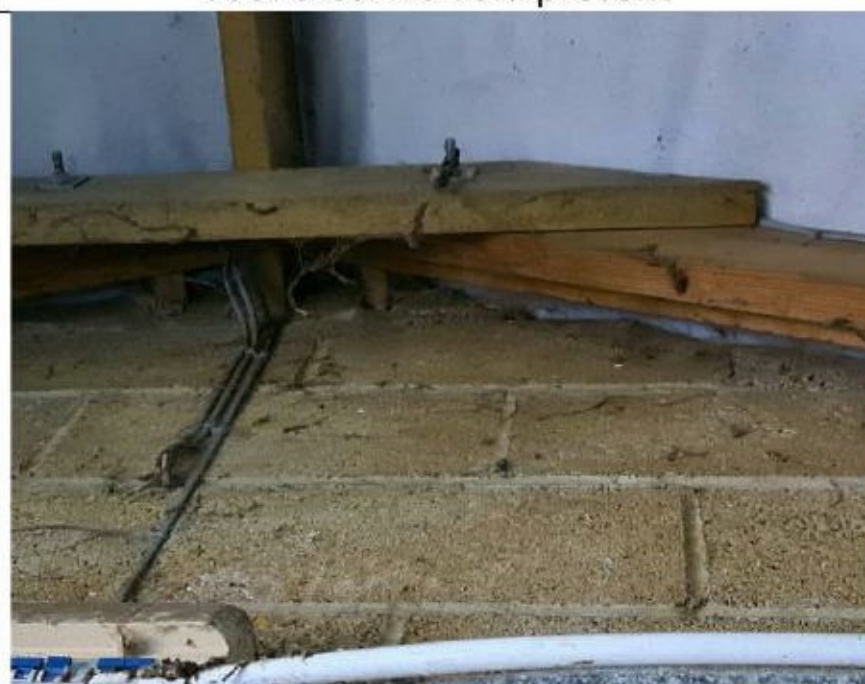
Structure 1- Gap between blocks and roof felt at gable end of stable block

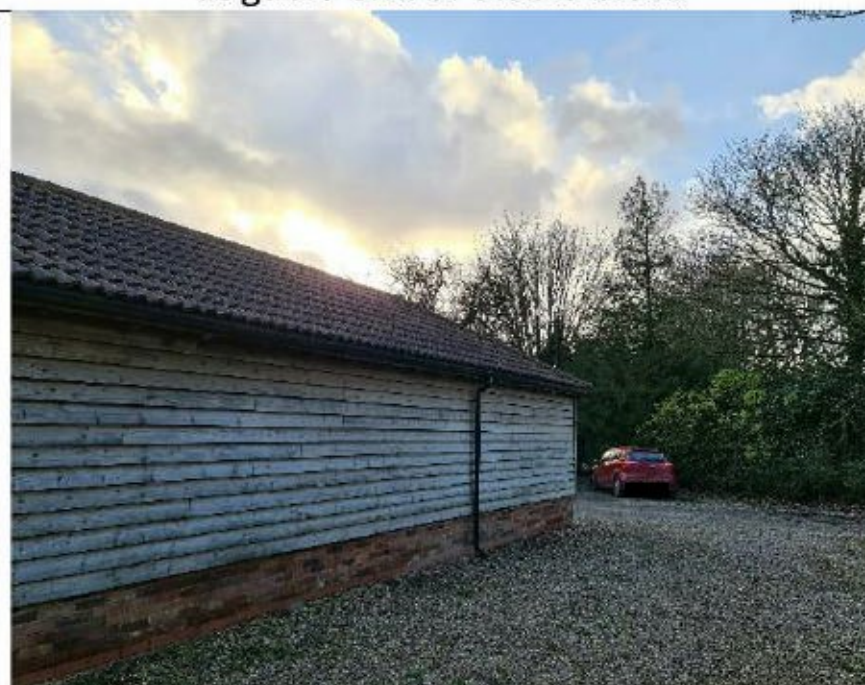
Structure 1- external timber cladding.

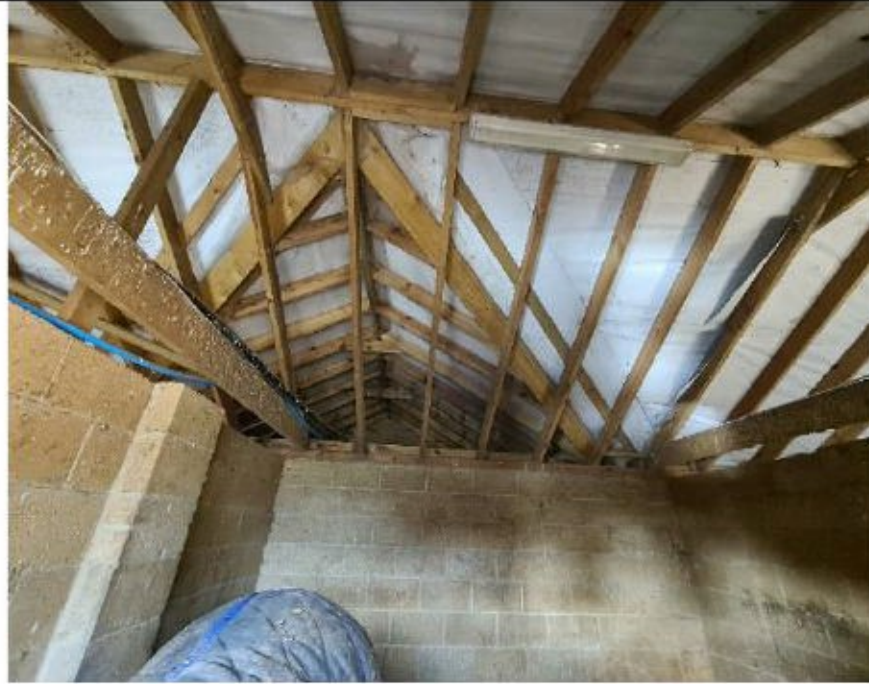
Structure 1- Roof structure where store room joins to stable block.

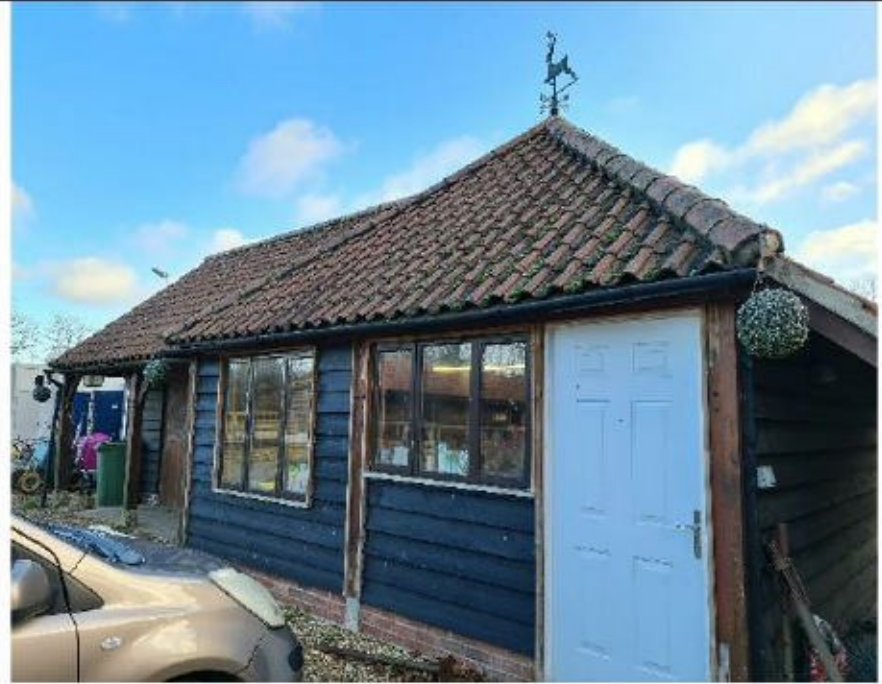
Structure 2. Office with windows on right and store room on left.

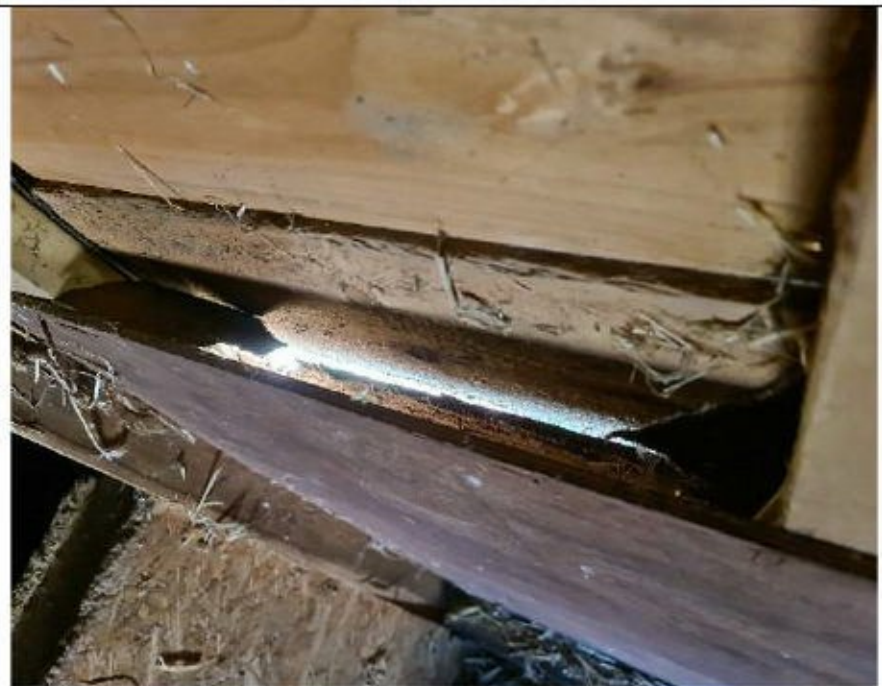
Structure 2- Eastern side internal, gaps present in timber cladding

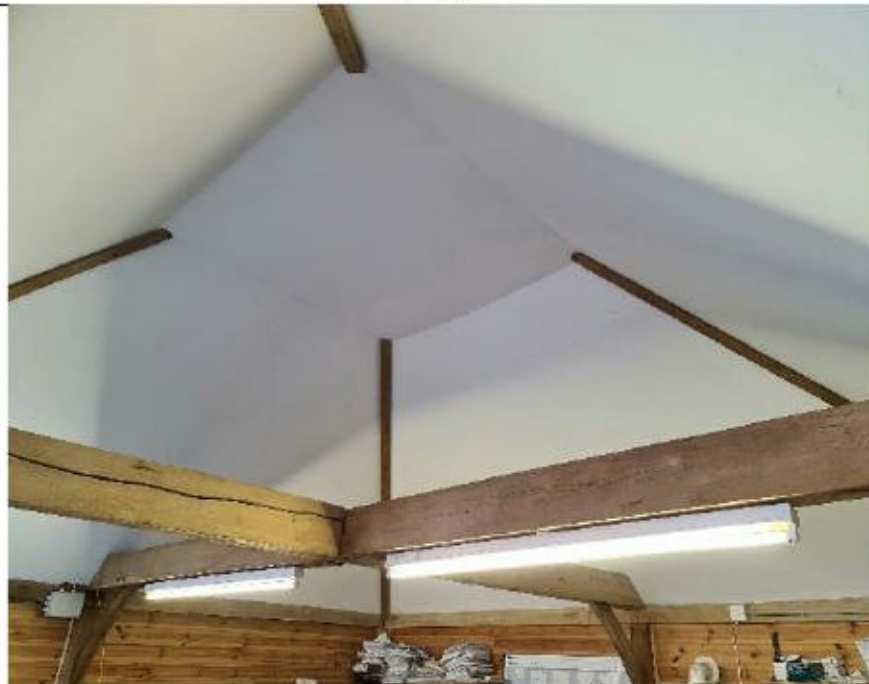
Structure 2- west side renovated office space.

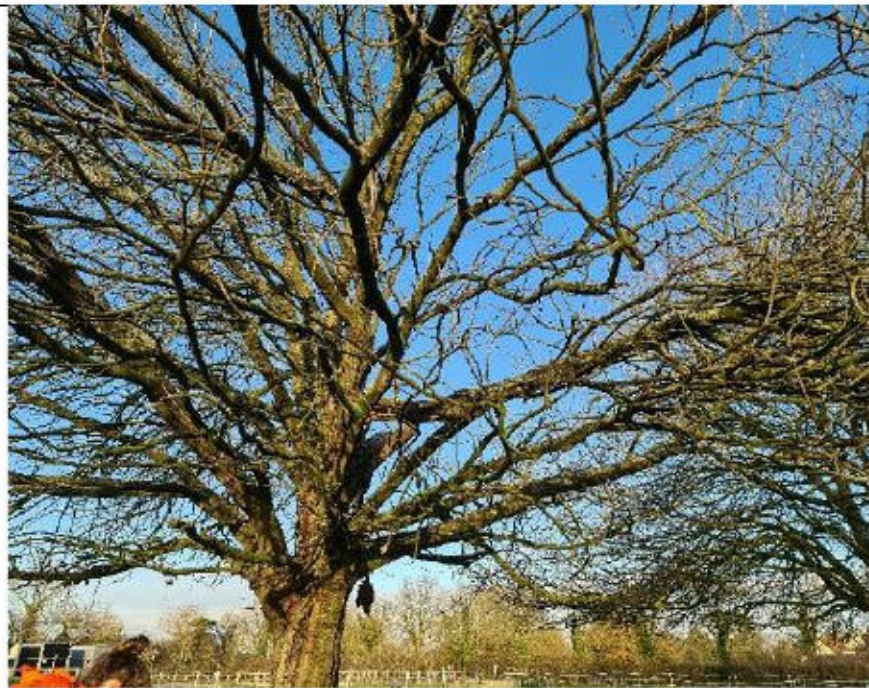
No evidence of bats was seen during the building and tree inspections. Structures 1 and 2 both had negligible potential to support roosting bats. Of the trees inspected, Tree 3 had low potential to support roosting bats due to the presence of flaking bark and rot holes.

Tree 3 (located in the paddock). Flaking bark and rot holes.

If Tree 3 will be impacted by the works then it is recommended that an aerial inspection is undertaken by, or supervised by, a licenced ecologist immediately prior to felling to ensure that no bats are present.

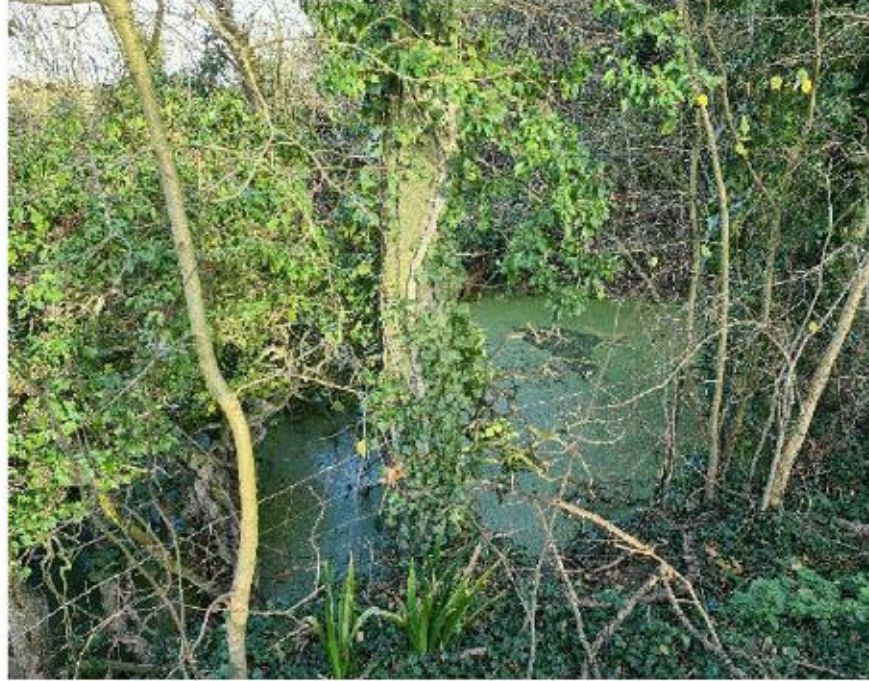
Pond 1. Small pond in copse. HSI Score 0.74  
'Good'.

It is recommended that Phase 2 great crested newt surveys, are carried out on the waterbodies (P1-3) found within the zone of influence in order to confirm the presence/absence of great crested newts. Such surveys can only be carried out in the spring months (April-June).

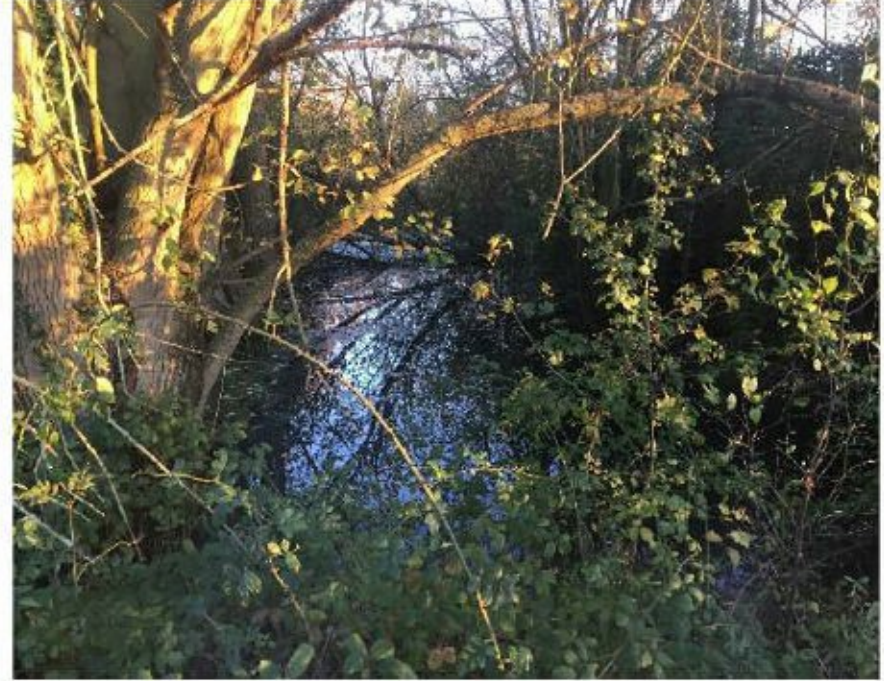
Pond 2- Small pond adjacent to neighbouring  
driveway. HSI Score 0.83 'Excellent'.

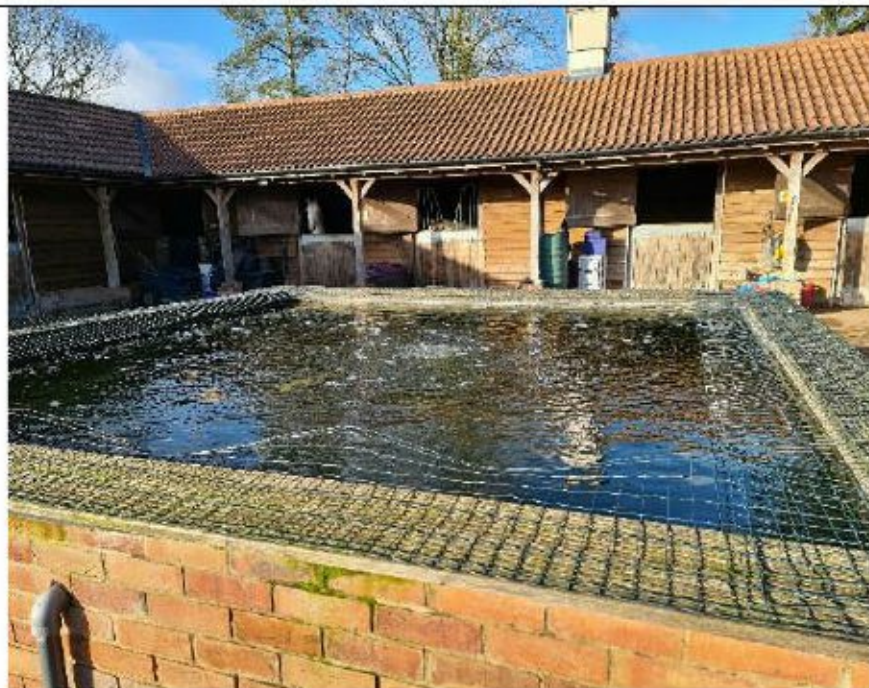
Pond 3- Ornamental pond in middle of stable  
yard hardstanding. HSI score 0.23 'Poor'.

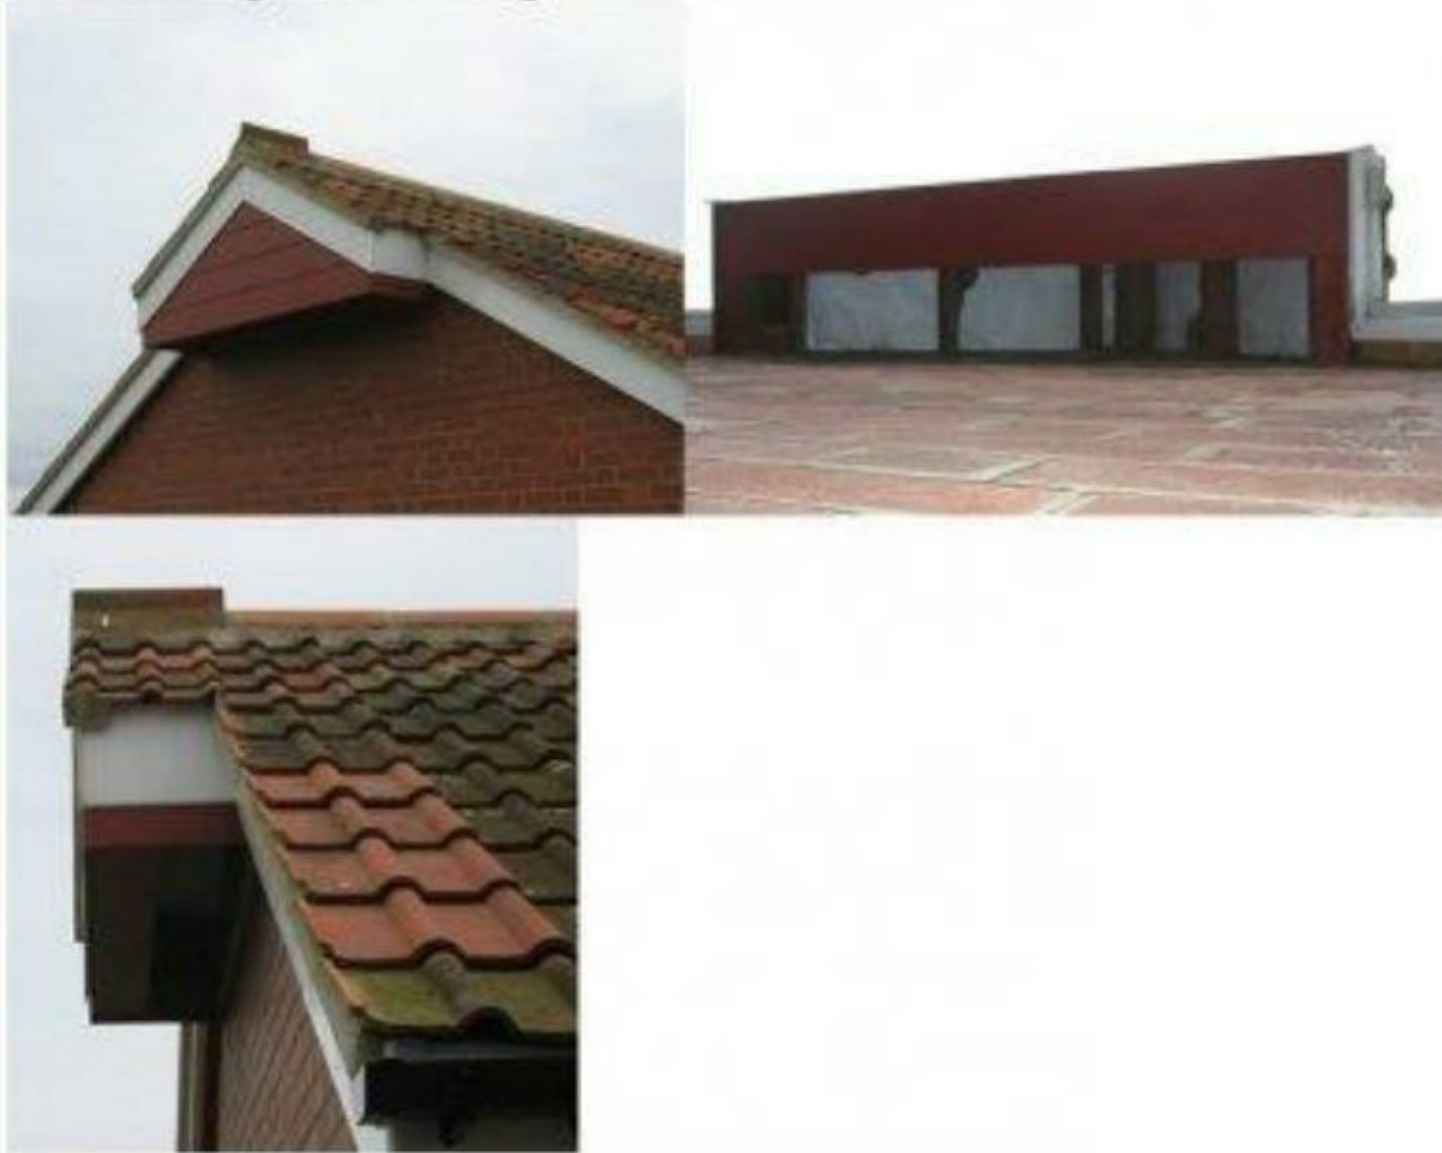
**Eaves/ridge overhang swallow nest box**

Similar to Option 2, seven of these eaves extension designs should be incorporated into the design.

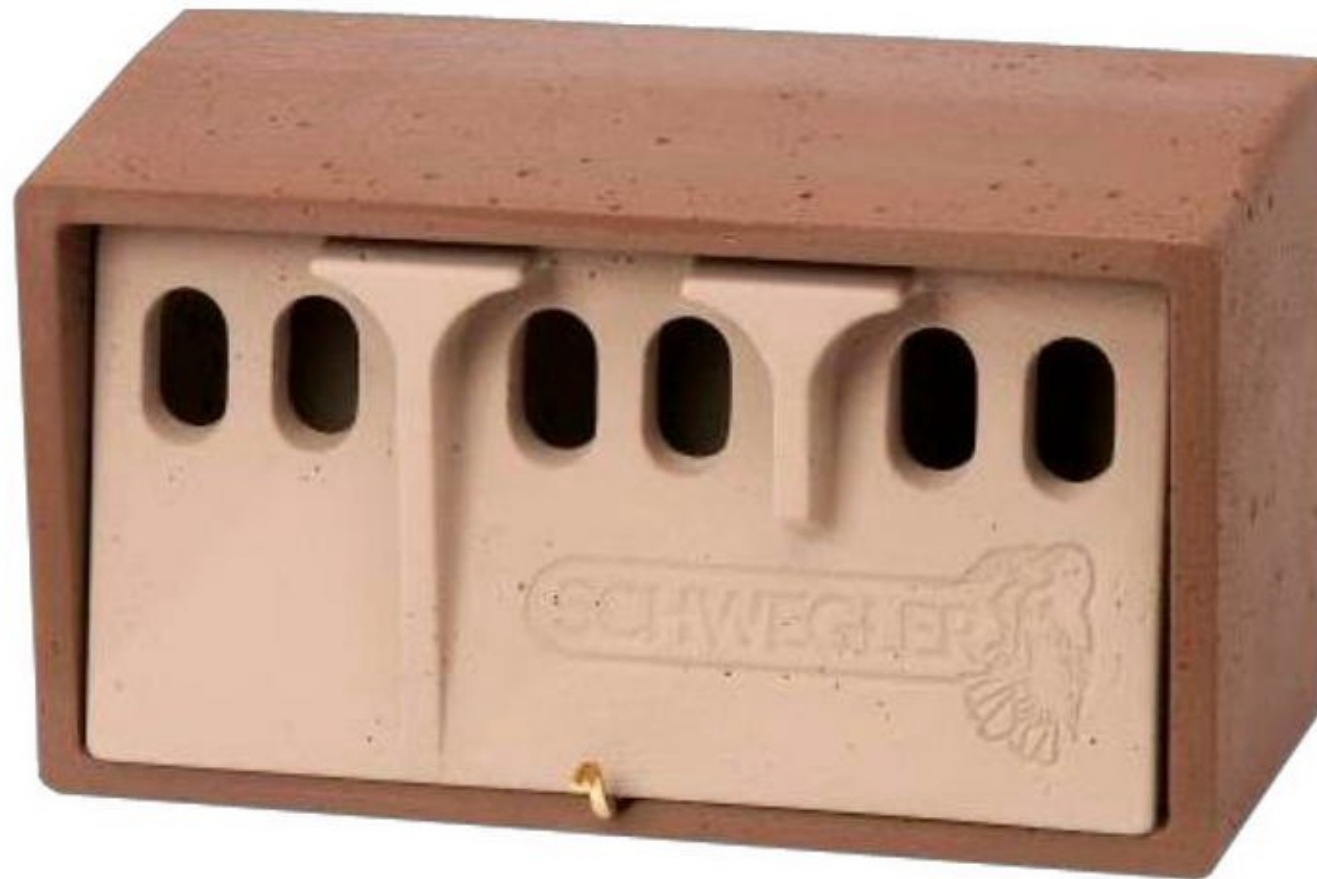
Schwegler 1SP Sparrow Terrace.

Three sparrow terraces will be incorporated into the final building design. Sparrow terraces can be fixed on to the surface of a suitable wall or incorporated into the wall and should be installed at a height of 2 m or above. The three terraces should be installed in a group together as sparrows are communal roosting birds.

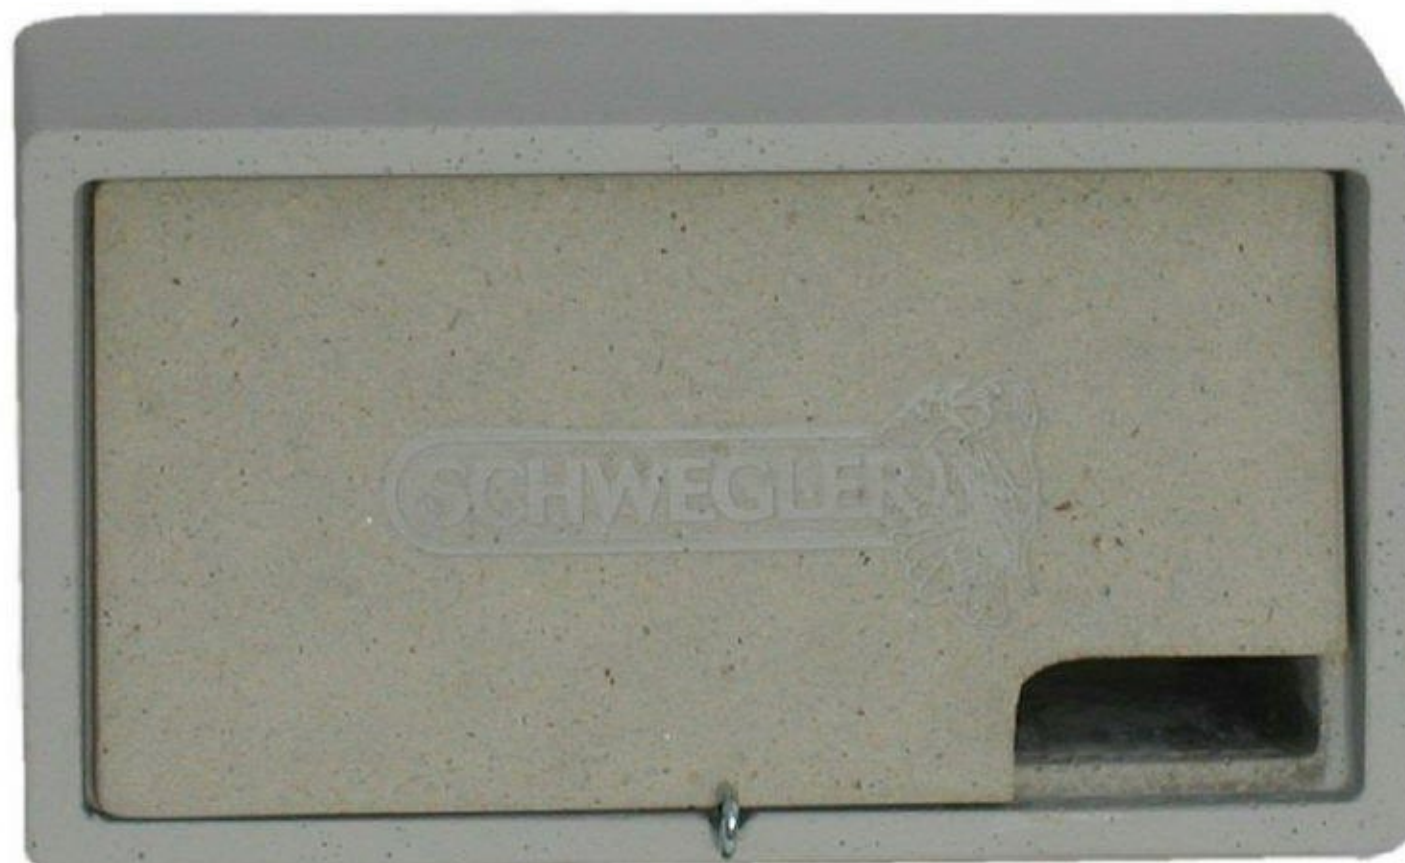
Three Schwegler 16 S Swift Box should be installed. These boxes can be fixed externally to a north or east facing wall but are best integrated within the wall structure. These boxes should be installed at 5m or above, with unobstructed access. Swift boxes should not be installed in groups side by side but instead spaced out across the face of the building that they are to be installed on.

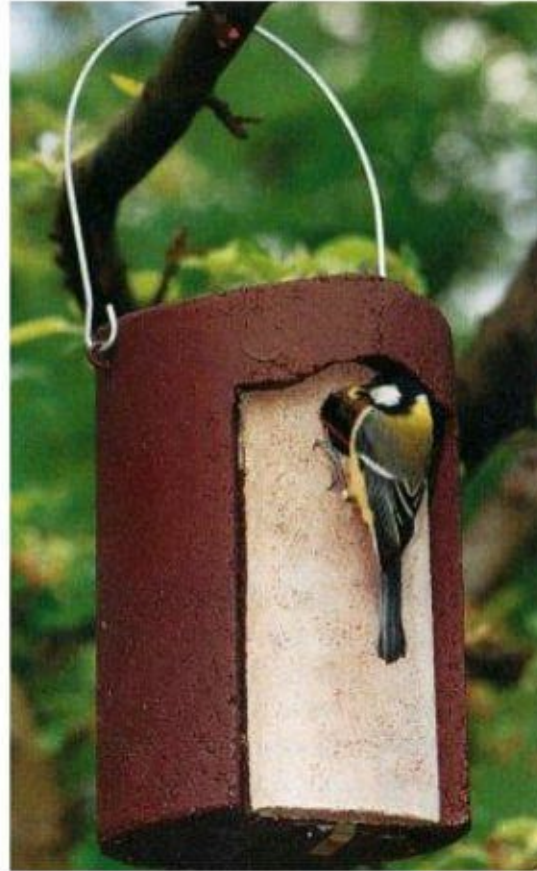
Schwegler 1B Nest Box

Additional non-integrated nest boxes should be installed in the woodland area. Schwegler 1B Nest Boxes with 26 mm and 32 mm holes will cater for a range of species. They should be installed on trees at a minimum height of 2m.

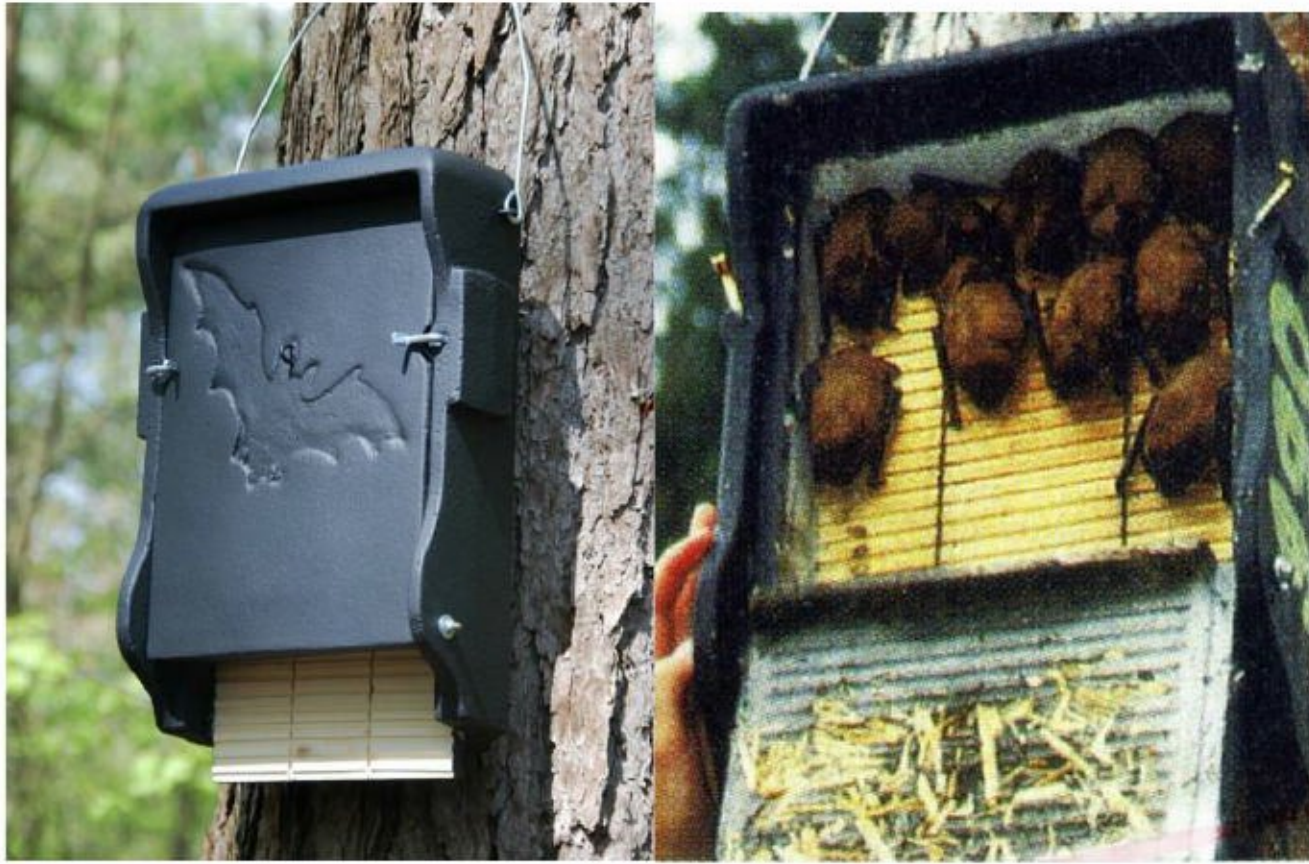
Schwegler 1FF Module bat box.

Two 1FF non-integrated boxes or similar should be provided as enhancement within the copse.

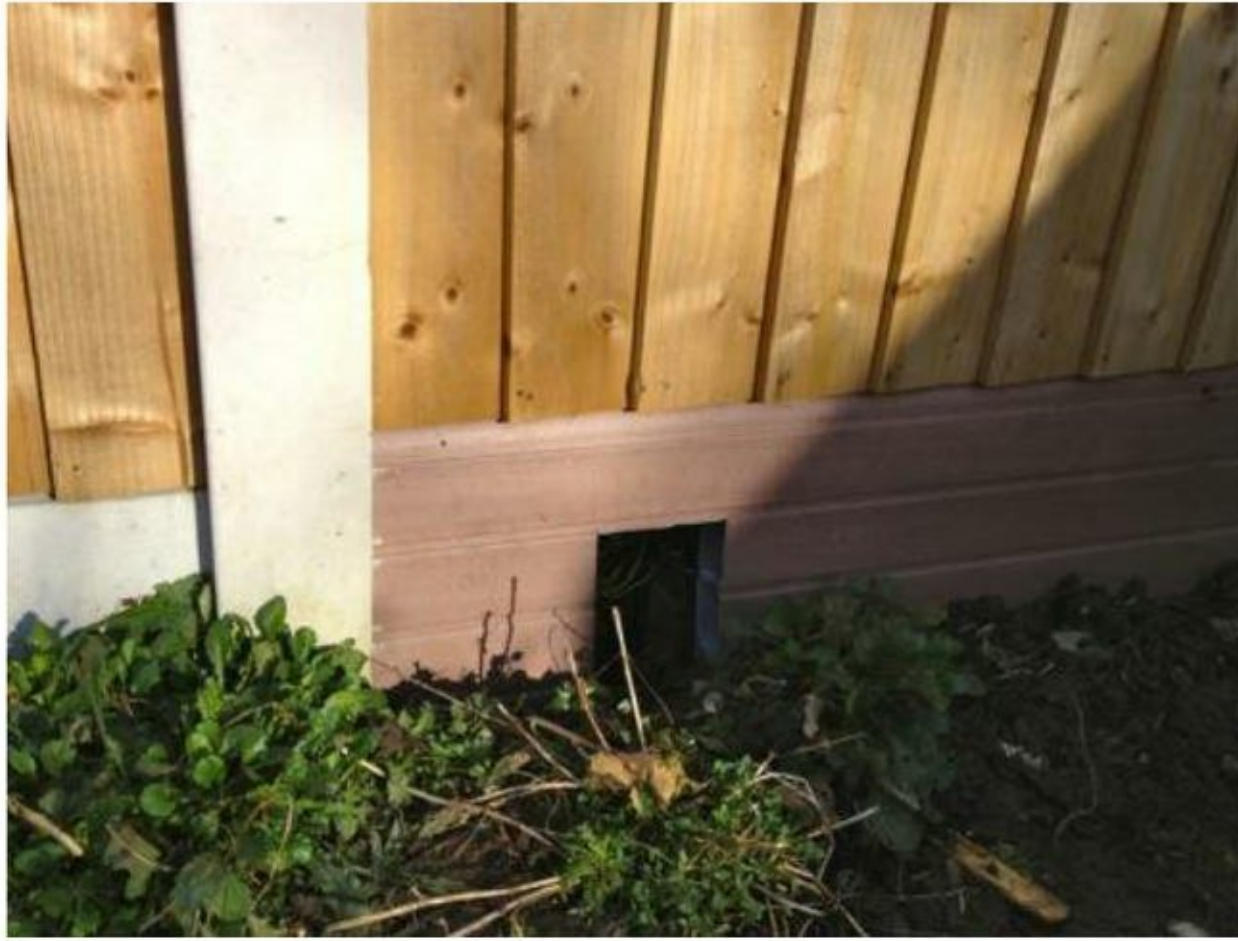
Example of access provision for hedgehogs into site (13 x 13cm). At least two of these should be provided in total, across more than one boundary line.
