**ZA921 Little Court Wratting Road, Haverhill,  
RSA Designers Response  
For CARE (Little Court)  
August 2021**

**Stage 1 Road Safety Audit**

**A143 Haverhill Road, Little Wratting, Suffolk**

**Little Court Care Home Access Arrangements**

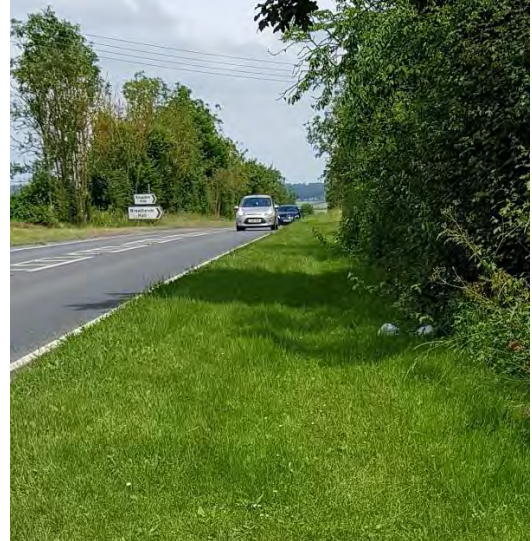
Location: At the eastern crossing point for bus stop

Summary: Reduced forward visibility at the crossing point and high approach speeds may lead to pedestrian to vehicle collisions

The A143, east of the development access, has a slight rolling vertical crest curve, with a raised verge area along the southern side of the A143. This may reduce the forward visibility (stopping sight distance) to and for pedestrians crossing at the bus stop hardstanding. Reduced forward visibility may lead to pedestrian to vehicle collisions, particularly as this section of the A143 is on a straight alignment and vehicle speeds appeared to be high.

4.1.1	<p><b>Location:</b> At the eastern crossing point for bus stop</p> <p><b>Summary:</b> Reduced forward visibility at the crossing point and high approach speeds may lead to pedestrian to vehicle collisions</p> <p>The A143, east of the development access, has a slight rolling vertical crest curve, with a raised verge area along the southern side of the A143. This may reduce the forward visibility (stopping sight distance) to and for pedestrians crossing at the bus stop hardstanding. Reduced forward visibility may lead to pedestrian to vehicle collisions, particularly as this section of the A143 is on a straight alignment and vehicle speeds appeared to be high.</p>	It is recommended that adequate forward visibility (stopping sight distance) is provided at the crossing point, consistent with free flow approach speeds.	<p><b>Drawing ZA921-PL-SK-006-P02</b> has been prepared to demonstrate that vertical visibility is achievable to the site access and proposed crossing points.</p> <p><b>Drawing ZA921-PL-SK-001-P09</b> shows the updated site access strategy.</p>

It is recommended that adequate forward visibility (stopping sight distance) is provided at the crossing point, consistent with free flow approach speeds.

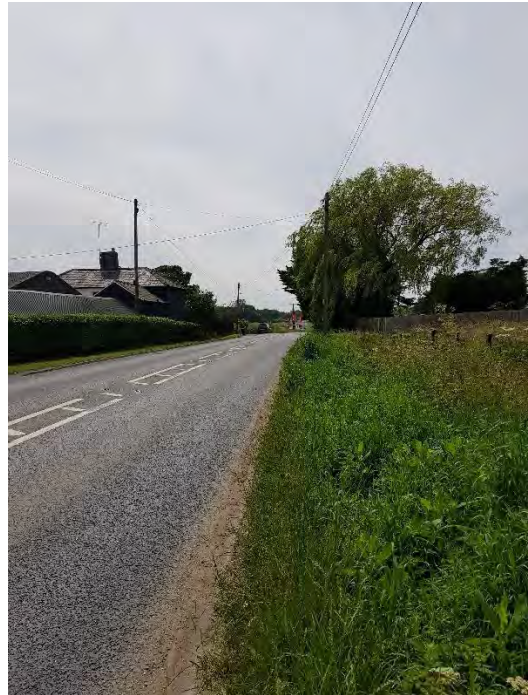
**Location:** On the A143, eastbound approach to the western pedestrian / cyclist crossing

**Summary:** Reduced forward visibility at the crossing point may lead to pedestrian / cyclist to vehicle collisions

At the crossing, there is reduced forward visibility (stopping sight distance) to the east to / from the northern crossing point. Reduced forward visibility may lead to poor crossing decisions by users and to pedestrian / cyclist to vehicle collisions.

4.1.2	<p><b>Location:</b> On the A143, eastbound approach to the western pedestrian / cyclist crossing</p> <p><b>Summary:</b> Reduced forward visibility at the crossing point may lead to pedestrian / cyclist to vehicle collisions</p> <p>At the crossing, there is reduced forward visibility (stopping sight distance) to the east to / from the northern crossing point. Reduced forward visibility may lead to poor crossing decisions by users and to pedestrian / cyclist to vehicle collisions.</p>	It is recommended that the crossing point is relocated to a point where adequate stopping sight distance is available to the crossing point, consistent with free flow approach speeds.	<p><b>Noted:</b> This crossing has been removed from the scheme and a crossing point is instead provided just east of the site access.</p>

It is recommended that the crossing point is relocated to a point where adequate stopping sight distance is available to the crossing point, consistent with free flow approach speeds.

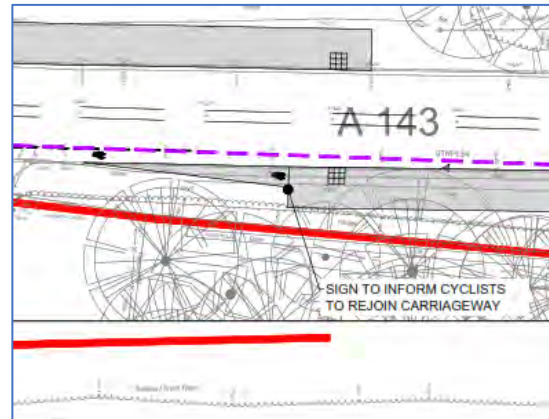
**Location:** On the A143, westbound cycle facility transition from footway to carriageway

**Summary:** Cycle to vehicle collisions at the return to the carriageway

At the transition, cyclists will have difficulty viewing westbound approaching vehicles. The westbound traffic lane is narrowed by the presence of the central hatched markings and a merging cyclist may be vulnerable to collisions with vehicles at this point.

4.1.3	<p><b>Location:</b> On the A143, westbound cycle facility transition from footway to carriageway</p> <p><b>Summary:</b> Cycle to vehicle collisions at the return to the carriageway</p> <p>At the transition, cyclists will have difficulty viewing westbound approaching vehicles. The westbound traffic lane is narrowed by the presence of the central hatched markings and a merging cyclist may be vulnerable to collisions with vehicles at this point.</p>	It is recommended that cyclists are encouraged to make the left turn at the development access, making a positive turn on to the A143 rather than a merge manoeuvre (see also Problem 4.1.2 for the recommended relocation of the crossing point).	<p><b>Noted:</b> The scheme has been updated to encourage cyclists to cycle on the A143.</p> <p>A crossing point has been provided for eastbound cyclists to access the site.</p>

It is recommended that cyclists are encouraged to make the left turn at the development access, making a positive turn on to the A143 rather than a merge manoeuvre (see also Problem 4.1.2 for the recommended relocation of the crossing point).

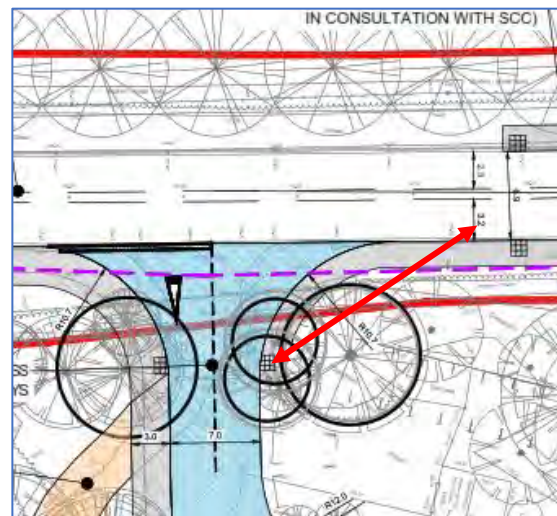
**Location:** At the development access

**Summary:** Pedestrian to vehicle collisions at the side road crossover due to reduced inter-visibility

At the eastern footway crossing area, there may be reduced inter-visibility between pedestrians and drivers making the left turn in to the site. Reduced inter-visibility may lead to pedestrian to vehicle collisions.

4.1.4	<p><b>Location:</b> At the development access</p> <p><b>Summary:</b> Pedestrian to vehicle collisions at the side road crossover due to reduced inter-visibility</p> <p>At the eastern footway crossing area, there may be reduced inter-visibility between pedestrians and drivers making the left turn in to the site. Reduced inter-visibility may lead to pedestrian to vehicle collisions.</p>	It is recommended that adequate inter-visibility is provided between conflicting users at this point; this may require the cutting back of vegetation and / or landscaping at this point.	<p><b>Noted:</b> The vegetation will be cleared in this location of maximise inter-visibility between vehicles and pedestrians. The crossing has been moved further towards the junction mouth. Although this will increase the width needed to cross it will increase inter-visibility between pedestrians/cyclists and vehicles.</p> <p>A separate pedestrian and cycle access is now proposed to provide direct access into the car park.</p>

It is recommended that adequate inter-visibility is provided between conflicting users at this point; this may require the cutting back of vegetation and / or landscaping at this point.

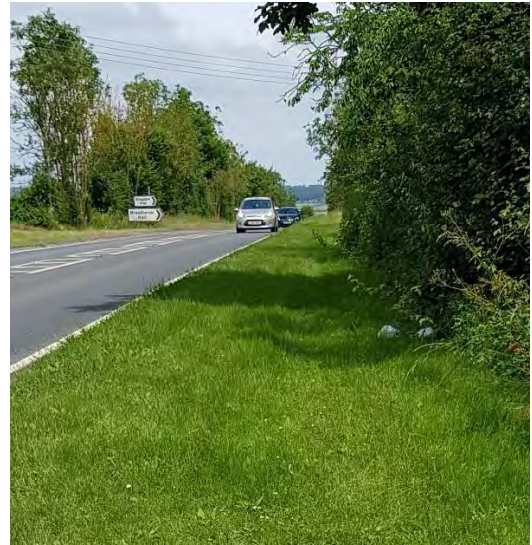
Location: At the development access

Summary: Reduced side road visibility and high approach speeds may lead to failure to give way type collisions

The A143, east of the development access, has a slight rolling vertical crest curve, with a raised verge area along the southern side of the A143. This may reduce the side road visibility to the right from the development access. Reduced side road visibility may lead to failure to give way type collisions, particularly as this section of the A143 is on a straight alignment and vehicle speeds appeared to be high.

<b>4.2 Junctions</b>				
4.2.1	<p><b>Location:</b> At the development access</p> <p><b>Summary:</b> Reduced side road visibility and high approach speeds may lead to failure to give way type collisions</p> <p>The A143, east of the development access, has a slight rolling vertical crest curve, with a raised verge area along the southern side of the A143. This may reduce the side road visibility to the right from the</p>	It is recommended that adequate side road visibility is provided, consistent with free flow approach speeds.	<p><b>Drawing ZA921-PL-SK-006-P02</b> has been prepared to demonstrate that vertical visibility is achievable to the site access and proposed crossing points.</p> <p><b>Drawing ZA921-PL-SK-001-P09</b> shows the updated site access strategy.</p>

It is recommended that adequate side road visibility is provided, consistent with free flow approach speeds.

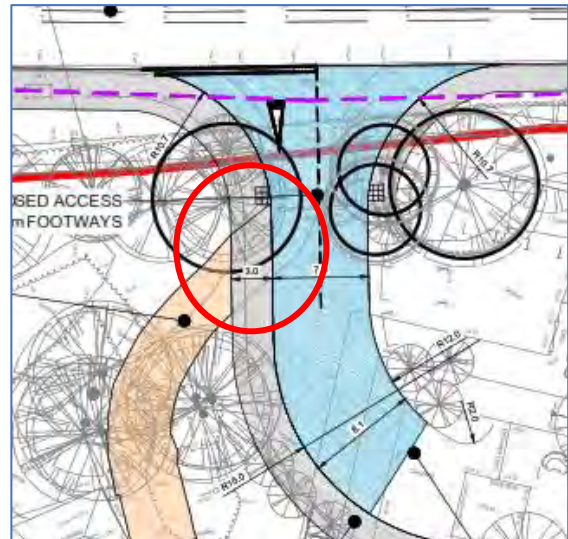
Location: On the development access

The private driveway is located close to the dropped kerb pedestrian crossover and the give way line. This may lead to occasional over-run of the tactile paving and possible damage to paving. It is suggested that the driveway access is relocated further from the crossing area, to provide separation; this would also increase the distance between the give way line and the access.

<b>5. Other Observations</b>				
5.1	<p><b>Location:</b> On the development access</p> <p>The private driveway is located close to the dropped kerb pedestrian crossover and the give way line. This may lead to occasional over-run of the tactile paving and possible damage to paving. It is suggested that the driveway access is relocated further from the crossing area, to provide separation; this would also increase the distance between the give way line and the access.</p>		<b>Noted:</b> The location at which the private drive meets the site access road has been moved away from the site access junction with the A143. The private drives access will be used very infrequently as the property has another driveway to the west which is their principle access.

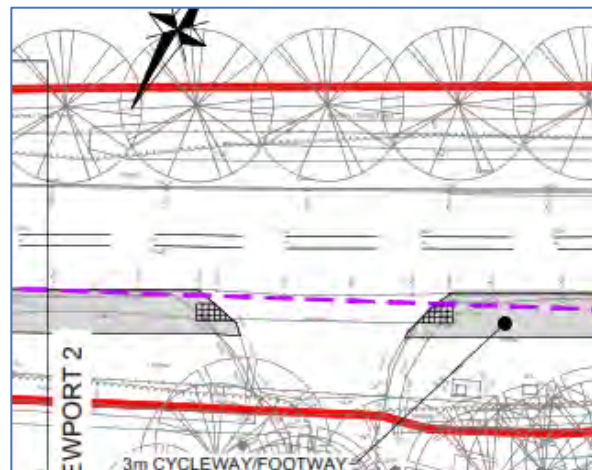
Location: Driveway off A143

The driveway is shown as a fully kerbed access. It would appear to be a single property access and it may be appropriate to provide this as a dropped kerb crossover, to remove the need for tactile paving.

5.2	<p><b>Location:</b> Driveway off A143</p> <p>The driveway is shown as a fully kerbed access. It would appear to be a single property access and it may be appropriate to provide this as a dropped kerb crossover, to remove the need for tactile paving.</p>		<b>Noted:</b> The updated scheme removes the need to cross this side road.

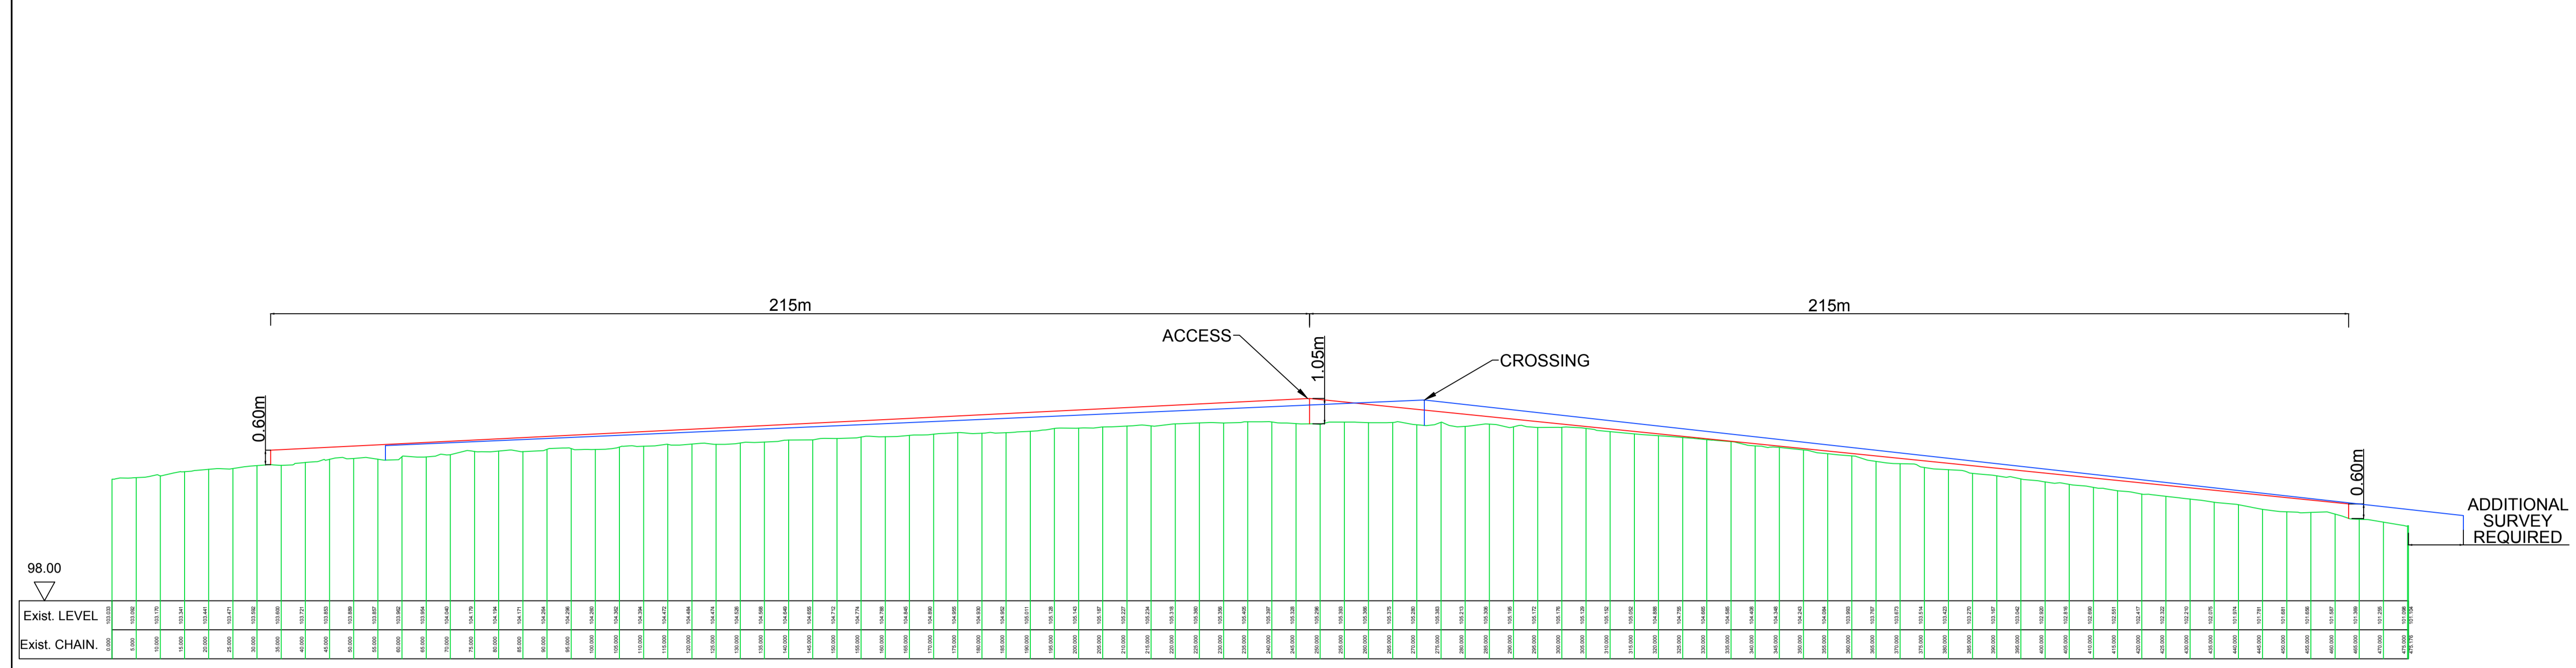
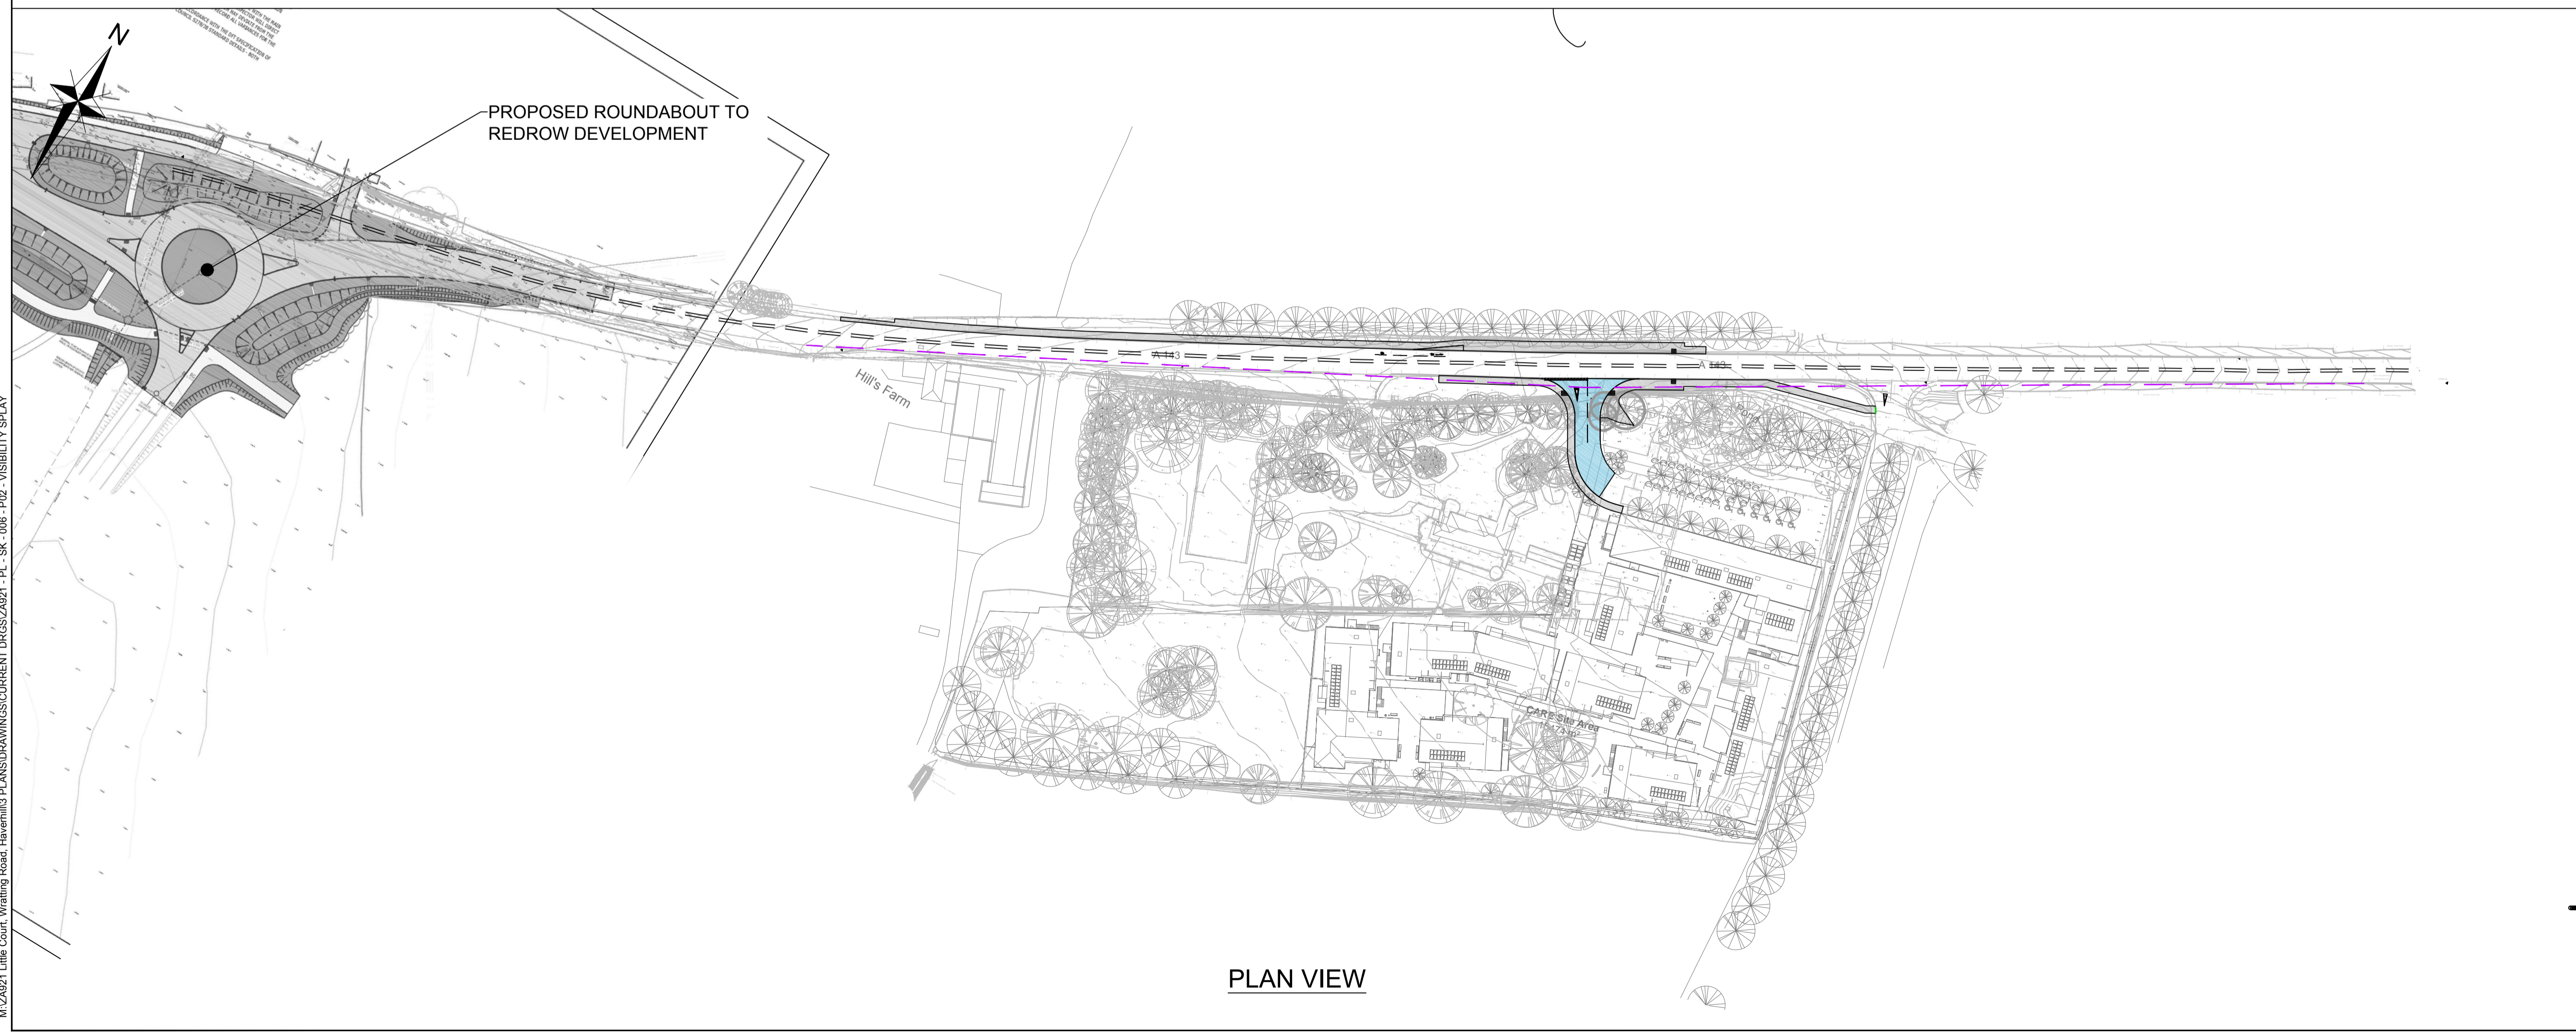
DRAWING NUMBER	REV.
ZA921 - PL - SK - 006	P02

**SECTION 1**  
Horiz. 1:500 Vert. 1:100

**SECTION ALONG SOUTHERN CHANNEL LINE**  
VERTICAL ALIGNMENT SCALED UP BY 5

P02	CROSSING REMOVED	-	DP	-	08/2021
P01	PROPOSED CROSSING VISIBILITY SPLAYS ADDED	-	DP	-	05/2021
REV	DESCRIPTION	DE	DR	CH	DATE
DESIGNED BY	DRAWN BY	CHECKED BY			
-	DP	-			
SCALE @ A1 SIZE		DATE			
D.N.S.		29/07/2021			
PROJECT TITLE					
LITTLE COURT, WRATTING ROAD, HAVERHILL					
DRAWING TITLE					
VISIBILITY PLAN					
CLIENT					
CARE (LITTLE COURT) LTD

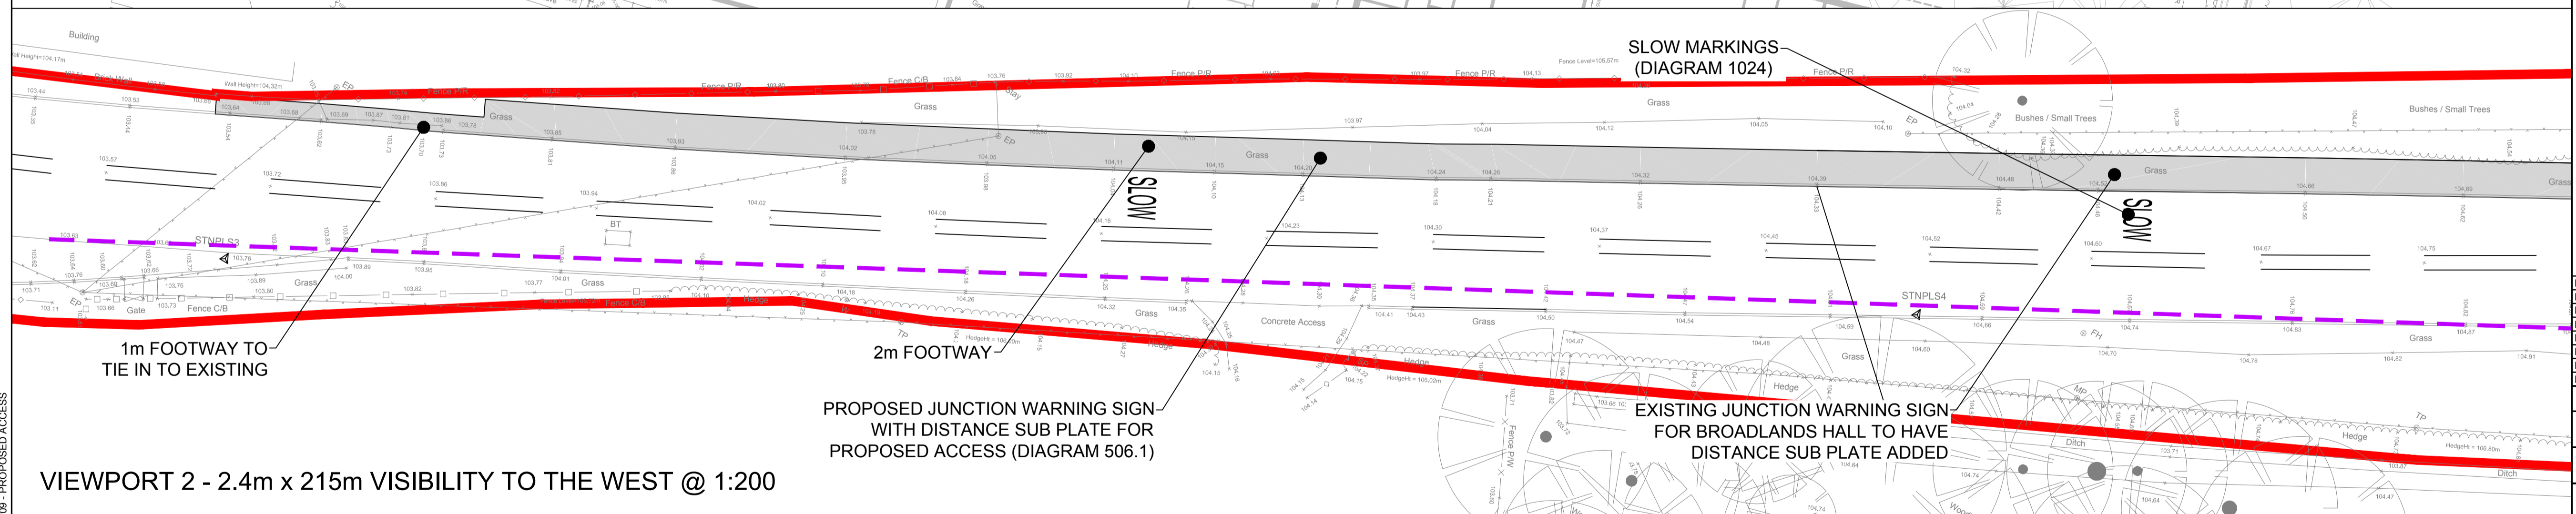
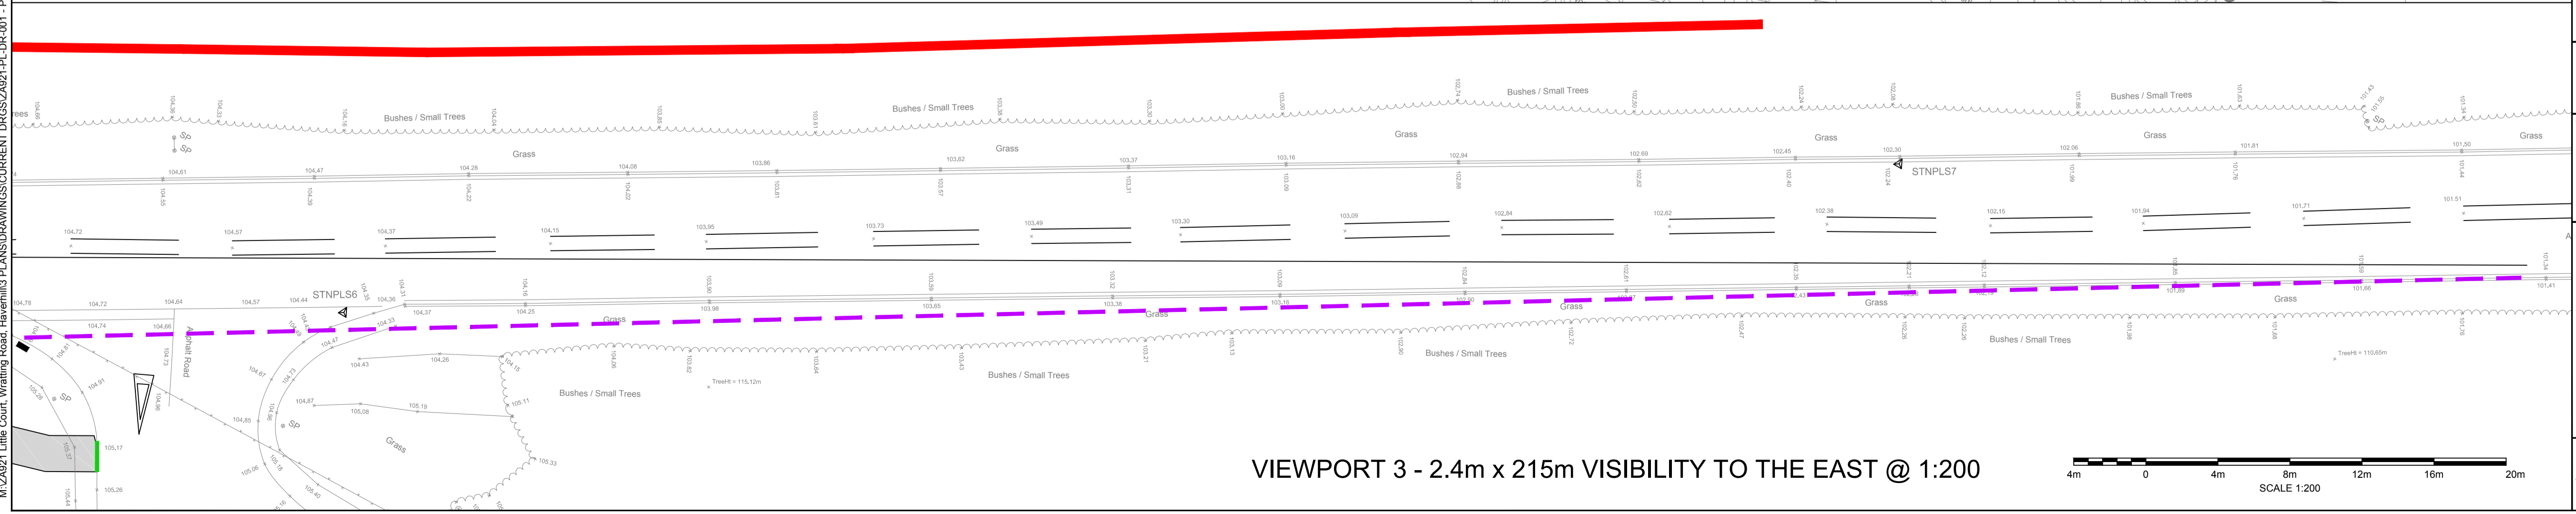
DRAWING NUMBER ZA921-PL-DR-001	REV. P09
-----------------------------------	-------------

KEY	
	VISIBILITY SPY (2.4 x 215m)
	HIGHWAY BOUNDARY
	DROPPED KERB

4.2.2	<p><b>Location:</b> On the A143, eastbound approach to the development access</p> <p><b>Summary:</b> High approach speeds may lead to late braking type collisions</p> <p>The alignment of this section of the A143 is relatively straight and vehicle speeds appeared to be high. Vehicles making a main road right turn may be vulnerable to late braking rear shunt type collisions.</p>	It is recommended that improved advanced warning of the location of the development access is provided. Measures may include but not be limited to providing a flag type sign at the junction, a diagram 506.1 junction warning sign and 'SLOW' carriageway marking to diagram 1024. (There is an existing junction warning sign for the adjacent side road, and this may need to be relocated as part of this recommendation).	<b>Noted:</b> Additional signing and road markings will be provided. See Drawing ZA921-PL-SK-001-P09.
