**CHURCHILL RETIREMENT LIVING LIMITED**

**PLACE COURT CARE HOME, CAMPS ROAD, HAVERHILL, CB9 8HF**

**DESK STUDY APPRAISAL**

November 2015  
Report No. CCL02775.BZ62

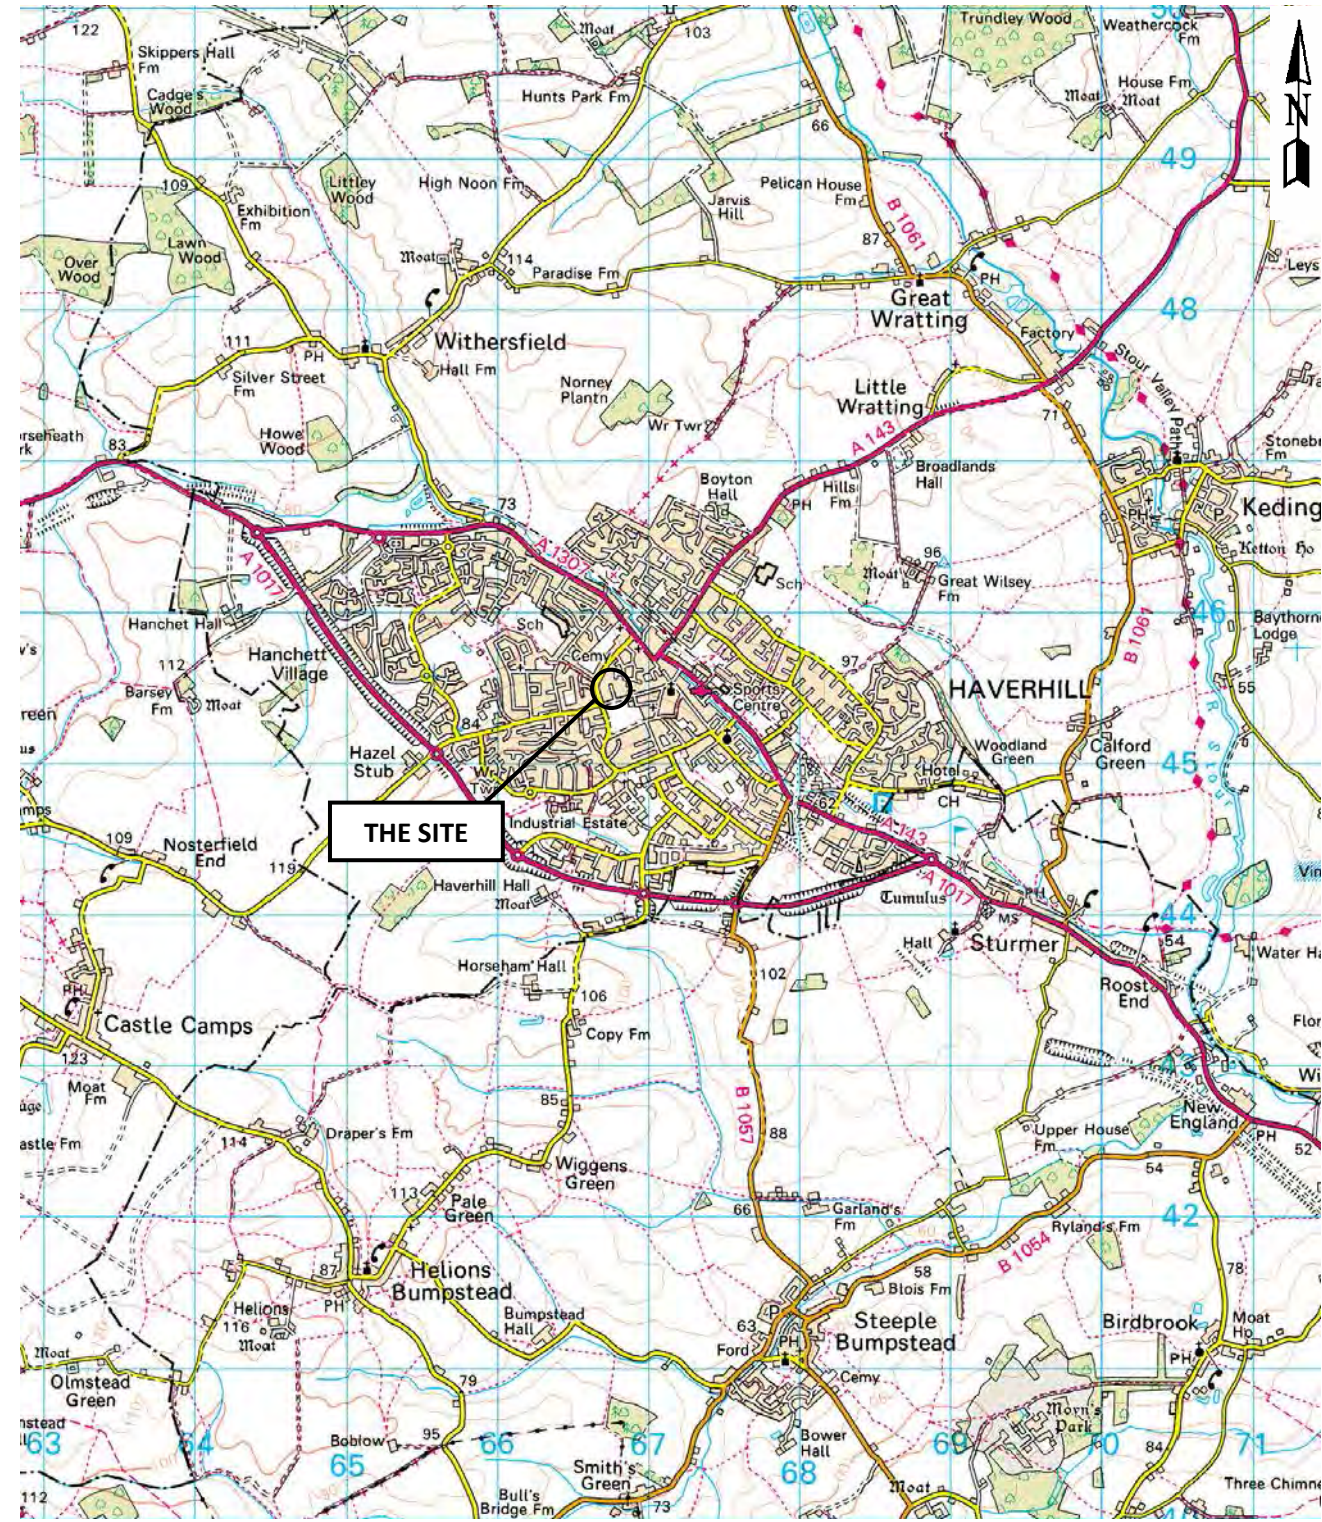
FIGURE 1

**SITE LOCATION PLAN**

The site is located to the North of Camps Road, approximately 0.5 km to the west of Haverhill town centre, as shown on Figure 1. The National Grid Reference for the site is TL 6676 4549. The site boundaries are defined by Crowland Road to the west, a school to the north, and Haverhill Methodist Church to the east, as shown on Figure 2. The southern boundary is marked by Camps Road, with a recreational ground opposite. The area around the site is noted to be predominantly residential in nature.

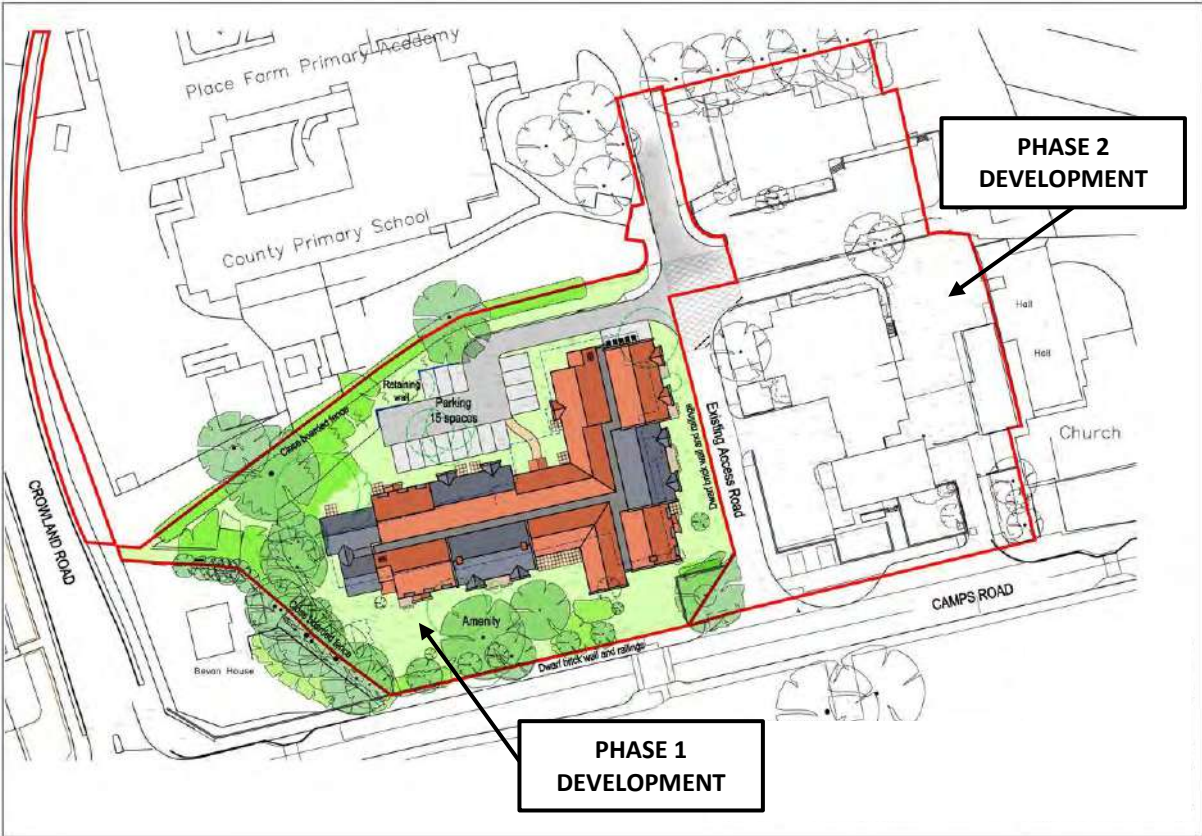
FIGURE 3

**PROPOSED DEVELOPMENT PLAN**

Churchill Retirement Living Limited proposes to redevelop a site at Place Court, Camps Road, Haverhill for residential purposes. The site has been divided into two sections; development proposals have been prepared for the western half of the site (Phase 1) and a future residential development may be located in the eastern section (Phase 2). Place Court Care Home is currently situated on the western section while Council buildings including an ambulance station, magistrate's court and day care centre extend across the eastern section of the proposed site. Historically, the site included farm buildings associated with Place Farm. The proposed development is to include a block of apartments together with associated car parking and landscaped amenity areas. The development will be for people of retirement age.
