Our Ref: JBA 17/364 ECO07 SR

30th October 2020

RE: Water Vole (*Arvicola amphibius*) Habitat Assessment – Haverhill Relief Road

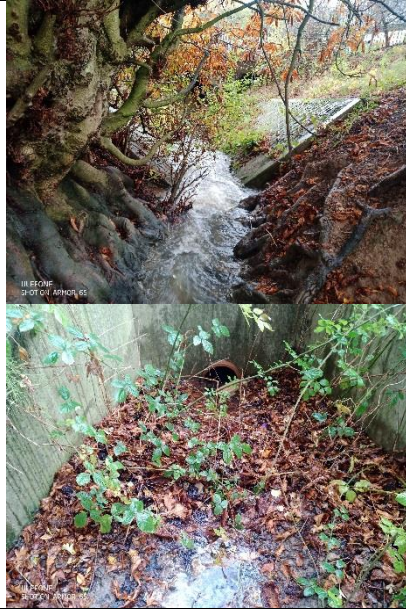
The western watercourse is a moderate to fast flowing stream which runs north along the western boundary of the site, from under Hales Barn Road via a culvert. The immediate area adjacent to the culvert is considered unsuitable for water vole burrow creation due to concrete banks present and a covering of thick tree roots, with limited digging substrate. There is also minimal vegetation for foraging in this area; dominated by common nettle (*Urtica dioica*). See Appendix A for watercourse photographs.

Habitat adjacent to culvert:

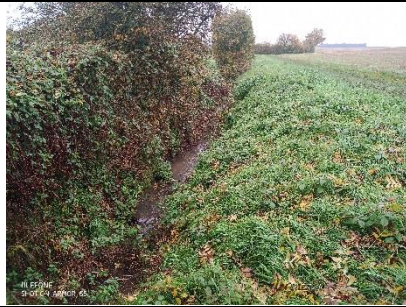
After ~115m the banks become vegetated on the eastern bank with grassland species such as smooth meadow-grass (*Poa pratensis*) and Yorkshire fog (*Holcus lanatus*) which are suitable food sources for water vole, although variation is limited. However, the bank sides are less steep in this area (~45°), whereas water voles prefer, though not limited to, steep banks for burrow creation. No aquatic vegetation was observed in the watercourse.

Suitable habitat ~115m from culvert:

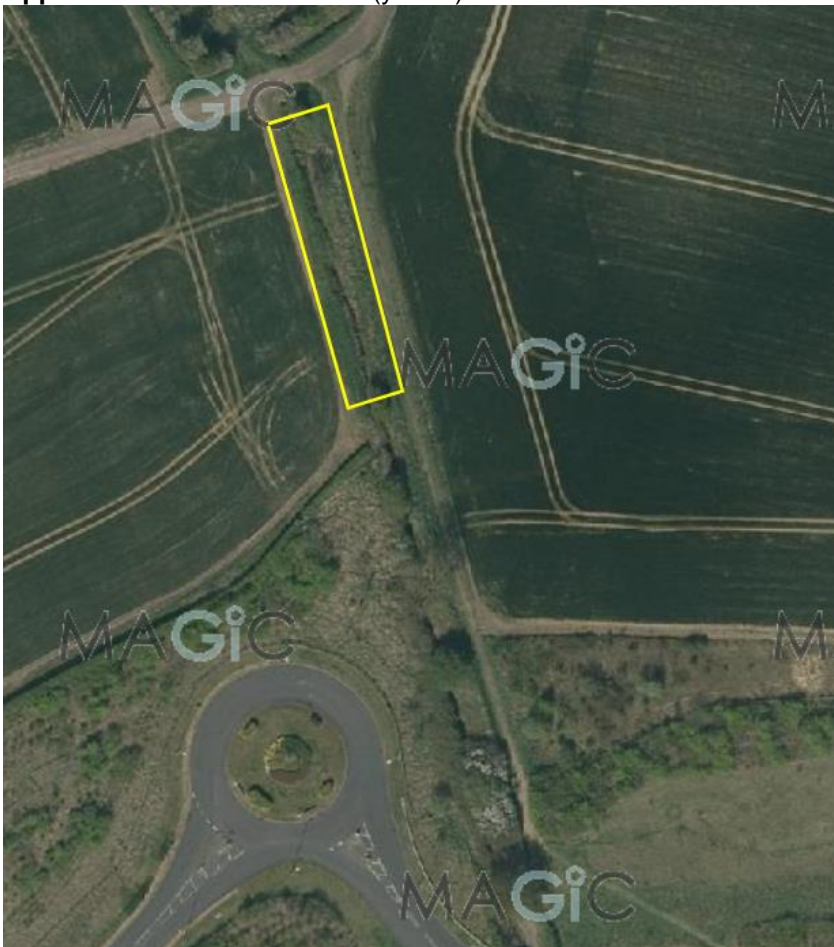
Appendix B – Suitable habitat (yellow)

The archaeology works will be undertaken at least 5m from the watercourse, it is therefore considered that there are no constraints for this work with regards to water voles. The proposed relief road footprint is approximately 35m from suitable water vole habitat and therefore no further surveys are considered necessary. However, if works come within 10m of the suitable habitat, then works should be undertaken under the supervision of an experienced ecological and reasonable avoidance measures may be required. See Appendix B for the suitable habitat location.

Majority of the watercourse at the western boundary of the site is considered suitable or sub-optimal for water vole. The archaeology works will not be working within 5m of the watercourse and therefore can continue without causing any significant impacts to the watercourse in relation to water vole. The proposed relief road development is unlikely to come within 10m of the suitable water vole habitat; however, works within 10m of the suitable habitats (if required) will be undertaken under the supervision of an ecologist.
