6.0 HOLISTIC DESIGN STRATEGY

ARBORICULTURE

ECOLOGICAL SURVEYS

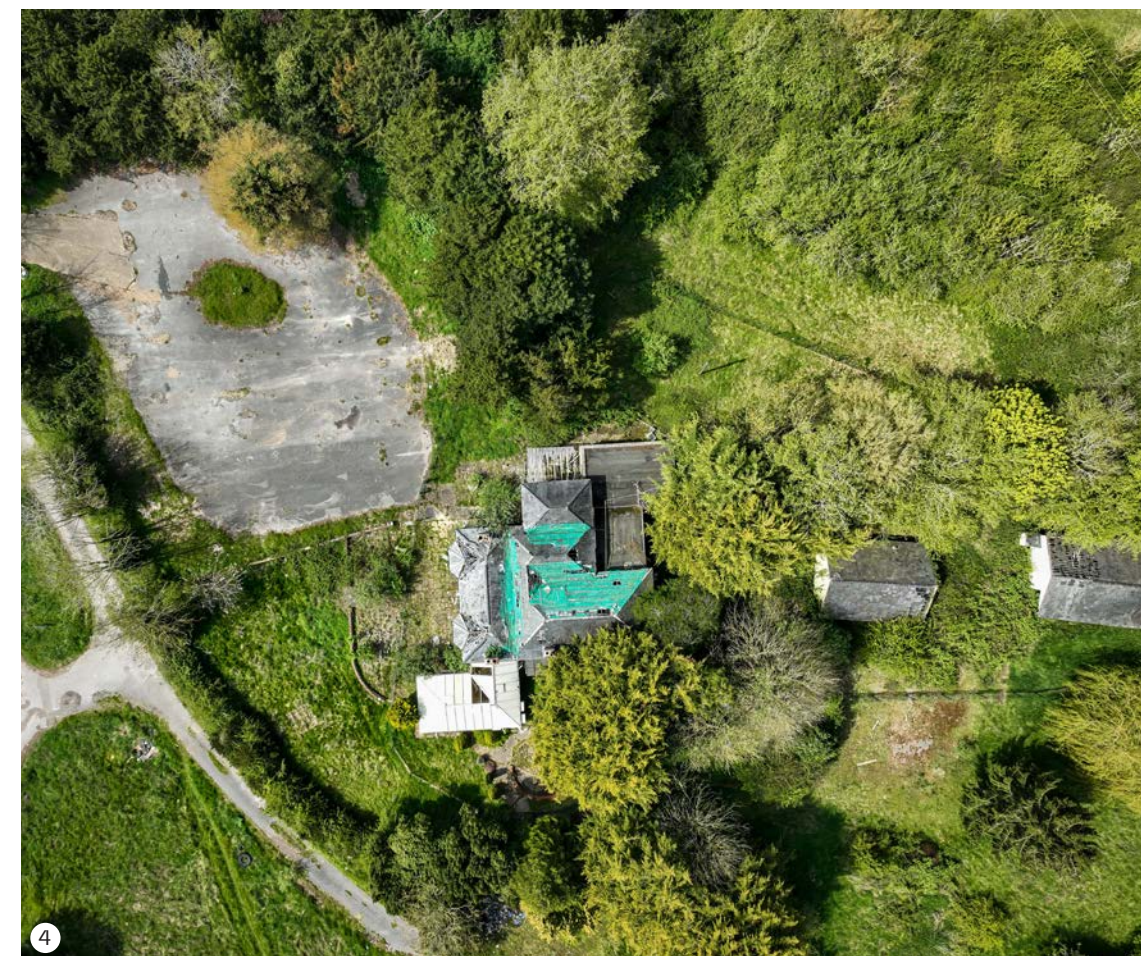
Site plan with tree survey
 1 2019 Pre-app
 2 2020 Pre-app
 3 2022 Pre-app
 4 Photograph, aerial view

An arboricultural survey was carried out in 2022. The findings were mostly the same as those from a survey in 2019, although the Cherry tree in the existing car park was downgraded to Category U.

Previously, several trees from the band of Yew at the front of the site were proposed to be removed. The current proposal is more sensitive to this band of trees and the car park has been reconfigured to maintain as much as possible.

The arboriculturalist advised that the row of Ash trees at the front of the site along the roadside are now in greater decline, with less than 5 years life expectancy. The advice therefore is to remove and replant, whereas previously it was to retain and plant new alongside.

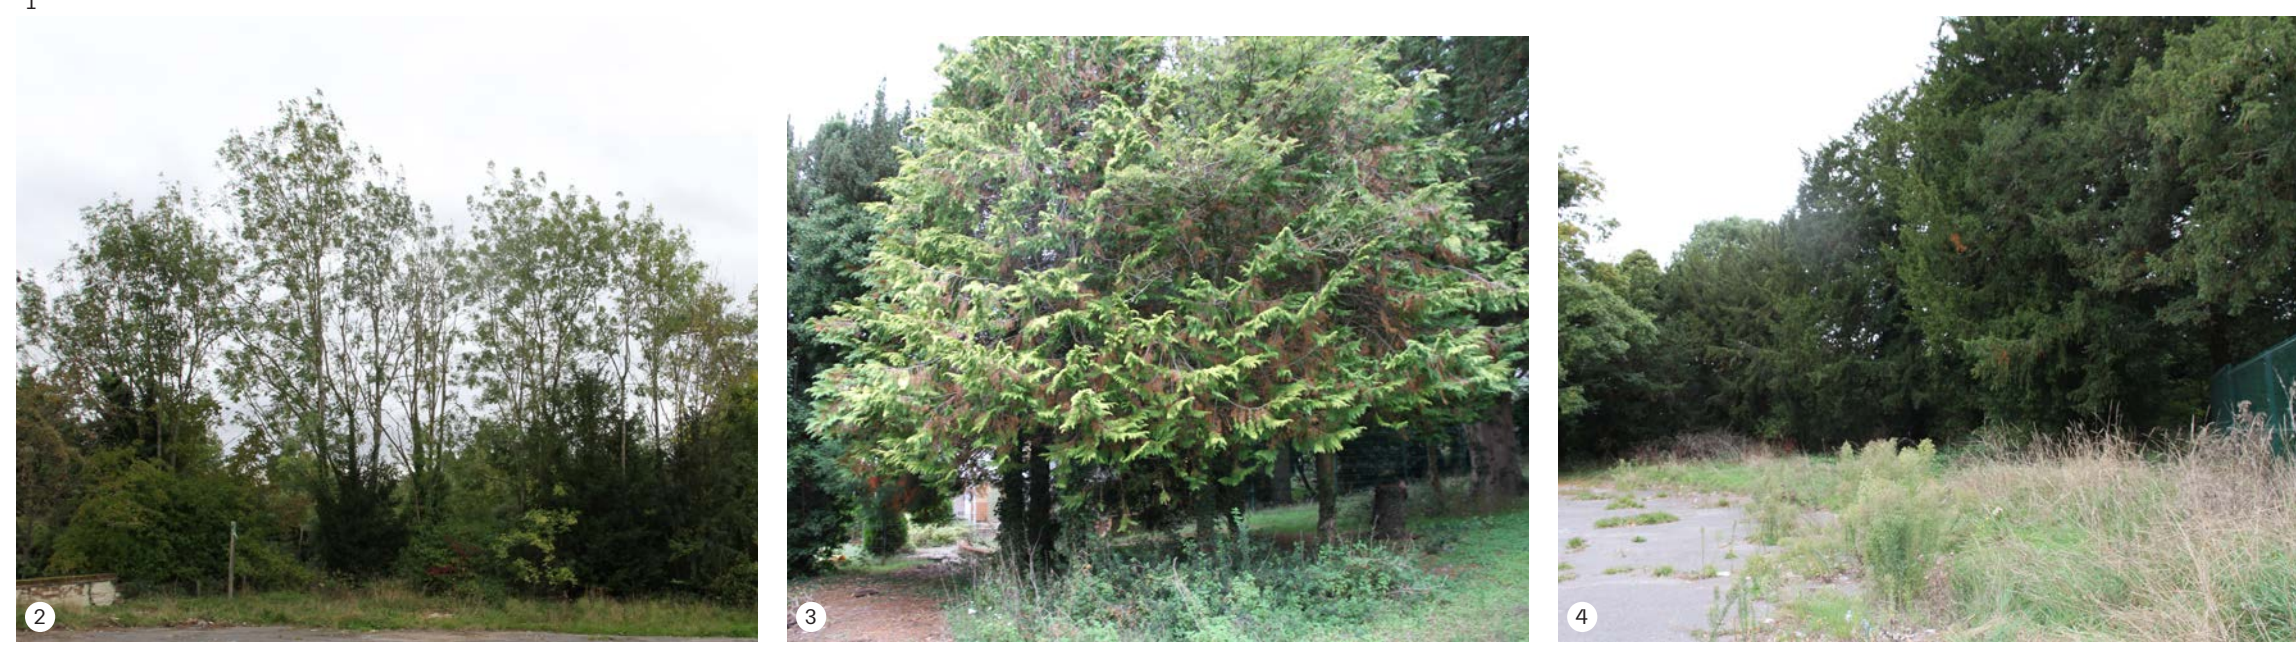
- Site plan with tree survey
- 1 2023 Planning application
 - 2 View A, row of Ash trees at front of site
 - 3 View B, group of Cypress trees
 - 4 View C, band of Yew trees

Mitigation for the removal of trees will come in the form of an extensive landscape plan that will also include general works to existing vegetation and trees so as to bring the site back into a reasonable state of management. Such works will include crown lifting, crowns reductions, creation of new areas within inaccessible areas of trees/ scrub and any general health and safety works required. It is recommended on any approval a full work specification be undertaken once initial scrub clearance and tree removals have taken place.

Overall the landscape scheme will replace tree numbers and improve the overall species numbers whilst allowing better quality specimens to be managed for the long term future.

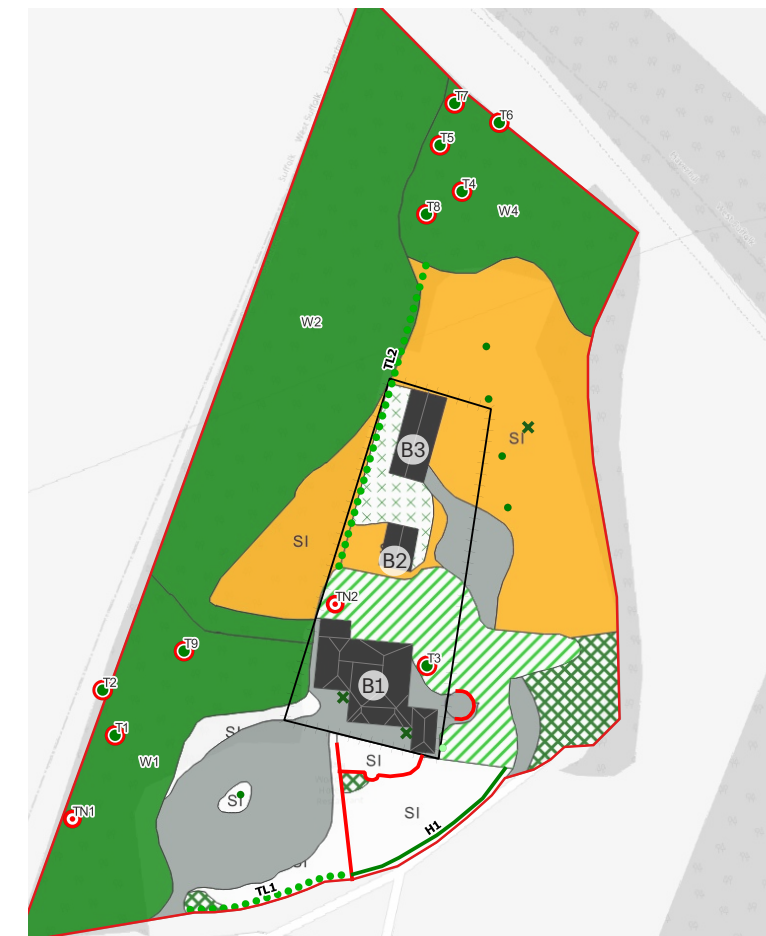
The following provides a summary of the ecology surveys carried out by FPCR in 2022. A Phase 1 Habitat Survey was undertaken on 24th August 2022 by an experienced ecologist with a FISC Level 4. Situated to the east of Haverhill, the dominant habitats comprise neutral semi-improved grassland and semi-natural broadleaved woodland. Other habitats present include coniferous woodland plantation, poor semi-improved grassland, a hedgerow, a treeline and areas of dense / continuous scrub, scattered scrub, and hardstanding / buildings.

The western (W1 & W2) and northern (W4) sections of the site consisted of three areas of seminatural broadleaved woodland. The woodlands were dense with generally semi-mature trees and varied ground flora. Bramble *Rubus fruticosus* agg. was mostly dominant throughout the understorey which was generally sparse, consisting of hawthorn *Crataegus monogyna*, elm sp *Ulmus sp.*, or blackthorn *Prunus spinosa*. A target noted (TN1) coppiced beech was noted within W1 during the survey due to the presence of a bird box upon its trunk.

Two treelines were present on site, TL1 & TL2, consisting of a range of species of young to mature age.

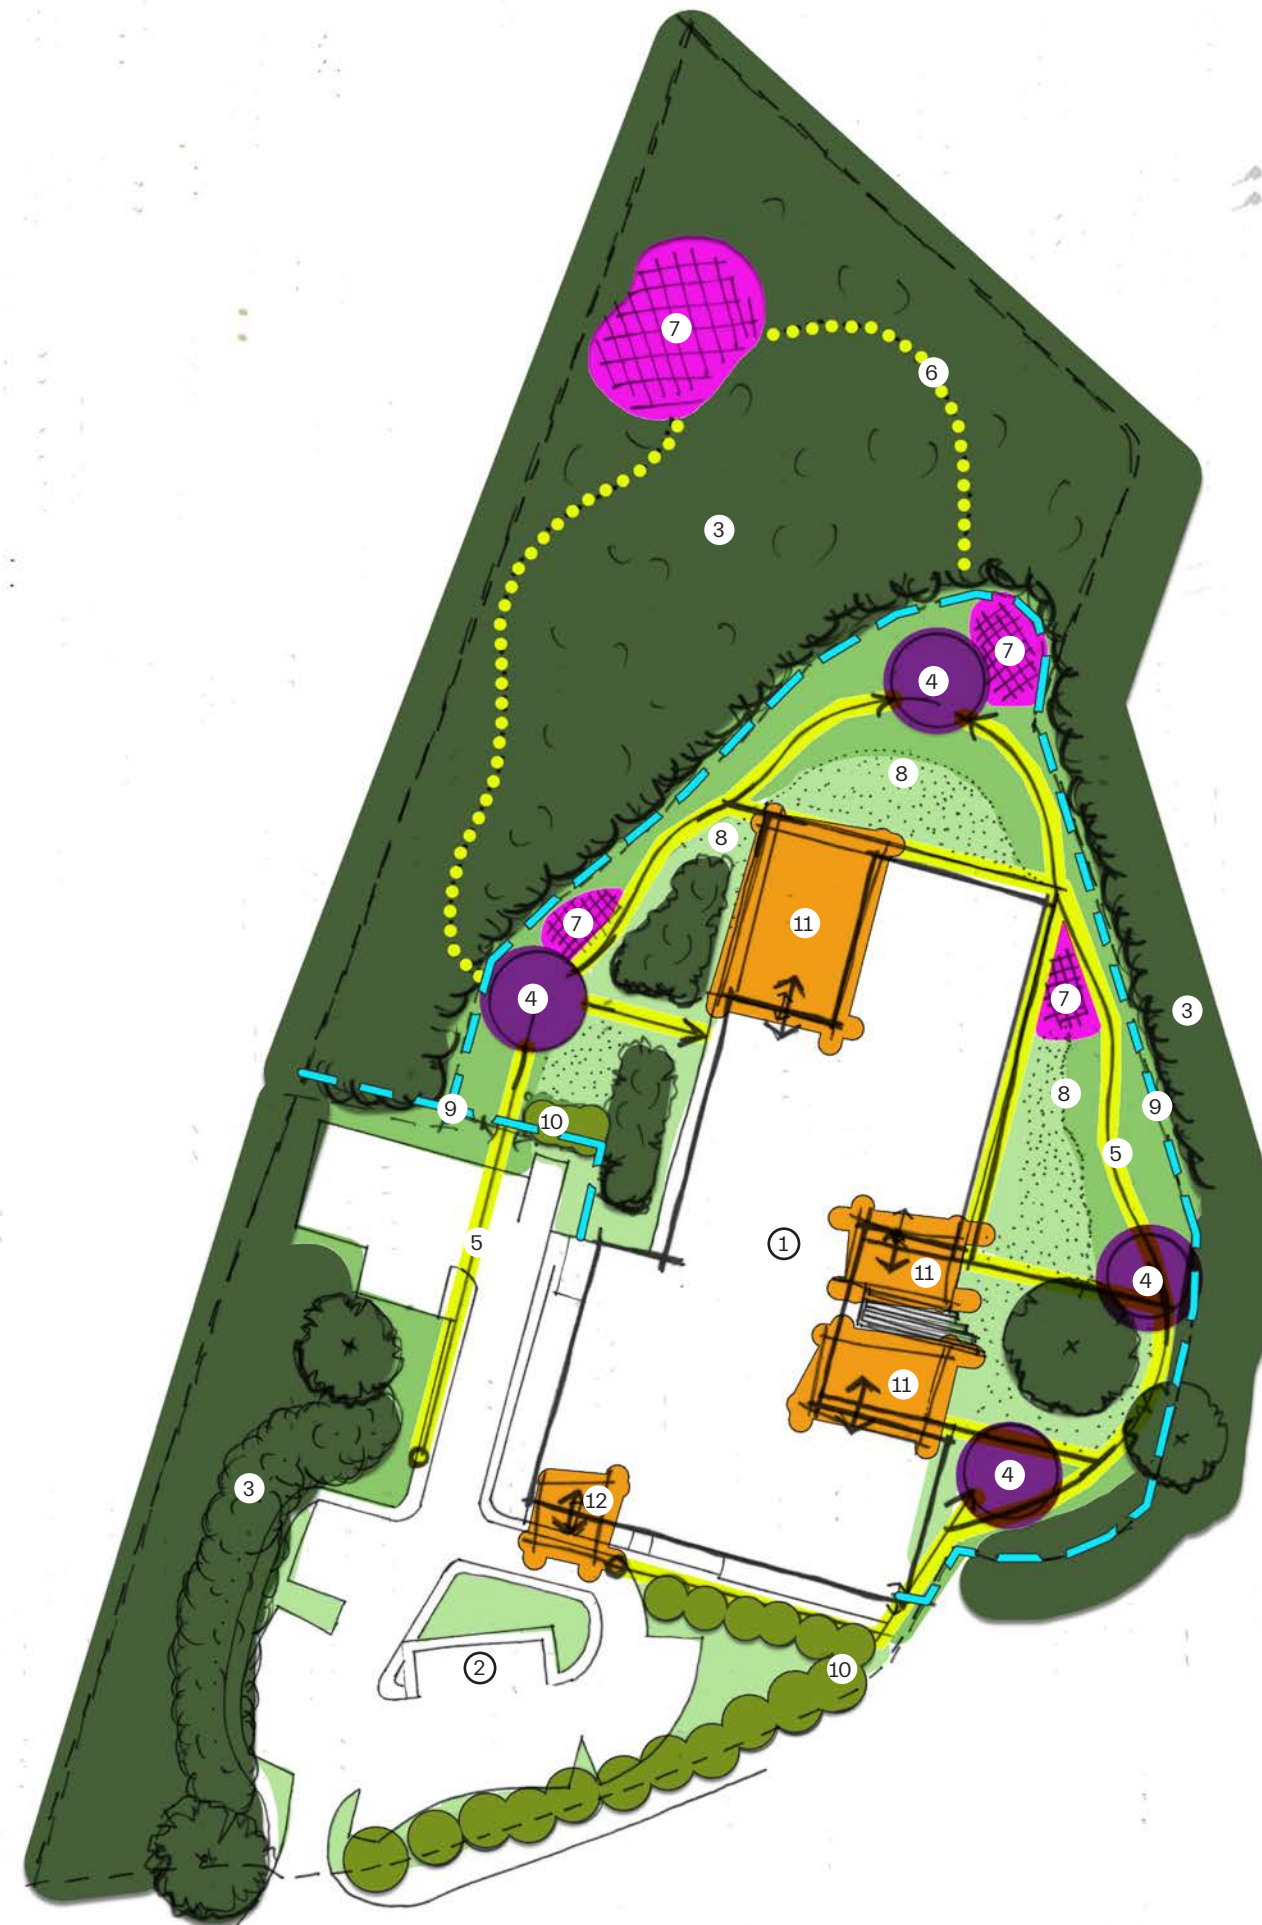
LANDSCAPE DESIGN CONCEPT PLAN

These are arranged simplistically, with looped routes to the north, east and west of the garden. The footpaths connect destination points such as allotments, sheds, seating, greenhouses and features for attracting wildlife.

An avenue of trees at the front of the building leads to the eastern garden access. These trees will have a compact, upright form which responds to the external cladding of the building and maintains views of the façade. On the western side, there is a pathway from the car park into the garden. This visual connection is important as it is the only aspect where views from the garden are likely, given the amount of boundary tree planting.

This is an existing high-quality feature of the site - by limiting access to the woodland and enhancing the species variety and sizes, there will be positive benefits. Additionally, drainage in the northern area of the woods (dependent on levels and existing vegetation, will require careful consideration for the safety of residents using this area. The woodland area also offers many opportunities to include habitat piles, wildlife boxes and hibernacula for habitat and ecological enhancements.

The addition of an above ground drainage system will bring a more varied range of habitats through the inclusion of new, diverse grass and plant species. All drainage features will be designed to ensure they are safe and appropriate for inclusion within a dementia care facility. These above ground systems will create new habitats, provide a sustainable method of water management and add aesthetic and sensory value to the garden.

The grassland will be graded in its formality, having a wide range of species' diversity that is mown at different lengths and will be beneficial for biodiversity net gain. This design will create interest and form a unique edge when compared to the standard form of care home gardens.

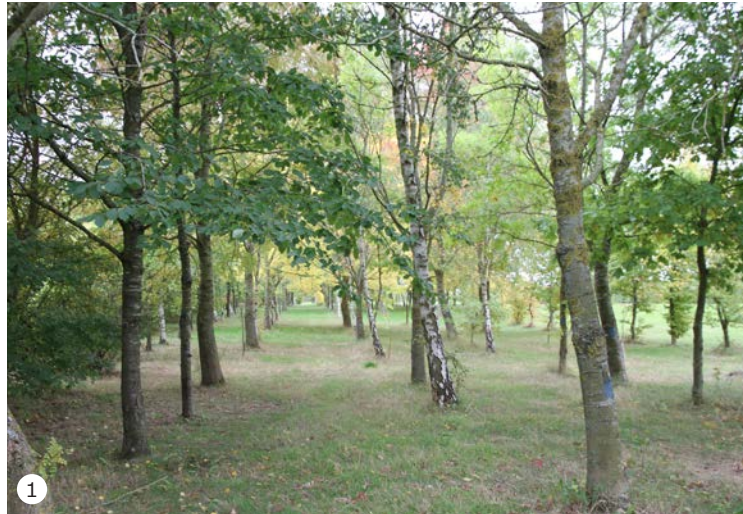
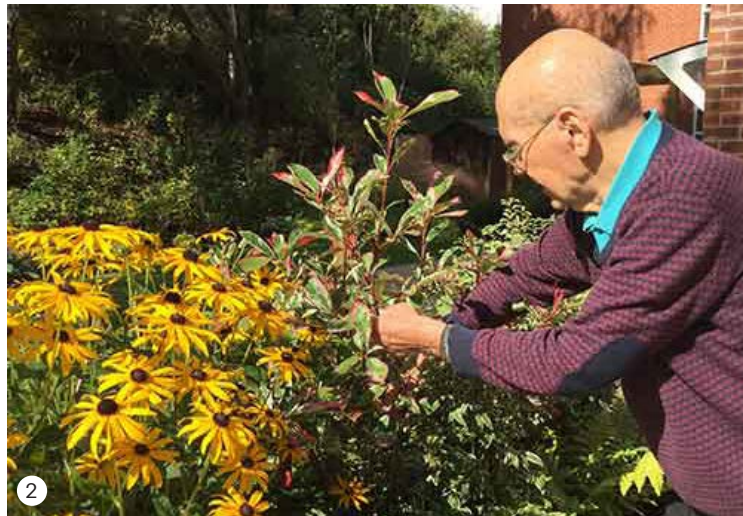
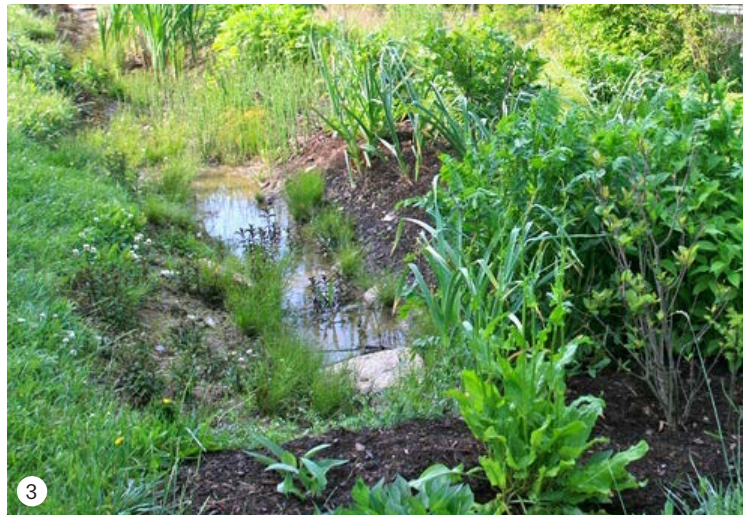
- Photographs
- 1 Newly planted tree avenues
 - 2 Outdoor activities - raised planters
 - 3 Habitat swales
 - 4 Formal footpaths
 - 5 Informal footpaths

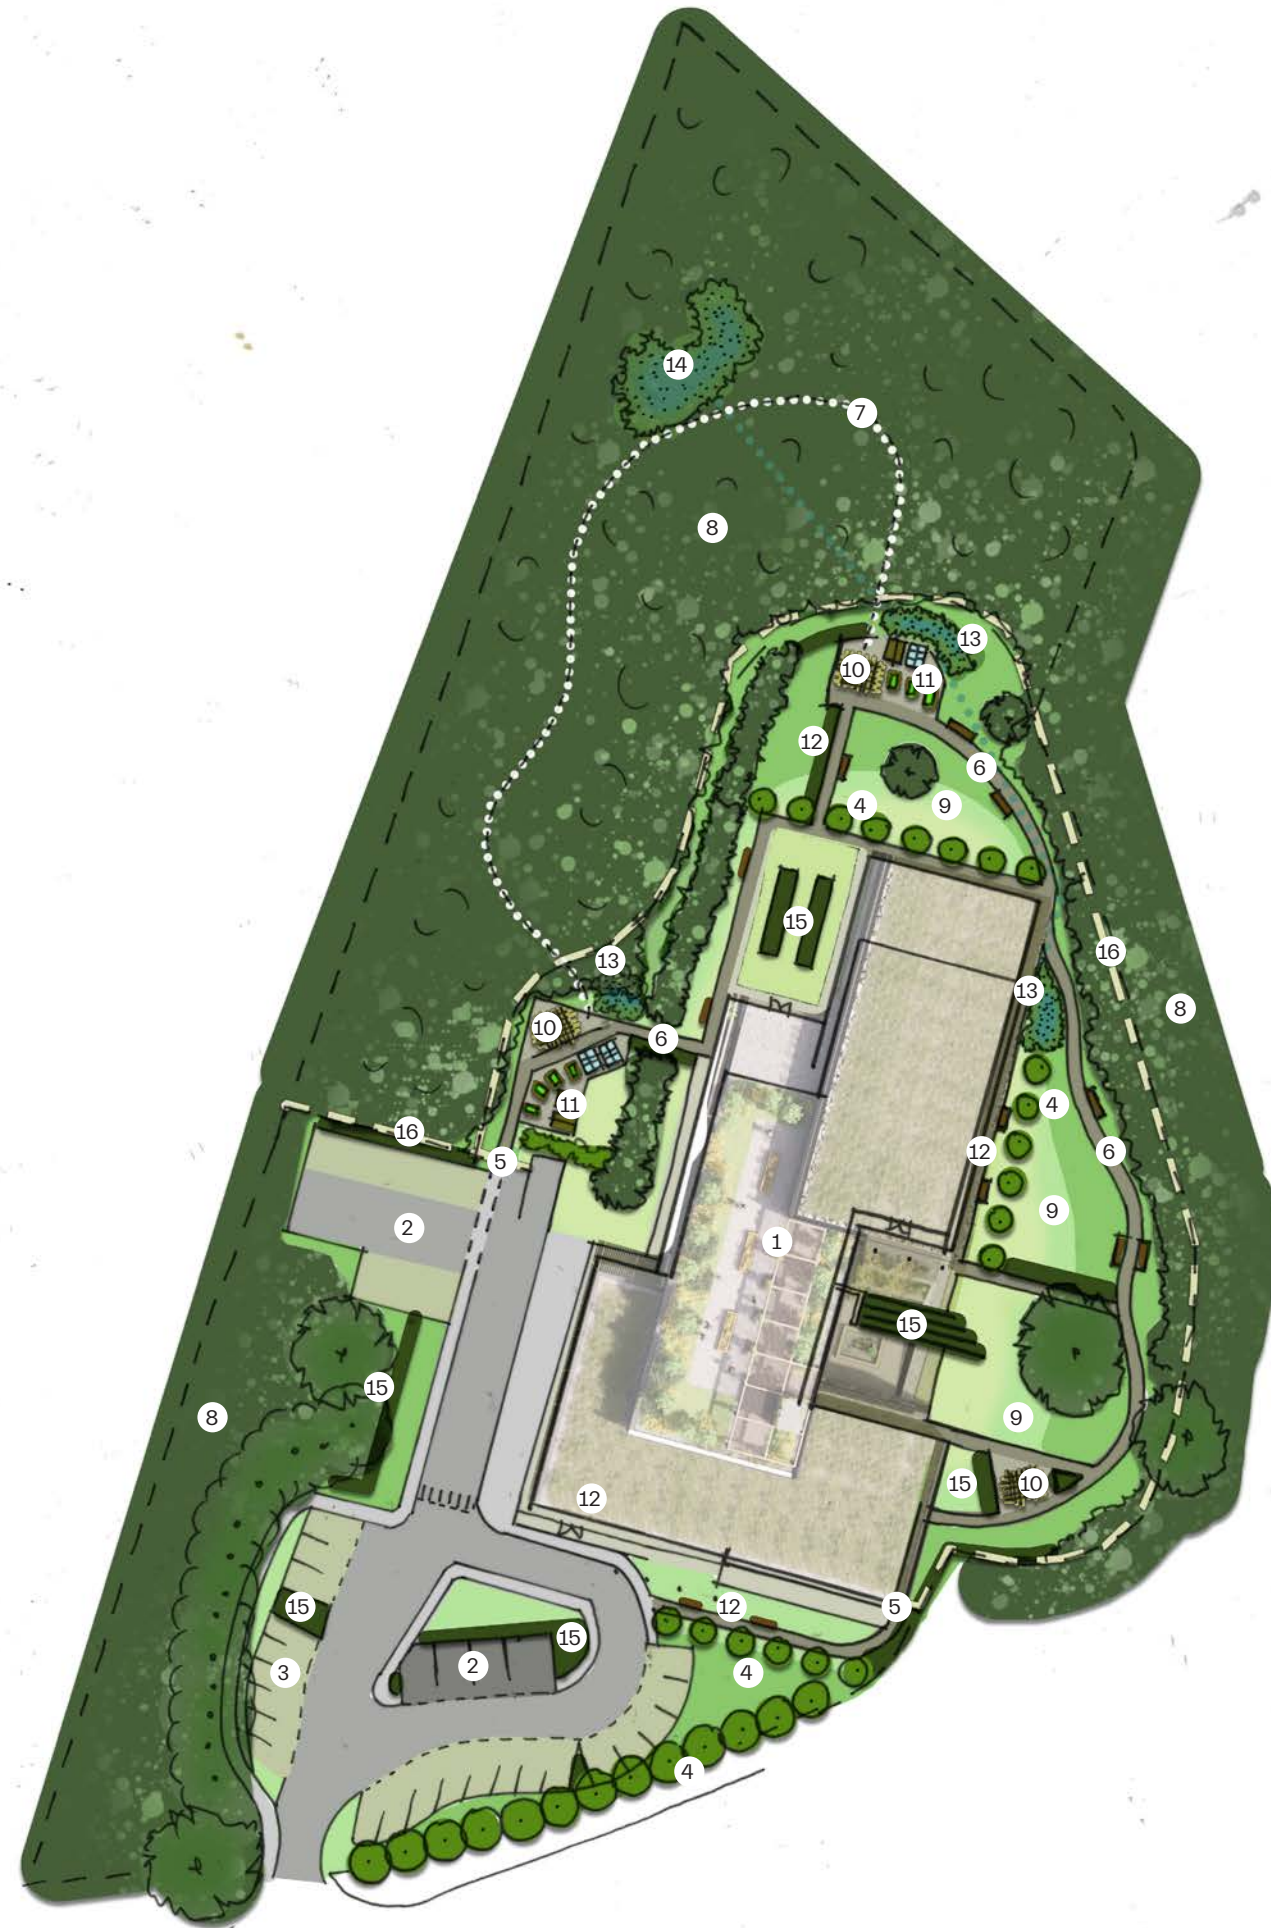
LANDSCAPE DESIGN ILLUSTRATIVE PLAN

- 1 Proposed care home
- 2 Proposed car park
- 3 Porous surface parking bays
- 4 Tree avenues
- 5 External pedestrian and maintenance access to garden
- 6 Single surface garden footpath
- 7 Informal footpath route through woodland
- 8 Existing trees / woodland (retained and enhanced)
- 9 Varied grass mixes and mowing regimes
- 10 Outdoor shelter and seating
- 11 Outdoor activity areas (greenhouse, seating, shelter, raised beds and sheds)
- 12 Seating alongside footpath
- 13 Habitat swales with underground connections
- 14 Wet habitat area (according to levels and vegetation)
- 15 Shrub, grasses and perennial planting
- 16 Secure garden boundary
