## Bat Emergence and Re-Entry Surveys (BERS)

19a Hamlet Road, Haverhill, Suffolk, CB9 8EH

This report is prepared to inform a planning application with West Suffolk Council for the proposal described as:  
“The construction of a building to accommodate two residential units”

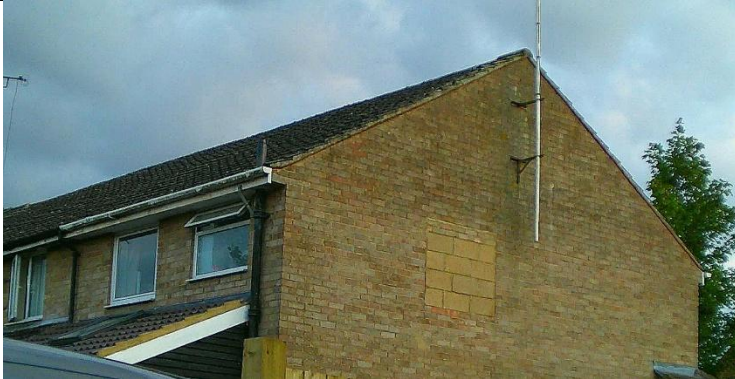
<p><i>IR position 1</i> <i>IR nightfox whisker</i> <i>and XB5 Pro torch</i></p>	<p>Camera position: observing northwest elevation of B1</p> <p>Emergences observed: No</p> <p>No emergences were observed and the footage was in line with the observations of surveyor 1 with no additional activity.</p>

<p>Darkest point of survey from IR position 1</p>
<p><i>Surveyor 2</i></p>	<p><b>No emergences observed.</b></p> <p>The first activity of the survey was a soprano pipistrelle commuting from south-west to northeast over the surveyor, and the adjacent wall at 21:15.</p> <p>The second bat was a common pipistrelle commuting south to north at towards the vegetation north of B1 and turning west away from the property at 21:19.</p> <p>The final bat seen was a common pipistrelle which travelled across the vegetation north of B1 heading south towards the surveyor and following the road south at 21:22.</p> <p>One further soprano pipistrelle and eight further common pipistrelle passes were heard, not seen, between 21:30 and 22:25.</p> <p>No further activity.</p>

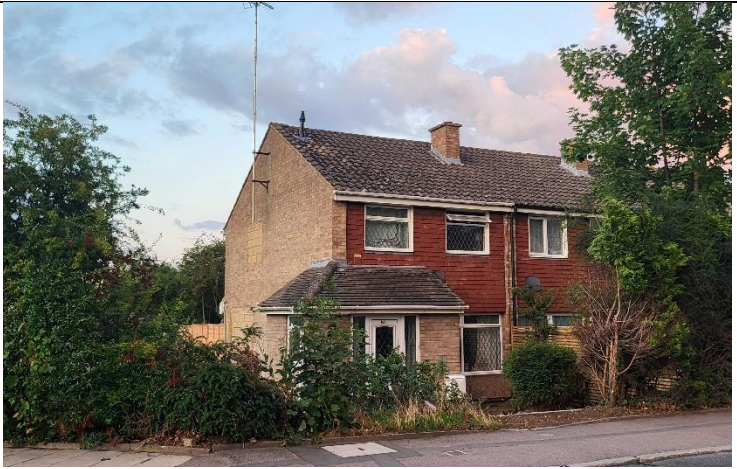
<p>Full elevation photo showing surveyor 2's view.</p>

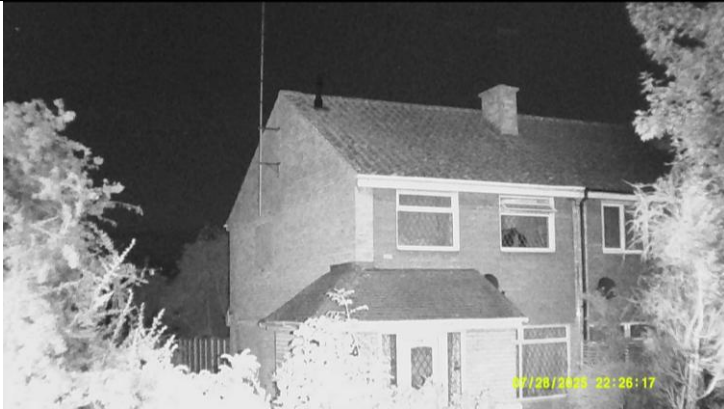
<i>IR position 2</i>	<p>Camera position: observing southwest elevation of B1 Emergences observed: No</p> <p>No emergences were observed and the footage was in line with the observations of surveyor 2 with no additional activity.</p>

<p>Darkest point of survey from IR position 2</p>
----------------------	---	---
