Arboricultural Impact Assessment for Streetly Hall Farm, Horseheath, CB21 4QG

**Arboricultural Report Ref: NWS 2022.095.1_Streetly Hall Farm – AD Plant
August 2023**

Client	Streetly Hall Farm Limited Streetly Hall Farm, Horseheath, CB21 4QG
Site address	Streetly End, West Wickham, Cambridge CB21 4RP
Survey scope	BS 5837:2012 'Trees in relation to demolition, design and construction – Recommendations'
Survey date(s)	14 th December 2022
Report reference	NWS 2022.095.1_Streetly Hall Farm – AD Plant
Principal author	James Allitt L4 Dip Arb (TechArborA)
Quality checked by	Seth Lambiase MCIEEM

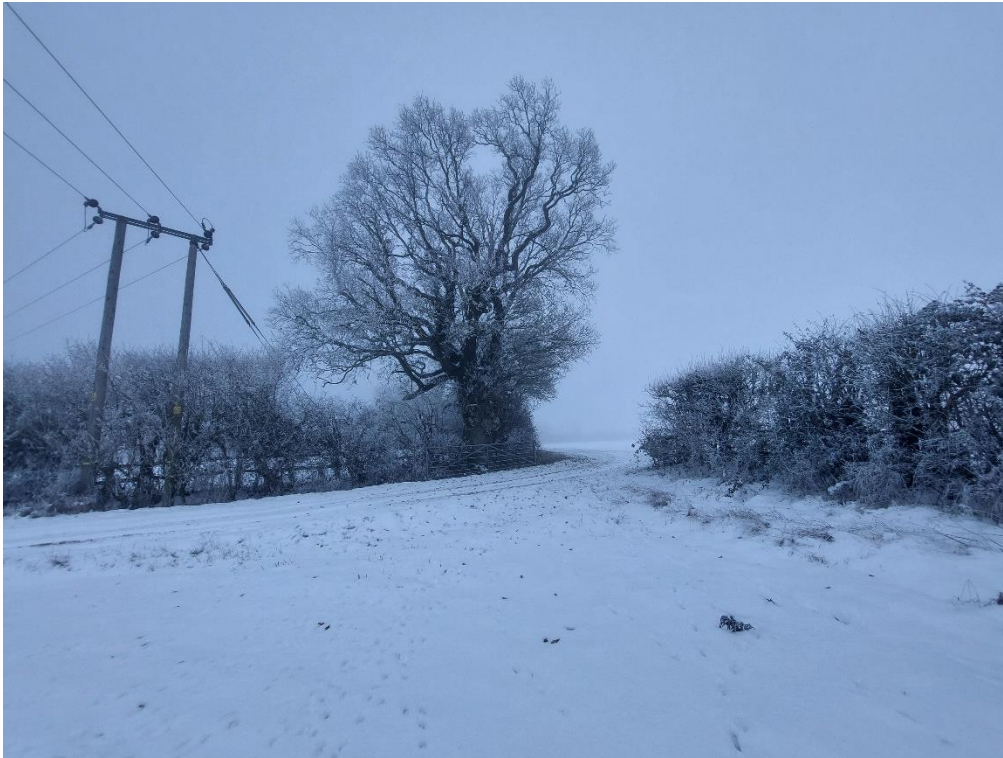
Photo 1: Existing farm track near tree T4.

- Tree T4 is an over-mature oak that grows adjacent to the existing farm track. The upgraded access road needs to be improved by excavating approximately 300mm to provide a stable sub-surface for the increased traffic. Excavating to this depth increases the risk of impacting the long-term health and stability of tree T4 by potentially damaging important roots. To avoid excavating (and therefore prevent long-term impact to T4) a no-dig cellular confinement system is needed to dissipate the anticipated load. The proposed road shall be specified by an appropriate engineer. More information on specifications can be obtained at [Geosynthetics - Home](#).

- Proposed AD plant access is from the A1307. It is anticipated that the loss of 1 or 2 small shrubs from G8 will not impact the aesthetic value or continuity of the hedgerow.
- The upgrading of the farm track has the potential to impact the long-term health of tree T4. A no-dig cellular confinement system is to be designed with the input from an engineer and arboriculturist.
- Tree T5 is at risk from construction activities and shall be protected using adequate barrier fencing to form a CEZ.

- Any work within the RPA of tree T5 will be supervised by the project arboriculturist.
- The no-dig cellular confinement system for the upgrading of the farm track will be designed in conjunction with an engineer and arboriculturist.

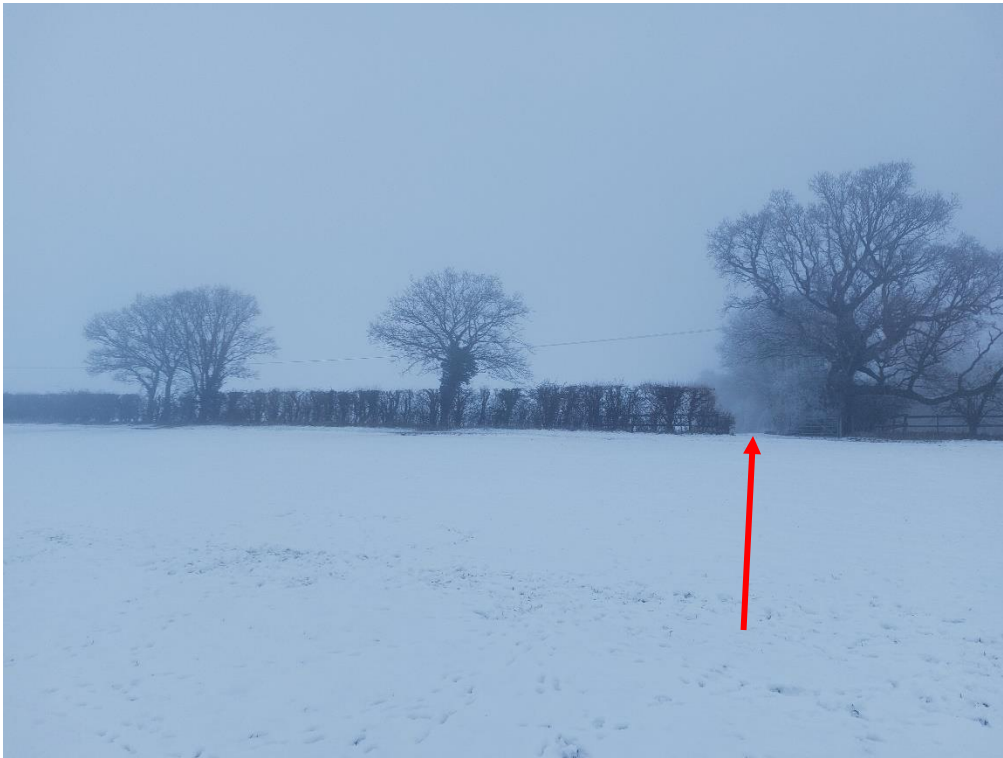
Photo 2: Route of proposed access track adjacent to T4

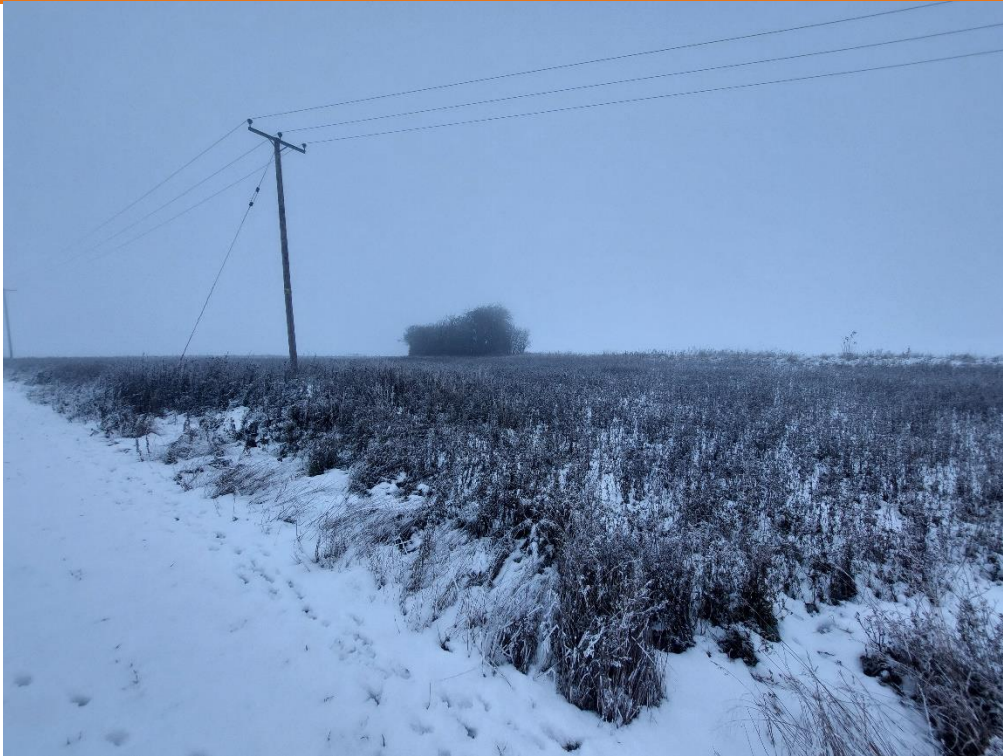
- Tree group G6 – It is estimated to be a distance of 20m between the RPA of G6 and the proposed access road. This is considered a sufficient distance so as not to cause an impact to the long-term health of these trees.

Photo 3: Tree group G6

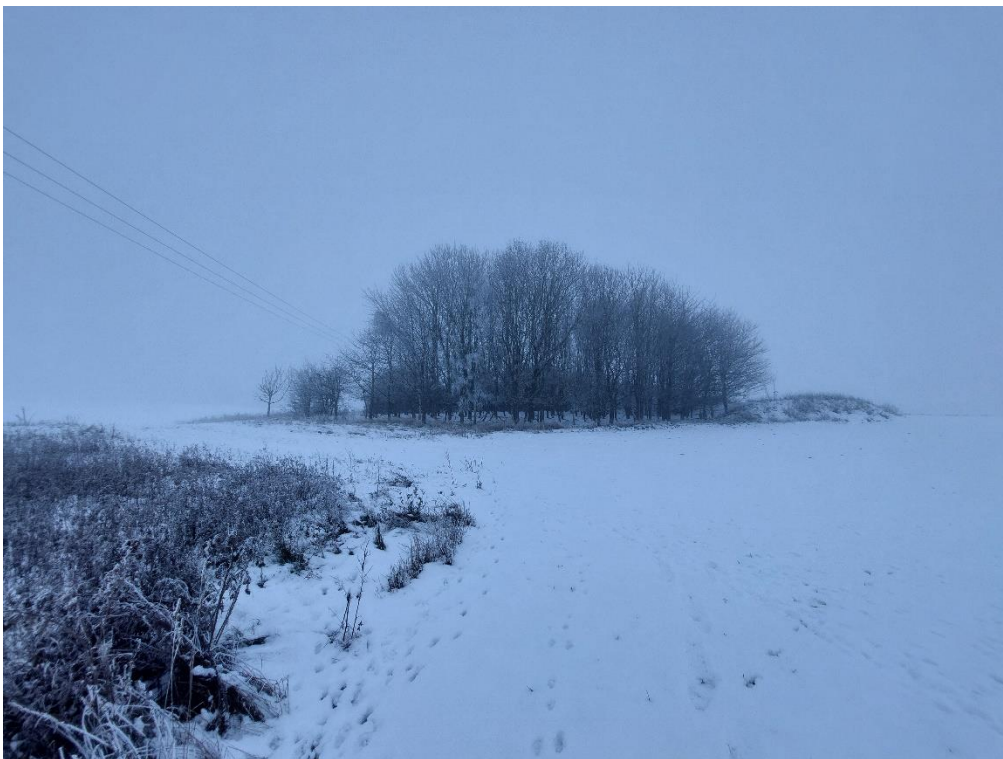
- Tree group G7 - It is estimated to be a distance of 24m between the RPA of G7 and the proposed access road. This is considered a sufficient distance so as not to cause an impact to the long-term health of these trees.

Photo 4: Tree group G7

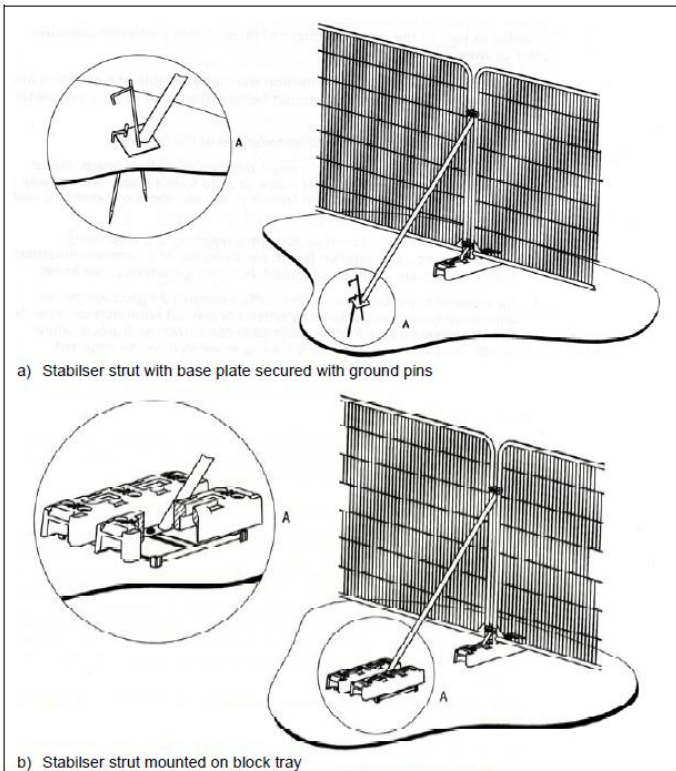
Figure 3: BS5837:2012 Examples of above-ground stabilising systems
