PROPOSED ANAEROBIC DIGESTION FACILITY SPRING GROVE GREEN POWER

Ground Investigation Report
Prepared for: Acorn Bioenergy

SLR Ref: 404.11923.00004.0021
Version No: Final
December 2022

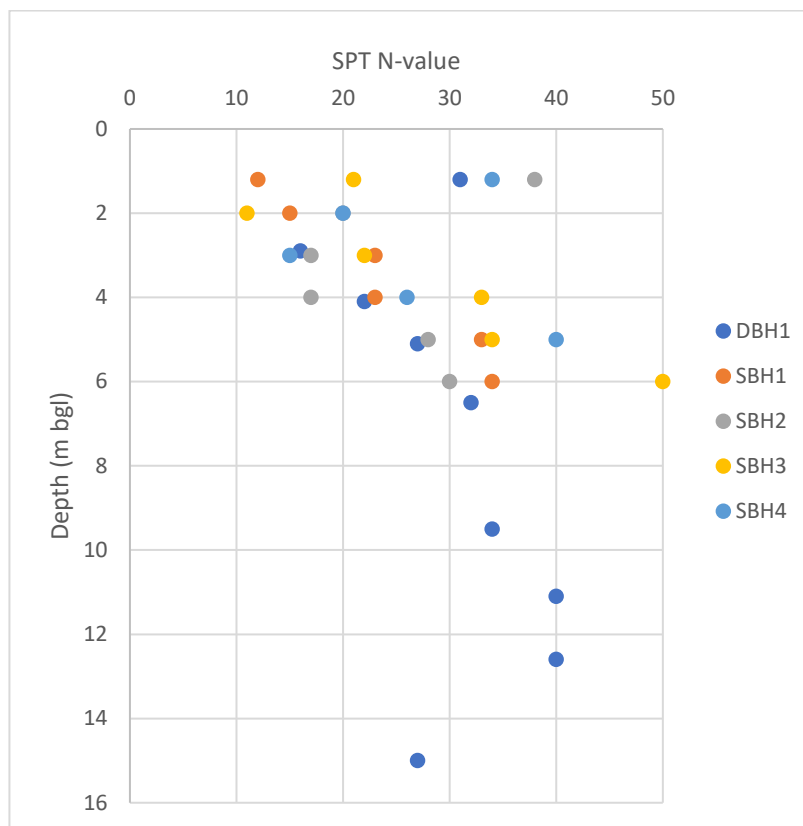
Figure 3-1
SPT N-value with Depth

Tests were conducted within the Lowestoft Formation comprising sandy gravelly clay and resulted in N- values of between 11 and 50. **Error! Reference source not found.** displays an increase in SPT N-value with depth.

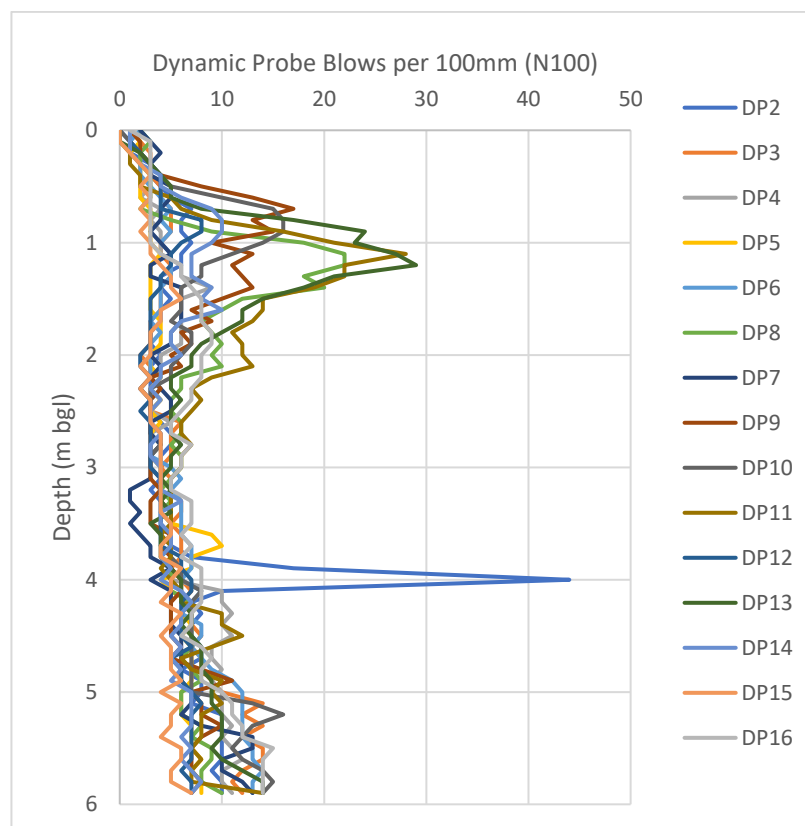
Figure 3-3
Dynamic Probe Blows with Depth

The results of the DPTs are presented in Appendix 05 and Figure 3-3 presents the N100 (number of blows per 100mm increment) with depth. The figure shows that the material across the Site is relatively consistent at each test location and shows a general increase in the N100 with depth. The figure shows a significant increase in the N100 from between 0.5m and 1.5m bgl in several locations and in DP12 at 4m bgl. This is likely due to the presence of gravels and cobbles of chalk and flint within the clay.

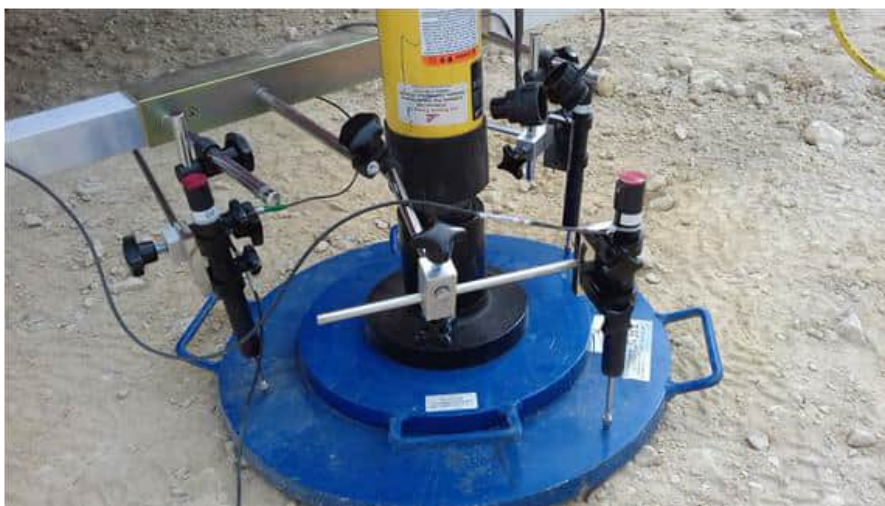
Determination of the Vertical Deformation and Strength Characteristics of Soil by the Plate Loading Test BS1377: Part 9: 1990:4 .1.6.4.2 - Incremental Loading Test

This test is suitable when the drained loading characteristics of the soil is required

In order to decide the loading for the increments, an initial estimate of the likely maximum load to be applied is obtained during the contract review stage with the client. At least five approximately equal spaced increments are then applied cumulatively to the plate. Each increment shall not be more than 1/5th of the proposed designed bearing pressure.

Incremental cycles of unloading and reloading may be made during this test to obtain an indication of the relative amounts of reversible, i.e. elastic, and irreversible deformation that have occurred. The slope of the load/deformation curve may be used to determine the undrained deformation modulus.
