# SPRING GROVE GREEN POWER

**Riparian Mammal Report**  
Prepared for: Acorn Bioenergy Ltd

SLR Ref: 404.11923.00002  
Version No: Final  
January 2023

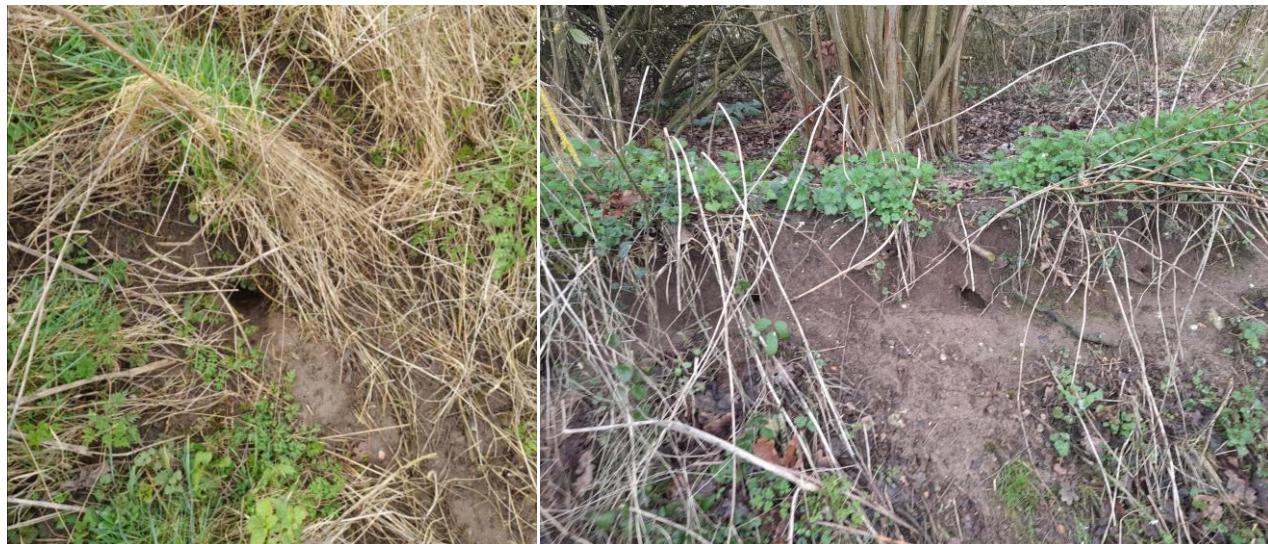
**Figure 1- Mammal holes in ditch observed during PEA**

During the UKHab Survey on 28<sup>th</sup> February 2022 small mammal holes were observed in the banks (Figure 1).

In the absence of other field signs, it is likely that the mammal burrows observed during the UKHab survey in February 2022 were created by other small mammals such as rat.

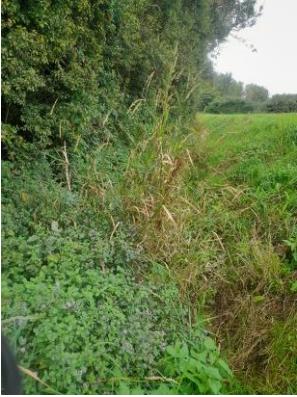
| Watercourse Reference Number & Photograph | Description | Evidence of water vole or otter |
|--|---|---|
| 1<br> | <p>The banks were steep, approximately 45-degrees.<br/>No water.<br/>Ditch 3 m wide, 2 m in depth.<br/>Clay substrate.<br/>Dense scrub and woodland to the south, arable land to the north.<br/>Vegetation within ditch: creeping thistle <i>Cirsium arvense</i>, nettles <i>Urtica dioica</i>, pendulous sedge <i>Carex pendula</i>, yellow flag <i>Iris pseudacorus</i>, water mint <i>Mentha aquatica</i> and silty in texture. The water was about 1 cm in depth, and 30 cm wide, with slow flowing water.</p> <p>This stream is assessed as unsuitable habitat for water vole.</p> | No evidence of water vole or otter. |

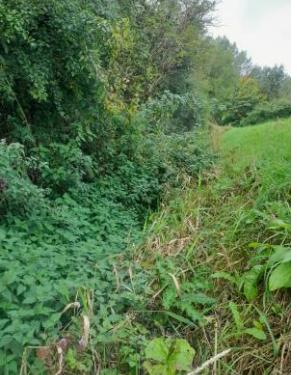
| Watercourse Reference Number & Photograph | Description | Evidence of water vole or otter |
|--|---|---|
| 2<br> | <p>Same as above, with addition of hairy willow herb <i>Epilobium parviflorum</i>, coltsfoot <i>Tussilago farfara</i>, bittersweet nightshade <i>Solanum dulcamara</i> within the ditch.</p> <p>This stream is assessed as unsuitable habitat for water vole.</p> | No evidence of water vole or otter. |

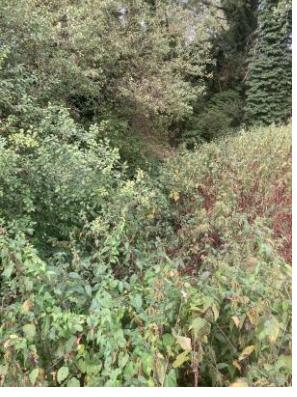
| Watercourse Reference Number & Photograph | Description | Evidence of water vole or otter |
|--|---|---|
| 3<br> | <p>Same as above, but with a greater density of nettles.<br/>This stream is assessed as unsuitable habitat for water vole.</p> | No evidence of water vole or otter. |

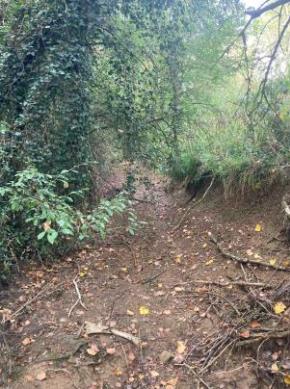
| Watercourse Reference Number & Photograph | Description | Evidence of water vole or otter |
|--|---|---|
| 4<br> | Steep banks, 80-90 degrees.<br>No water.<br>Ditch 5 m width, 1.5 m depth.<br>Sandy, gravel substrate.<br>Woodland to the north and south of the ditch (shaded).<br>No vegetation within ditch - dead wood present.<br>This stream is assessed as unsuitable habitat for water vole. | No evidence of water vole or otter. |

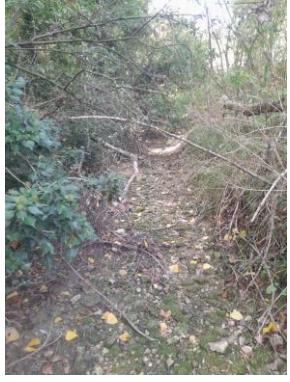
| Watercourse Reference Number & Photograph | Description | Evidence of water vole or otter |
|--|---|---|
| 5<br> | Steep banks, 80-90 degrees.<br>No water.<br>Ditch 3 m width, 1.5 m depth.<br>Substrate includes sand, gravel and larger stones with byrophytes<br>Woodland to the north and south of the ditch (shaded).<br>No vegetation within ditch, dead wood present.<br><br>This stream is assessed as unsuitable habitat for water vole. | No evidence of water vole or otter. |

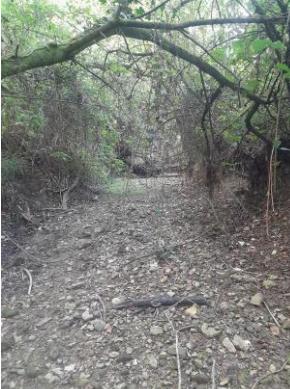
| Watercourse Reference Number & Photograph | Description | Evidence of water vole or otter |
|--|---|---|
| 6<br> | Same as above.<br>This stream is assessed as unsuitable habitat for water vole. | No evidence of water vole or otter. |

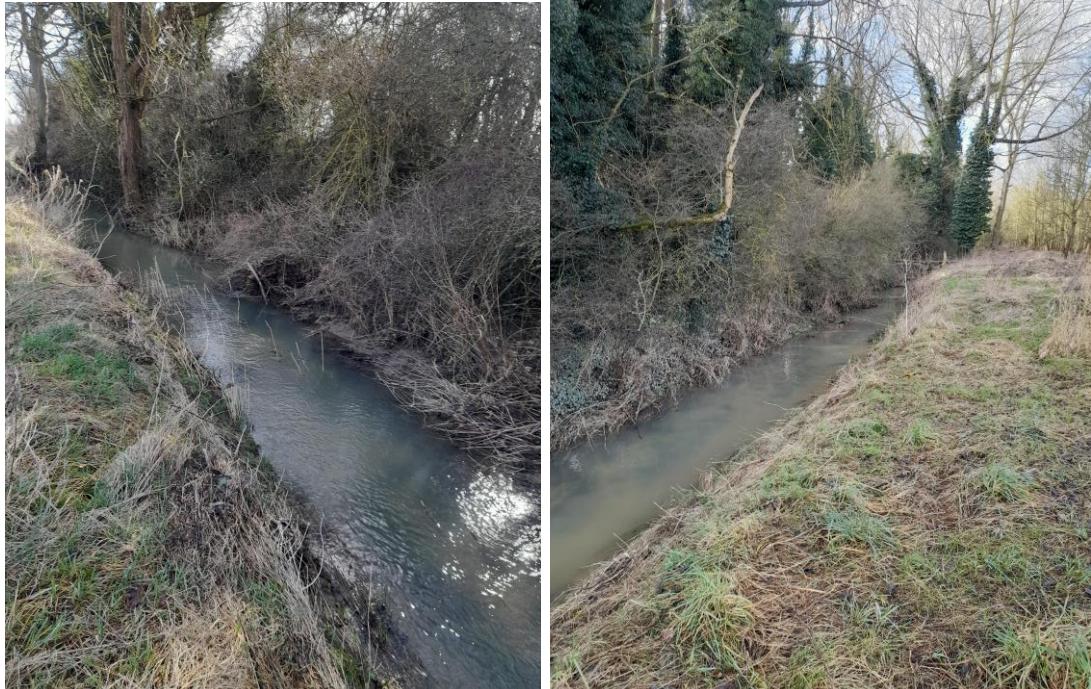
**Figure 2- Ditch during the UKHab survey in February 2022**

Though the ditch was dry during the survey in August and September, it was not the case during the UKHab survey in February (Figure 2). It is possible that habitat suitability was higher during the earlier parts of the

year, and results may be different if it had been surveyed during spring. The Site may provide suitable habitat for parts of the year.
