ML-ECOLOGY
SURVEYS & SOLUTIONS

Preliminary Ecological Appraisal – The Vixen , Millfields Way, Haverhill, Suffolk, CB9 0JB

28th March 2025

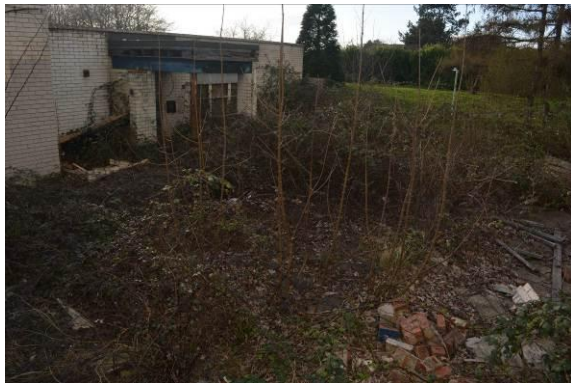
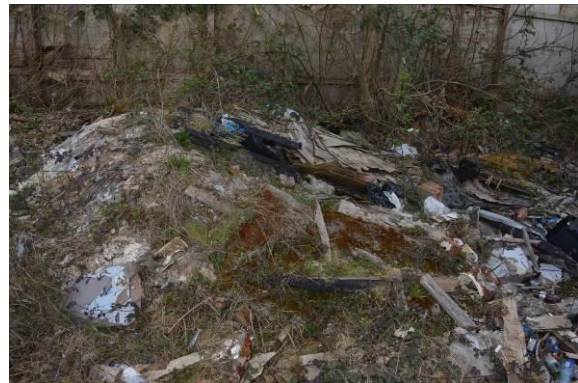
Figs. 1 & 2 Scattered scrub and spoil

The small areas scattered scrub which had colonised the small outdoor yards comprised Bramble, Butterfly Bush along with self-set Ash, Hawthorn and Hazel (Fig. 1 and 2).

As all in-use bird's nests and their contents are protected from damage or destruction, any hedge, tree or shrub removal works should be undertaken outside the period 1st March to

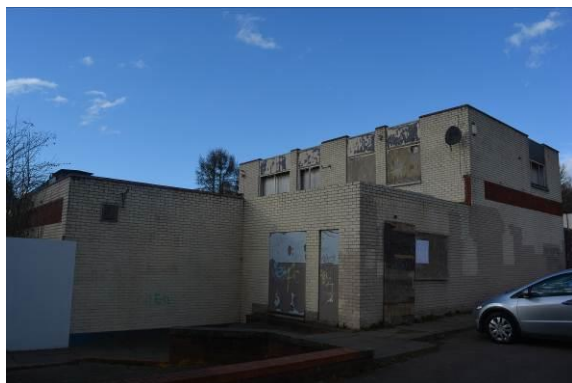
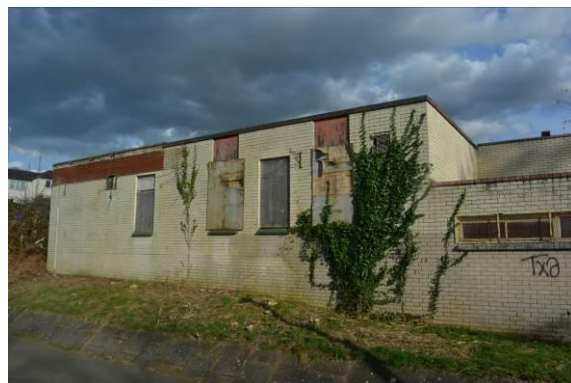
Figs. 3 & 4 Building and hard standing

The former public house building and yard represented building and hard standing (Figs. 3 and 4 - overleaf).

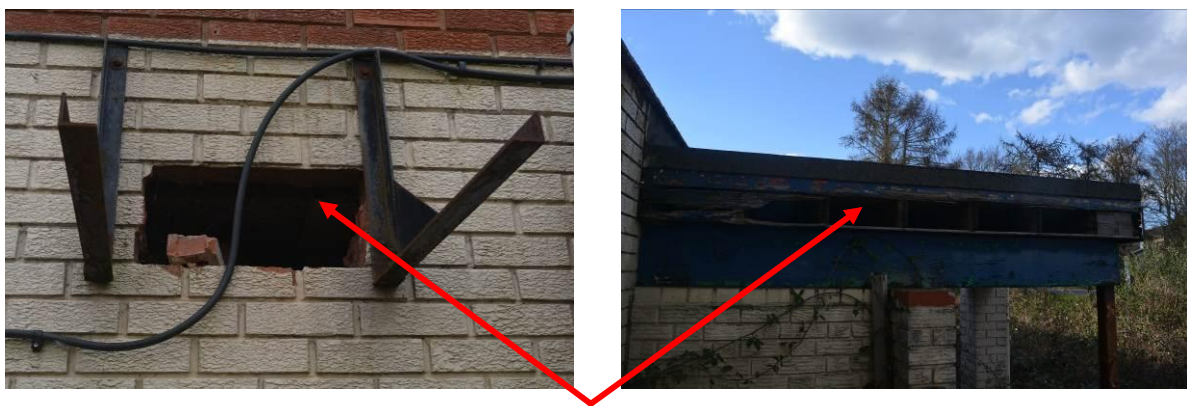
Figs. 5 & 6 External gaps and potential access points (arrowed)

The external inspection of the building revealed a number of potential access points, typically associated with holes through brickwork, missing doors and broken windows (Figs. 5, 6, 7 and 8).

An inspection of the building revealed no signs or evidence of roosting bats. However, a number of potential access points along with suitable internal niches and cavities were present.

As the building was classified as having moderate suitability for roosting and hibernating bats, it is recommended that two nocturnal emergence surveys are undertaken within the period May to August to confirm the presence or absence of roosting bats.

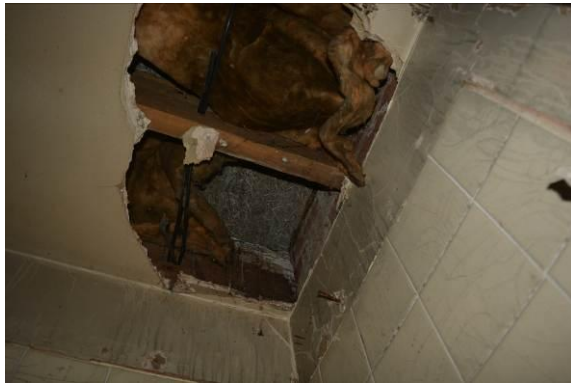
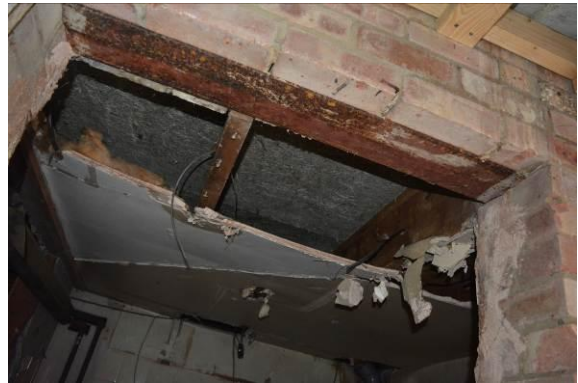
Figs. 9 & 10 Internal cavities beneath flat roofing

Internally, the inspection revealed no roof voids were present, with narrow spaces between ceilings and the flat roofing providing internal niches and cavities (Figs. 9, 10,11 and 12).

No signs or evidence of bat roosting was found at the time of the survey.
