Woodlands Hotel, Haverhill, CB9 7UW
Structural Inspection Report

Prepared for Country Court Care Group

20 June 2022

Glyme Structures Ltd

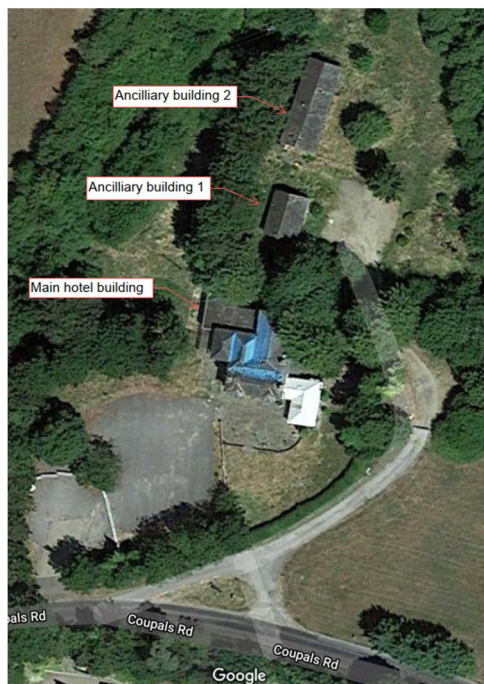
The photo gives an aerial view of the site, identifying the main two-storey hotel building and two single storey ancillary buildings.

There are numerous large trees on the site (presumably giving rise to the name Woodlands). Several of these trees are in close proximity to the buildings (sufficiently close to have an impact on the foundations).
