Project Number: 22-0364

Project Title: 23/01994/FUL WHCH Former Woodlands Hotel, Coupals Road, Haverhill

In relation to planning application 23/01994/FUL, Anglian Water have objected to a proposed discharge of surface water from the proposed development to the adopted surface water drainage network. Their concerns are raised in their Pre-Planning Assessment Report as follows:

Aquajet CCTV Survey Results

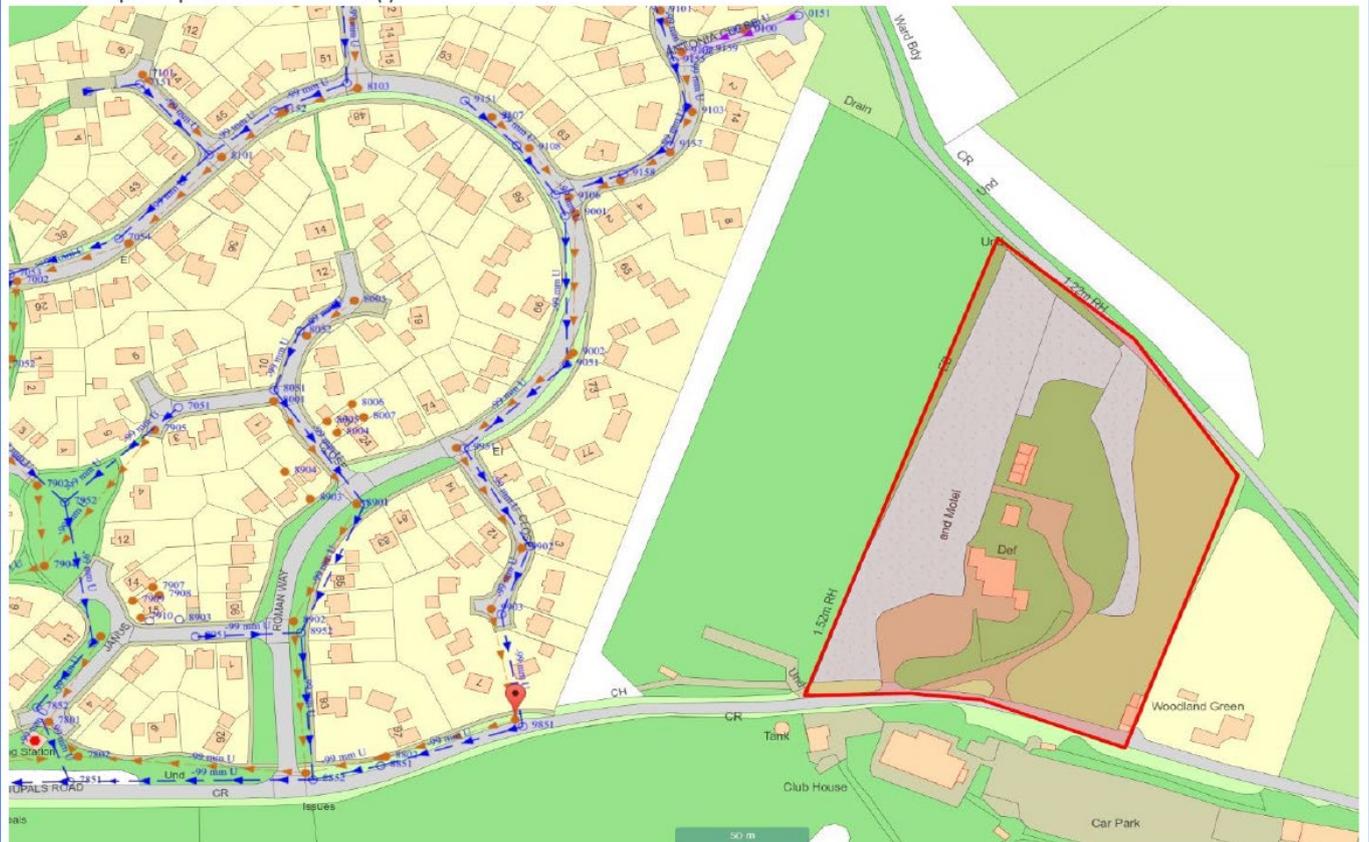
Figure 1: Showing your water recycling foul point of connection

The key issue raised by AWS is highlighted above. This is that, based on their understanding of the sewer network, there is insufficient capacity in the sewer network at the proposed point of connection to serve the site's proposed minimal discharge of 2.5 litres per second. In their report AWS include Figure 1, as reproduced on the next page. This confirms what AWS believe to be the layout of their surface water sewers.

Figure 1 shows surface water sewers collecting surface water runoff from the housing development to the north of Coupals Road and then conveying this in an easterly direction along Coupals Road beyond the western edge of Figure 1.

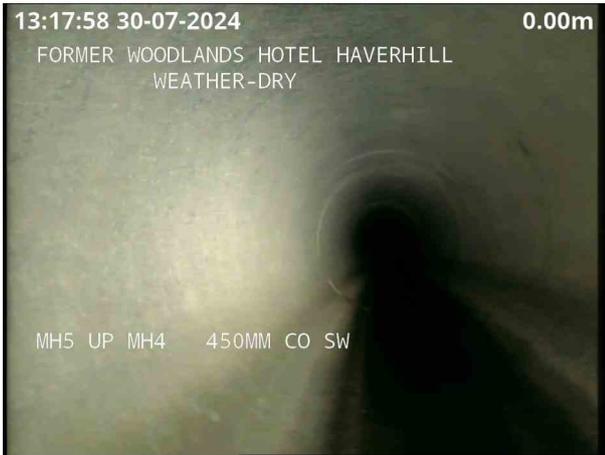
MH4X_f8c570ee-f513-4102-8dc0-f6d57a9eaf37_20240808_102750_198.jpg, 00:00:00, 0.00 m
 Water level, 5% of the vertical dimension

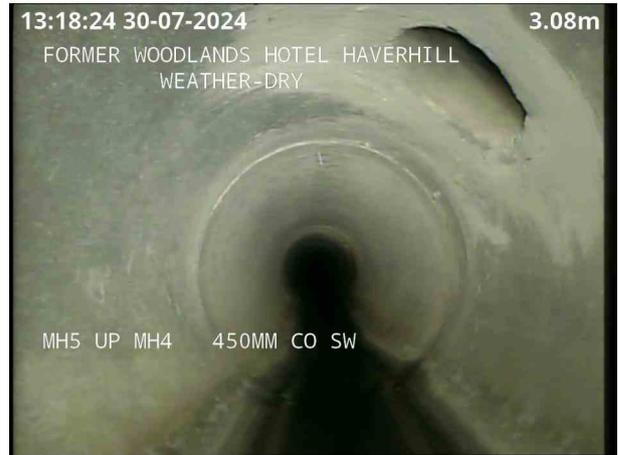
MH4X_faaf8d3a-2aba-4d3d-bc57-fbaba6405249_20240808_102850_086.jpg, 00:00:26, 3.08 m
 Connection other than junction at 1 o'clock, diameter: 150mm

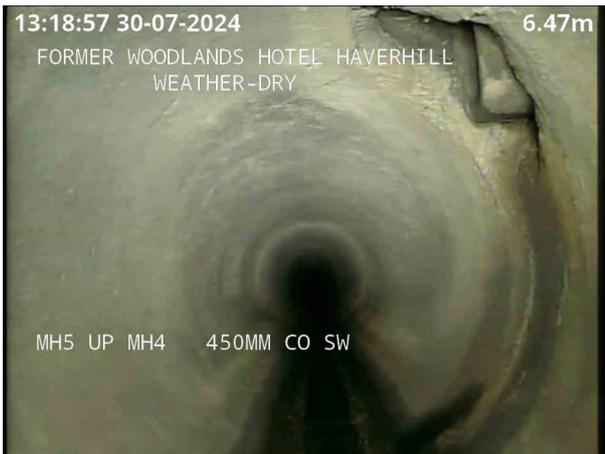
MH4X_5f71cea8-178e-44c7-9e77-b120f6bba2f2_20240808_103034_641.jpg, 00:00:59, 6.44 m
 Connection other than junction at 1 o'clock, diameter: 150mm

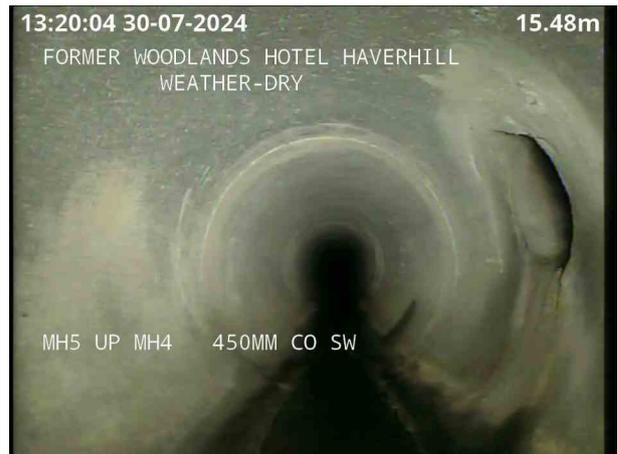
MH4X_d78165c0-7323-4dd7-bb0b-b40ceb43886e_20240808_103110_972.jpg, 00:02:06, 15.48 m
 Connection other than junction at 2 o'clock, diameter: 150mm

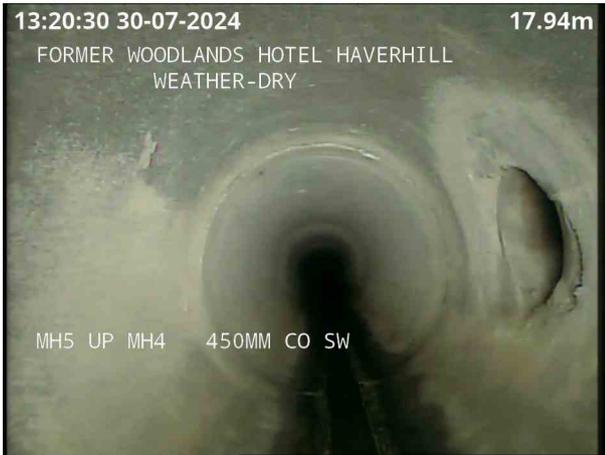
MH4X_7d810eb1-bc6b-4271-ae58-2617f380a01f_20240808_103155_884.jpg, 00:02:32, 17.94 m
 Connection other than junction at 3 o'clock, diameter: 150mm

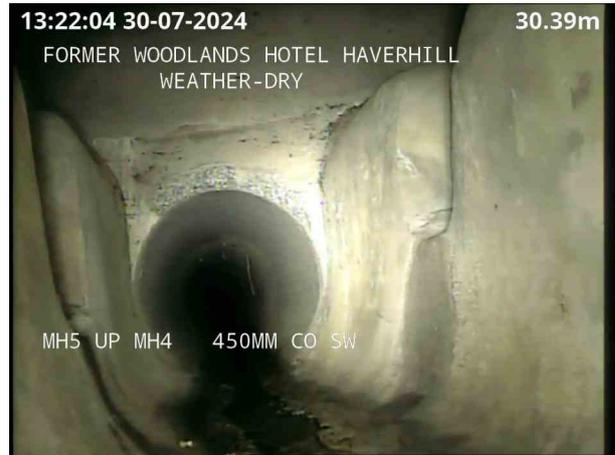
MH4X_a1bef827-aa9a-4270-b2b3-0fbb55a71f1d_20240808_103234_518.jpg, 00:04:06, 30.39 m
 Finish node type, manhole, reference number: MH4

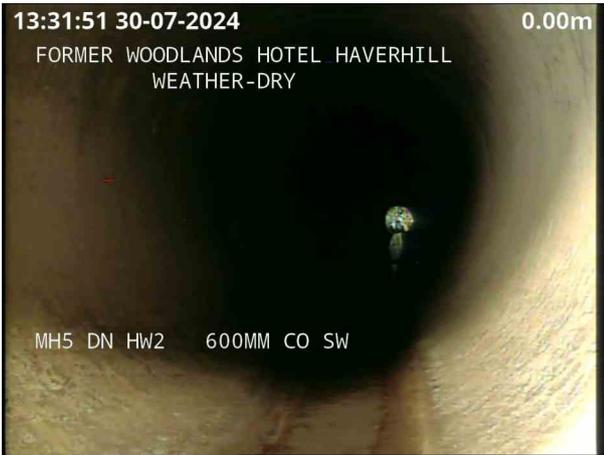
MH5X_30575b05-770c-4bb3-878c-5ec429ba5216_20240808_103342_349.jpg, 00:00:00, 0.00 m
 Water level, 5% of the vertical dimension

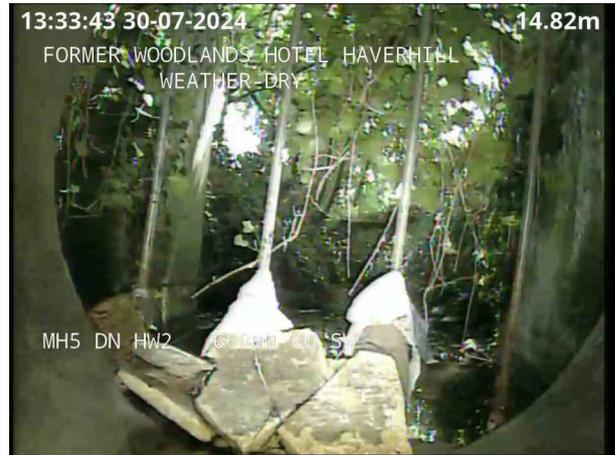
MH5X_7b88d868-373d-4963-9d24-2e012fc9aee7_20240808_103410_613.jpg, 00:01:53, 14.82 m
 Finish node type, outfall, reference number: HEADWALL2

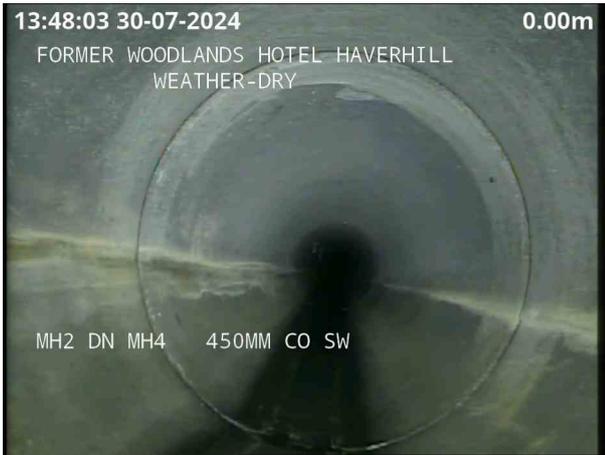
MH2X_2e5d8368-53c8-49d7-a477-7af58928ee29_20240808_103529_820.jpg, 00:00:01, 0.00 m
 Water level, 5% of the vertical dimension

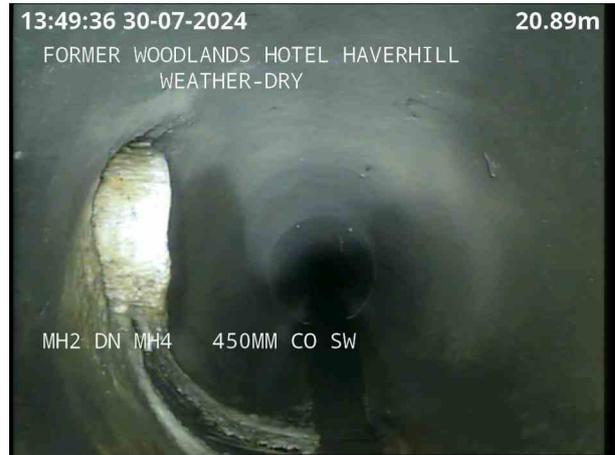
<table><tr> <td style="width: 10%;"></td> <td style="width: 10%;">0.00</td> <td style="width: 10%;">MH</td> <td style="width: 40%;">Start node type, manhole, reference number: MH2</td> <td style="width: 10%;">00:00:00</td> <td colspan="2"></td> <td></td> </tr><tr> <td></td> <td>20.89</td> <td>ID</td> <td>Infiltration, dripping at 8 o'clock</td> <td>00:01:35</td> <td colspan="2"></td> <td></td> </tr></table>

MH2X_3efe2c08-99b7-4999-8824-47dd395e93ce_20240808_103553_974.jpg, 00:01:35, 20.89 m
 Connection other than junction at 9 o'clock, diameter: 150mm

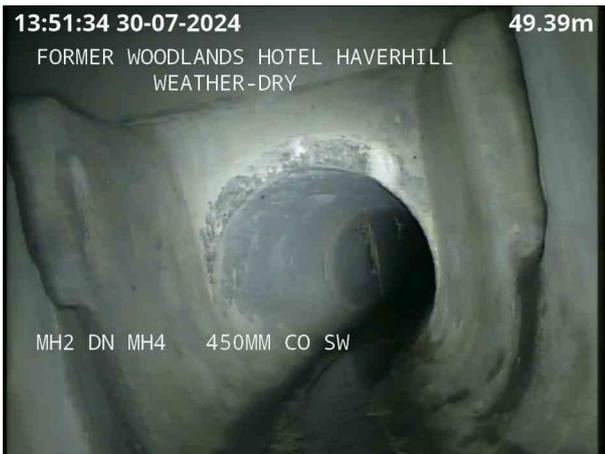
MH2X_53f16b38-1cb9-47ba-8a81-7a6118e7d8f2_20240808_104324_720.jpg, 00:03:33, 49.39 m
 Finish node type, manhole, reference number: MH4

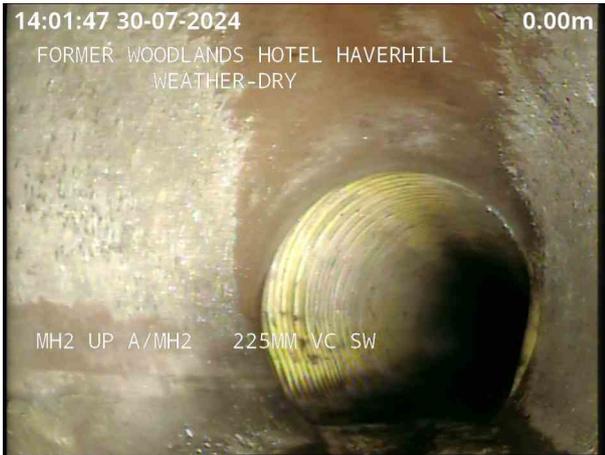
HEADWALL1X_8f0049a7-7583-4488-8ccc-2b1592f5f522_20240808_104501_522.jpg, 00:00:00, 0.00 m
 Water level, 5% of the vertical dimension

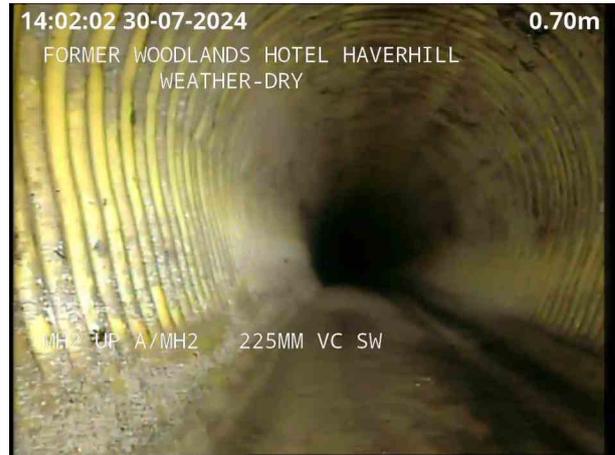
HEADWALL1X_cdf87446-05e4-4f55-ab3f-1d27256f92bf_20240808_104527_972.jpg, 00:00:14, 0.50 m
 Pipe material changes to polyvinyl chloride at this point

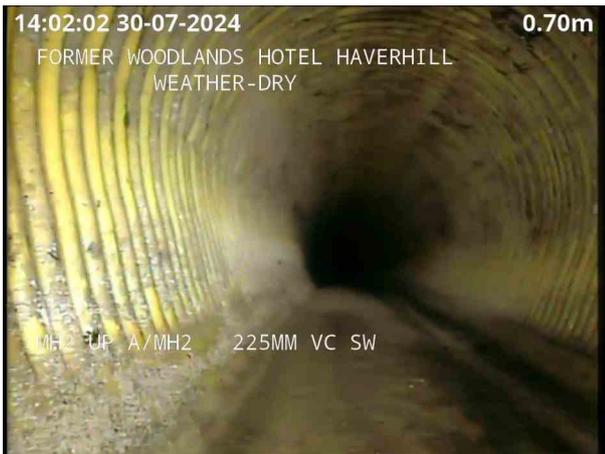
HEADWALL1X_76c6b51a-75c8-49bf-94cb-be86fd114760_20240808_104609_692.jpg, 00:00:14, 0.50 m
 Shape changes to horseshoe (i.e. inverted U), new size(s), 300mm high, 225mm wide

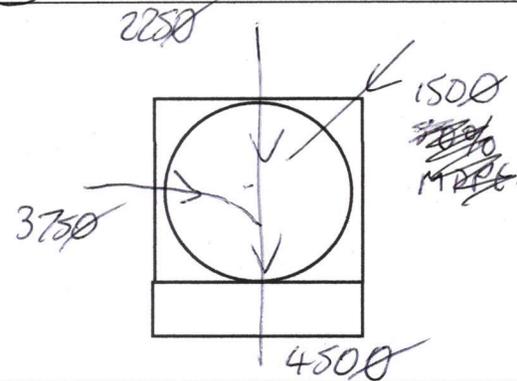
| <p>Reference: <u>IC1</u></p> <p>Duty: Foul/Surface/Combined/Other (detail in comments)</p> <p>Sketch-</p> <p>1100 PVC 0.34m 1100 PVC</p> | <p>Reference: <u>MH2</u></p> <p>Duty: Foul/Surface/Combined/Other (detail in comments)</p> <p>Sketch-</p> <p>2050 1500 3750 4500</p> |
| Observations/comments: | Observations/comments: LIVE FLOW WATERCOURSE? (NOT DAT) |
