**Tree Survey, Arboricultural Impact Assessment
Arboricultural Method Statement & Tree Protection Plan
In Accordance with BS 5837:2012**

Proj. No 10924	Haverhill Waste Development, North West of Falconer Road, Haverhill, CB9 7BG		
Client:		Leivers Consultancy Ltd	
Date of Report:	30/05/2024	Revision:	Original

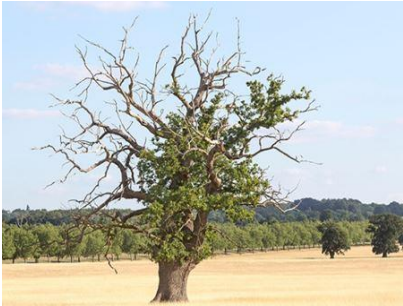
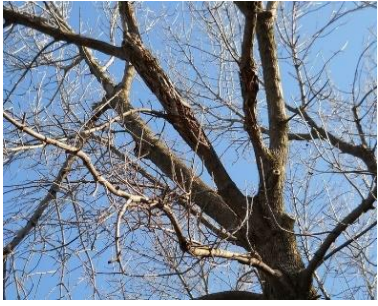
Name: Deadwood	
Symptoms/damage type and cause:	This relates to dead branches in the crown of the tree. In the majority of cases, this is caused by the natural ageing process of the tree or shading due to its close proximity to neighbouring trees. However, in some situations, it may be related to fungal, bacterial or viral infection.
Consequence:	Depending upon the location and mass of dead wood removal of the affected tissue may be necessary to prevent harm to persons or property as the wood will become unstable as it decays and in some circumstances is likely to fall from the tree with little or no warning.
Control:	Detailed monitoring should be undertaken on those trees showing signs of excessive deadwood production to identify the underlying cause.
Species affected:	Most tree species.
Images:
