**Redrow Homes Limited**

Great Wilsey Park, Wilsey Road, Little Wratting, Suffolk

**Arboricultural Method Statement - INFRASTRUCTURE FOOTPATHS**

February 2020

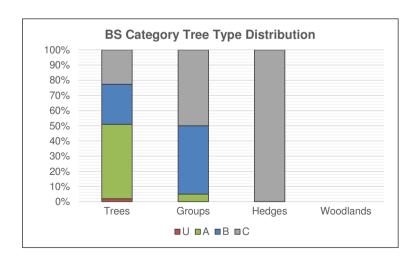
**BS Category Tree Type Distribution** displays the proportion of trees assessed in each type to enable a better understanding of the category distribution.

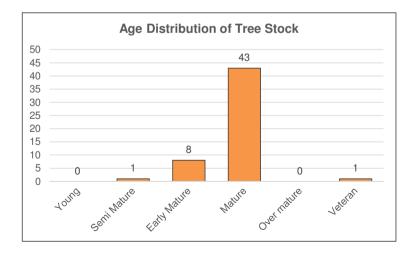
**Age Distribution of Tree Stock** shows the number of trees in each age category across the tree stock allowing assessment of their longevity to be made.
