Redrow Homes Limited

Condition 40 of DC/15/2151/OUT

Great Wilsey Park, Wilsey Road, Little Wratting, Suffolk

Arboricultural Method Statement

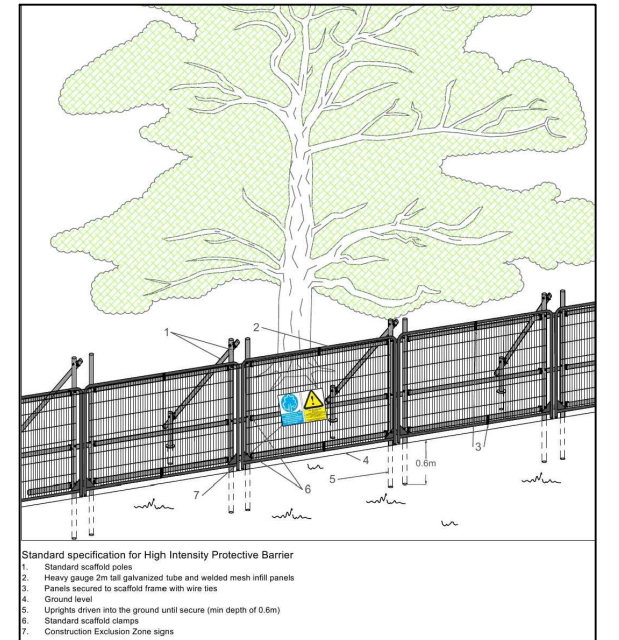
HIGH INTENSITY TREE PROTECTIVE FENCING - WORKING METHODOLOGY

Tree Protection Fencing will be installed as detailed on the Tree Protection Plan at, where possible, the extent of the root protection areas or the edge of the crowns of the retained trees. The positioning of the Tree Protective Fencing shall be measured out with assistance from the Arboricultural Clerk of Works and, where deemed necessary, with the Site Manager present. Highly visible fluorescent paint and / or marker pegs / stakes will be used to assist in identification.

- Heras Fence Panel to be supported by rubberised stabiliser blocks with a base plate which is secured to the ground using ground pins (as shown).
- No fixing shall be made to any tree and all possible precautions shall be taken to prevent damage to tree roots when locating posts.

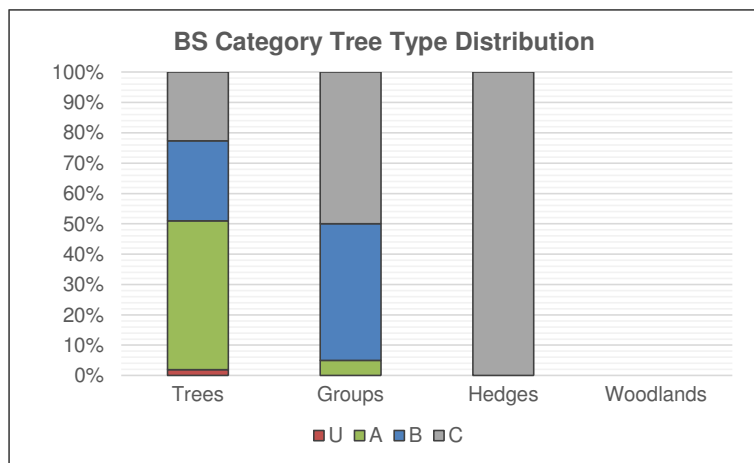
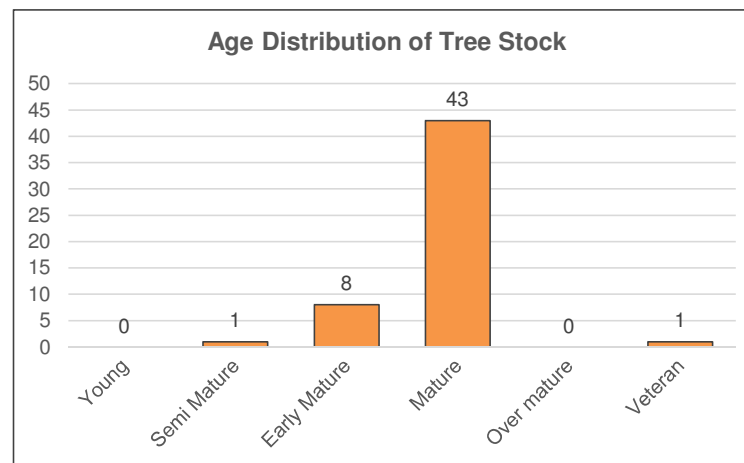
BS Category Tree Type Distribution displays the proportion of trees assessed in each type to enable a better understanding of the category distribution.

Age Distribution of Tree Stock shows the number of trees in each age category across the tree stock allowing assessment of their longevity to be made.

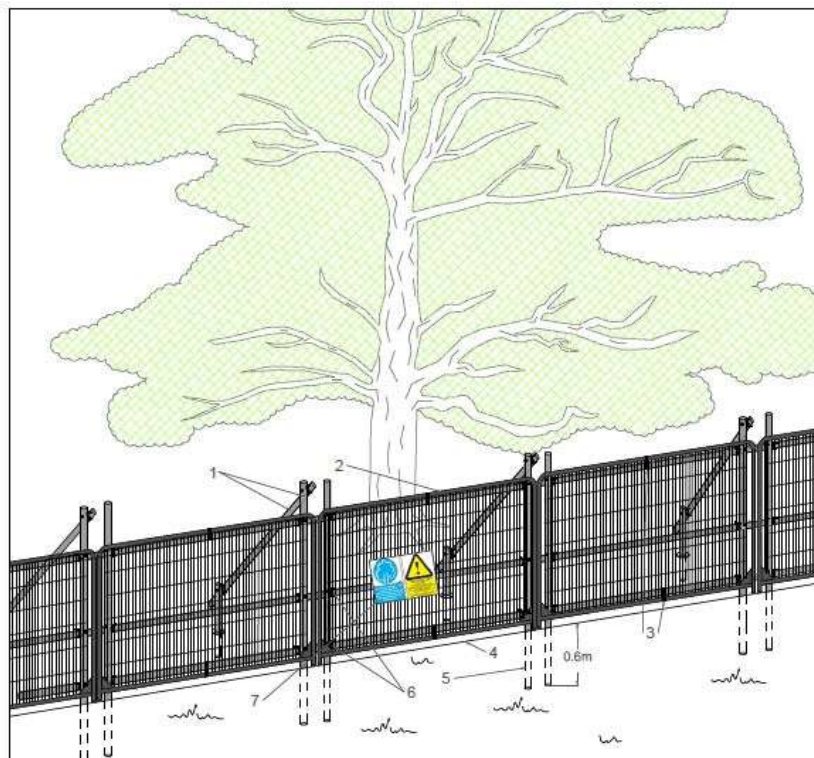
Standard specification for High Intensity Protective Barrier

Unless stated below, Protective Fencing will comprise a Heras HSG151 panel framework supported by scaffold poles driven into the ground. An example of this has been illustrated below.

1. Standard scaffold poles
2. Heavy gauge 2m tall galvanized tube and welded mesh infill panels
3. Panels secured to scaffold frame with wire ties
4. Ground level
5. Uprights driven into the ground until secure (min depth of 0.6m)
6. Standard scaffold clamps
7. Construction Exclusion Zone signs

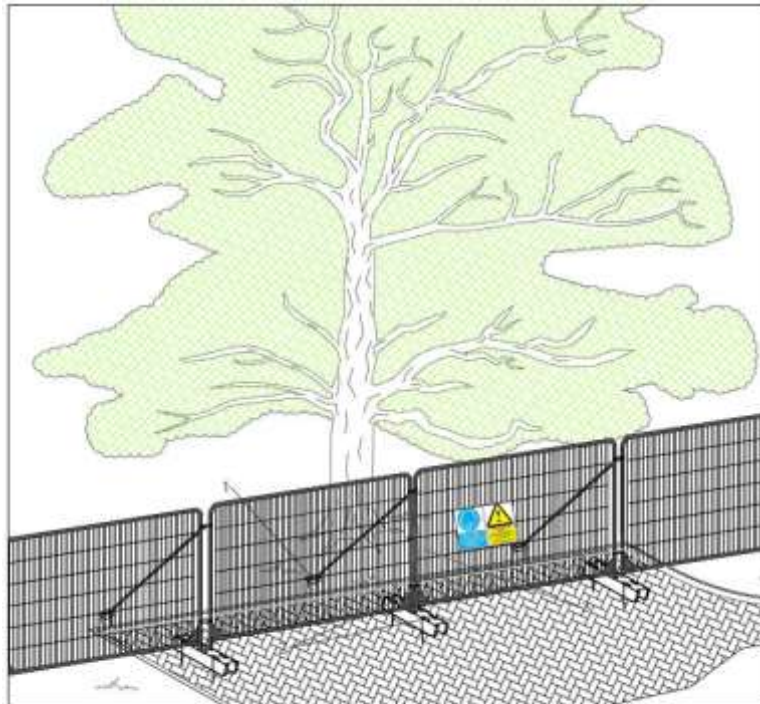
Standard Specification for Above Ground Stabilizing Systems
 1. Stabiliser post with base plate secured with ground pins
 2. Feet blocks secured with ground pins
 3. Construction Exclusion Zone sign

Heras Fence Panel to be supported by rubberised stabiliser blocks with a base plate which is secured to the ground using ground pins (as shown above).
