Arboricultural assessment & method statement

Camps Road, Haverhill

21st June 2021 19351-AA3-DC

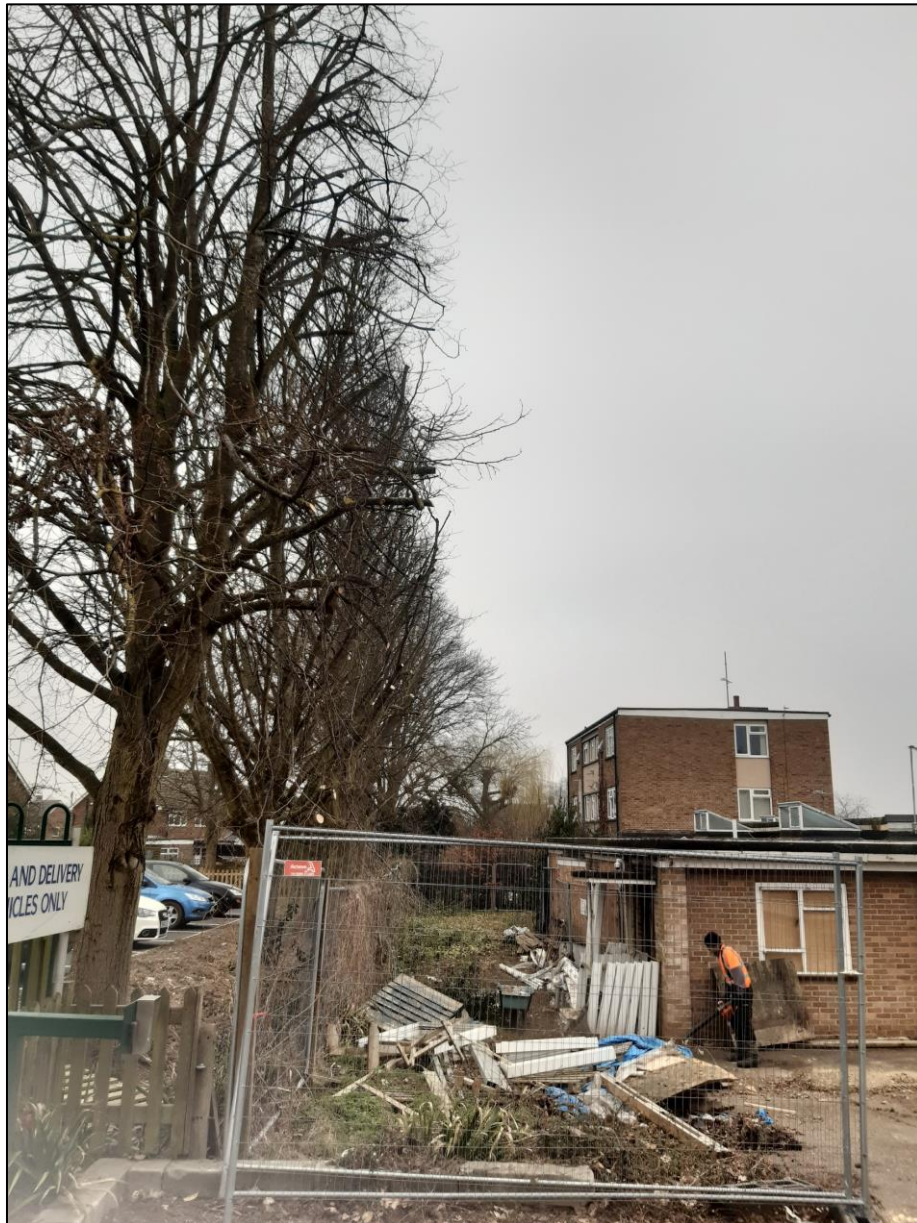
Photo 1: Showing trees T40 -T44 growing adjacent to the school boundary which have recently been pruned. The new dwellings are located on the same building line as the existing building. A new substation base and new parking are located within the RPA for tree T40. This will be carried out in accordance with the guidance within the SGNs to limit impact.

Trees T40, T41, T42, T43 and T44 have recently been pruned to reduce selected lateral branches on the southern aspect over the site. This work will have no long-term detrimental impact on tree health and because the profile from public viewpoints would remain largely unchanged, it will have no significant impact on local character.
