**REPORT ON  
GROUND INVESTIGATION  
AT  
HAVERHILL BUSINESS PARK,  
SUFFOLK**

<b>Client:</b>	HE2 Haverhill 1 GP Limited
<b>Report Title:</b>	Report on Ground Investigation at Haverhill Business Park, Suffolk
<b>Report Number:</b>	AG2983-19-AH86
<b>Report Status:</b>	Validated Issue 1
<b>Date:</b>	June 2019

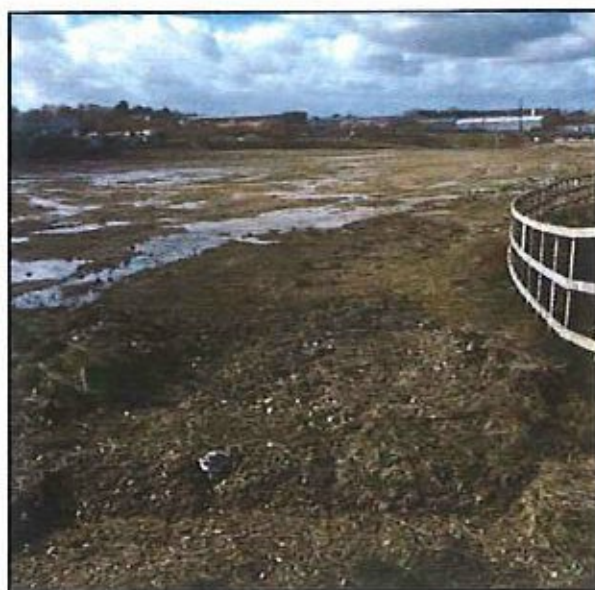
Standing water on the surface of the site

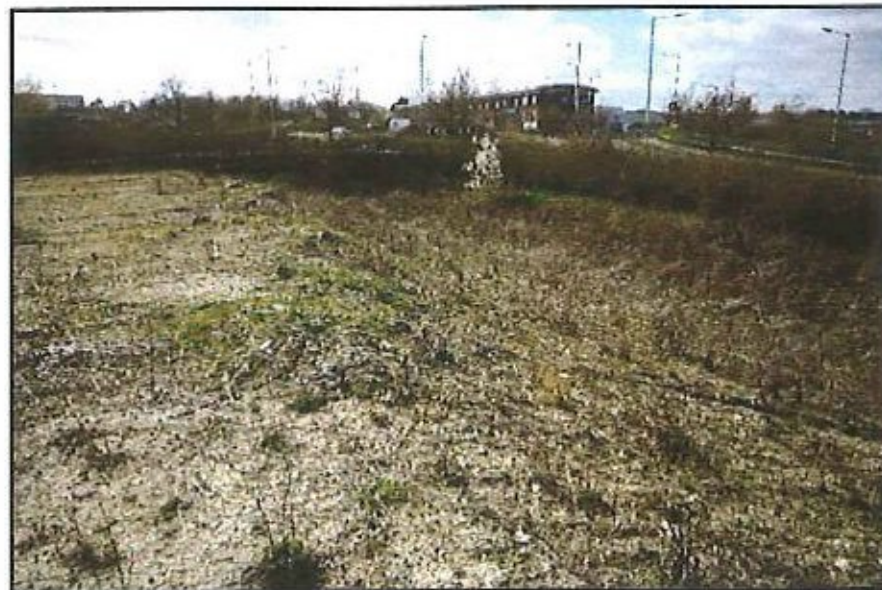
Northern edge of the site - lime stabilised retaining wall structure

- A cement stabilised earth retaining structure / steep embankment slope (residing at c. 70 degrees) was constructed along the northern site boundary to retain the earthworks and designed by ISC;
